CITY PROPERTY SERVICES

Property Inspection Report

Sample Report- Hill Side Property.inspx

Water On Yes
Temperature 75 F
Weather Partly cloudy Soil Conditions Dry
Space Below Grade Crawl Space
Building Type Duplex Garage Attached
Sewage Disposal City How Verified
Water Source City How Verified
Additions/Modifications Unknown
Permits Obtained Unknown

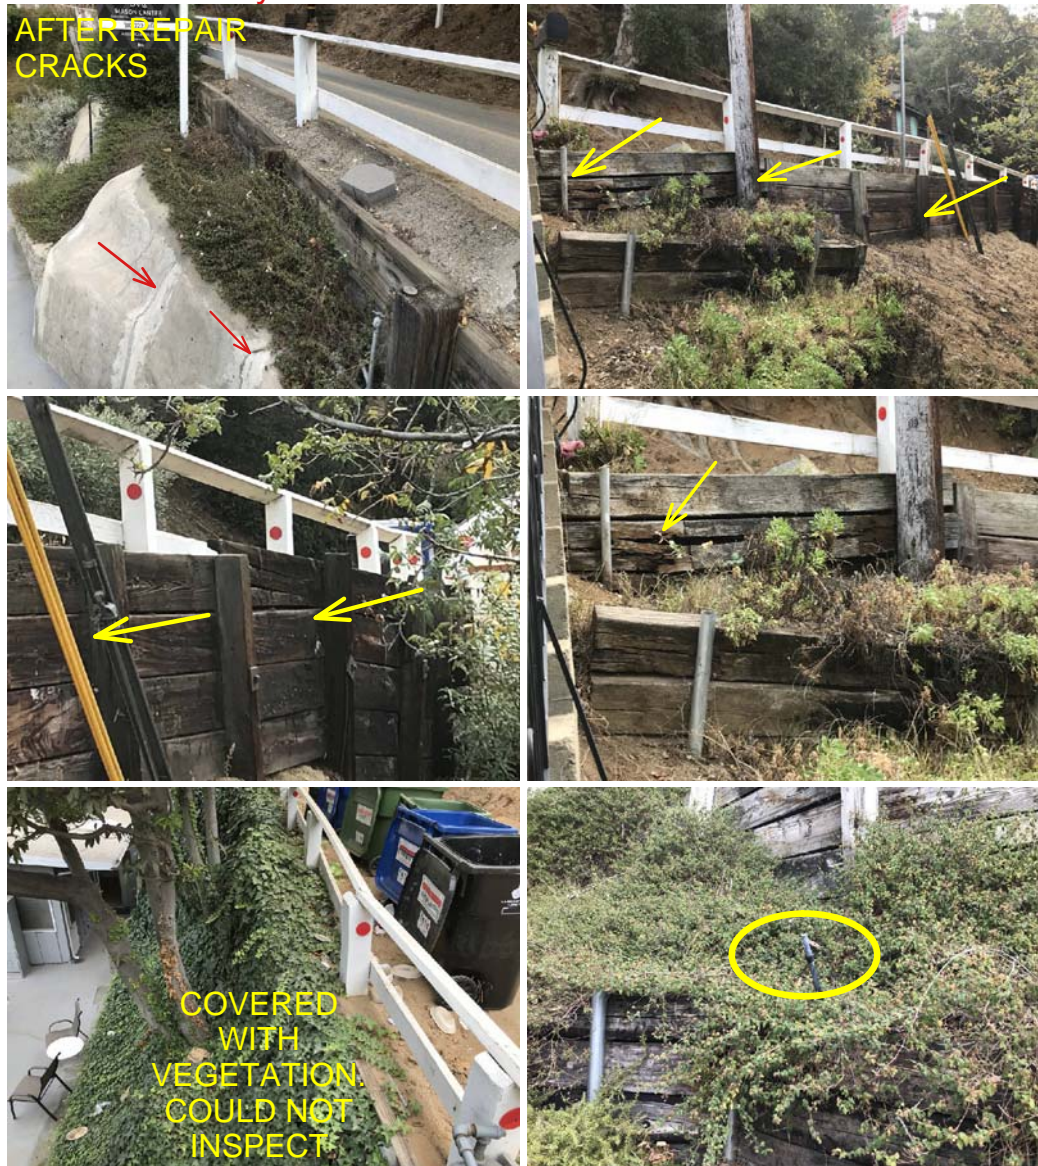
Retaining Walls: 1. Retaining walls need repair or reinforcement at different areas, including concrete stairs that are attached to them, which show deformation to some degree. Separation and minor displacement as well damage and rot on some of the wooden retainers are evident. Some of the cracks have occurred after sealing and grouting of some areas. Also see slabs and floors in Structure category. As this is a hill side structured property, a geologist or structural engineer could provide specialty opinion regarding the soil condition, etc and existing condition of this property, 2. If retaining walls adjacent to street have been installed by the local authority, then it is suggested that any defects and repair needs be conveyed to the local authority for maintenance or repairs if needed. Note: Some need repair and attention now. 3. The retaining walls / structure adjacent to

street pavement, at right side of property are covered with vegetation inspection of their condition was not possible. Recommend removal of the vines for two main reasons: A. Observation access for retainers condition, B. Prevention of moisture activity and rodent / insect traffic, 3. Recommend discontinuing with all sprinkler jetting heads to prevent moisture activity at all uncovered retained soil.

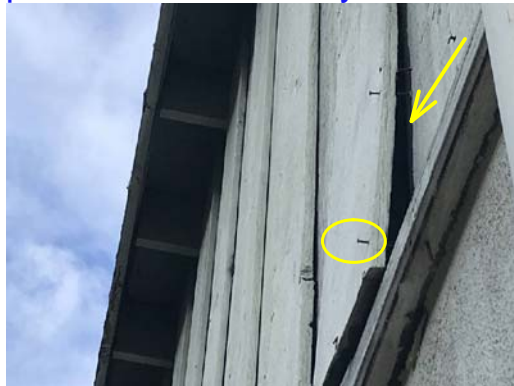
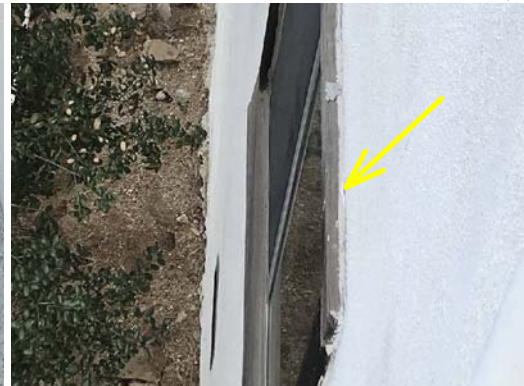
- 1. Needs Attention Type: Stucco, Siding - 1. Any opening, separation, or crack on the exterior walls should be sealed patched and painted if necessary, to prevent further decay and admittance of water or insect traffic,

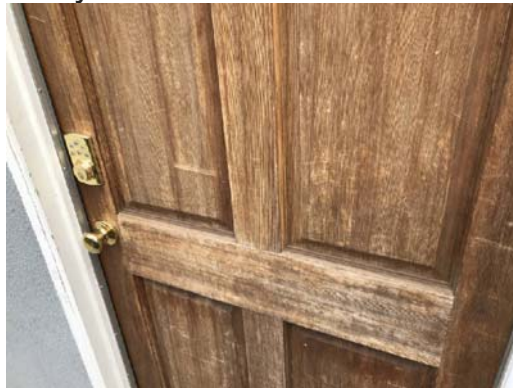
Entry Doors: Unit 2 - **Due for resurfacing and staining / Painting**

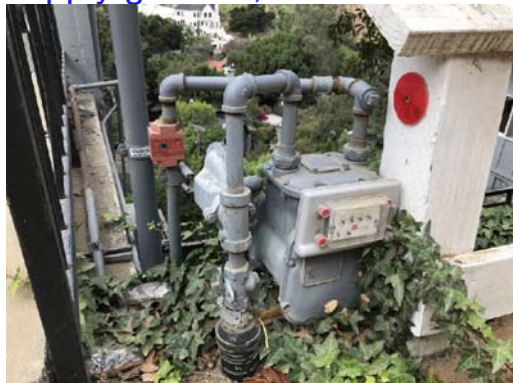
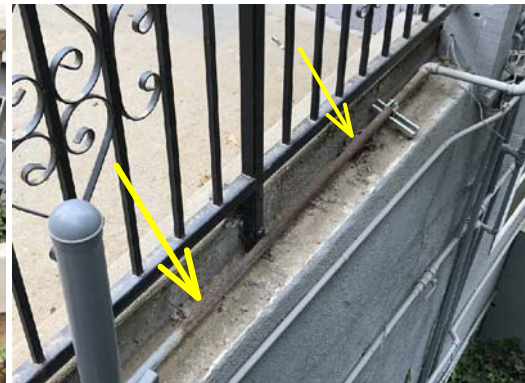
Gas Meter: Right side of Garage / At Curb. **1. Equipped with Earth Quake Shut Off Valve. Earth quake shut of valve should be checked periodically (at least every two years) by a qualified plumber for functionality and defects check, 2. Recommend sand and painting the supply gas line, as it shows corrosion.**

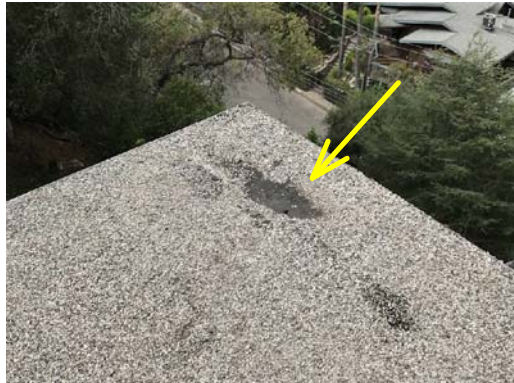
1. Method of Inspection: On roof
2. Not Inspected Unable to Inspect:
3. Needs Attention Material: Tar and gravel - **Minor gravel adding needed. In generally acceptable condition. Inspect roof on yearly basis for routine maintenance before rain season.**

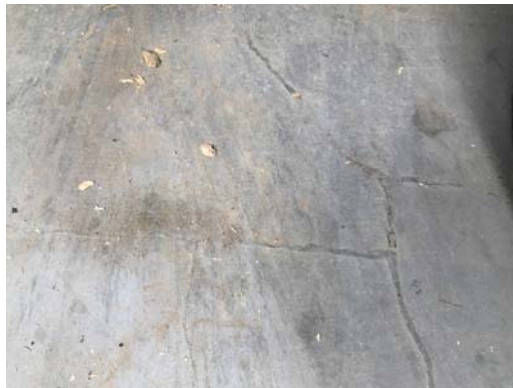
Floor/Foundation: Poured concrete - Evidence of past repairs

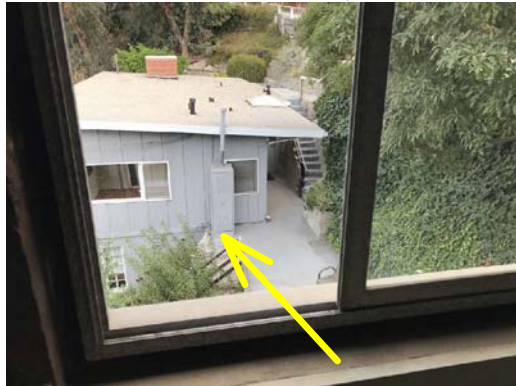
Windows: Alumimun, Slider - **Missing or damaged screen**

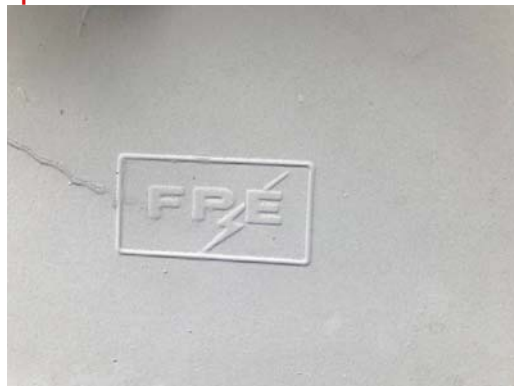
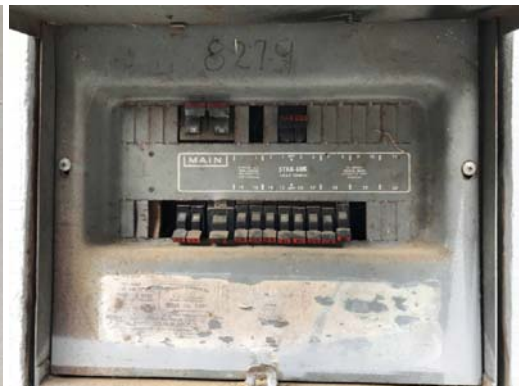
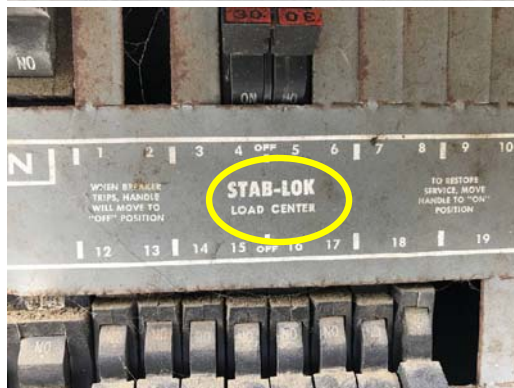
- 1. Service Size Amps: 100 Volts: 120-240 VAC
 - 2. Acceptable Service: Copper
 - 3. Acceptable 120 VAC Branch Circuits: Copper
 - 4. Acceptable 240 VAC Branch Circuits: Copper
 - 5. Not Inspected Aluminum Wiring:
 - 6. Acceptable Conductor Type: Non-metallic sheathed cable
 - 7. Acceptable Ground: Plumbing and rod in ground
 - 8. Acceptable Smoke Detectors: See individual rooms
- Left Side of Garage Electric Panel
- 9. Serviceable Manufacturer: Federal Pacific - **Federal Pacific panel breakers have a history of not tripping when circuit overloading exists (Stab-Lock Breakers) and cause fire. Recommend replacement. Consult a qualified electrician.**

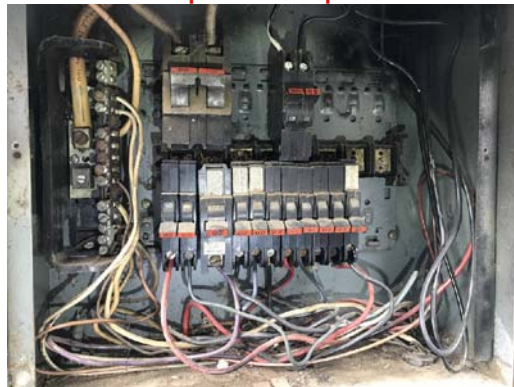
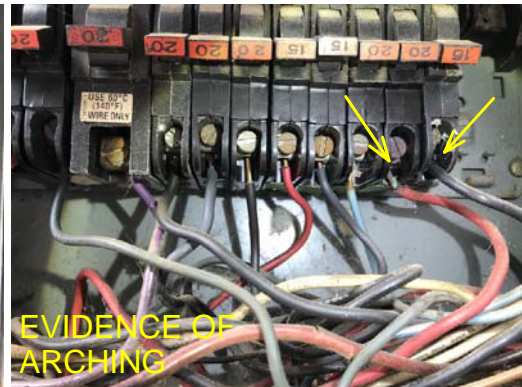
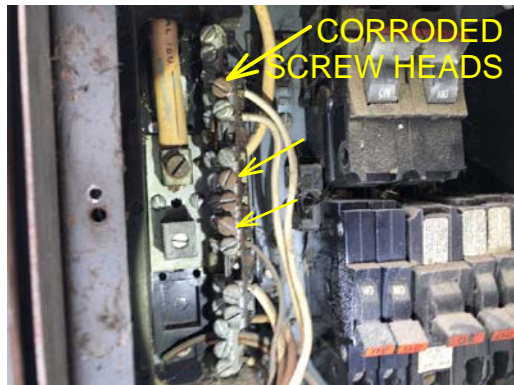
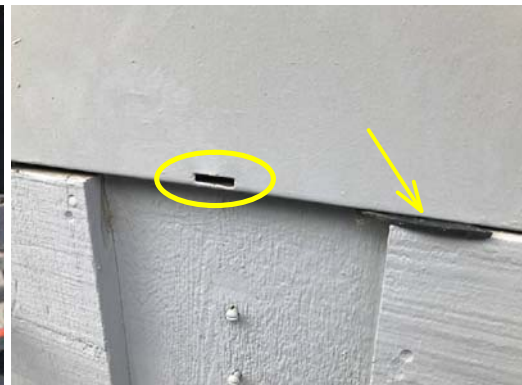
Breakers: Copper - Consult a qualified electrician. 1. Panel is undersized for the size of property or today's use. Recommend upgrade. Labeling not marked, not conspicuous or wrong. Labeling is necessary as a matter of convenience and emergency, 3. One or more branch circuit connection screws show corrosion. recommend replacement and keeping cover closed to prevent moisture and insect entry, 4. Signs of arcing and melting noted, 5. Latching tab broken. Consult a qualified plumber

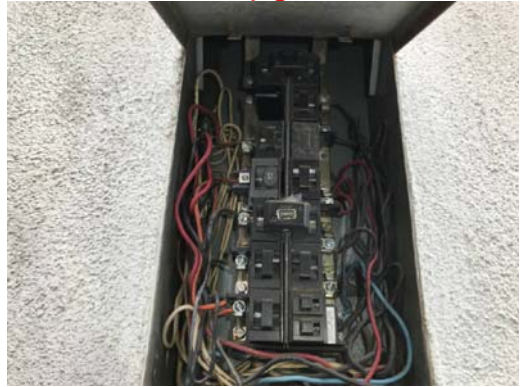
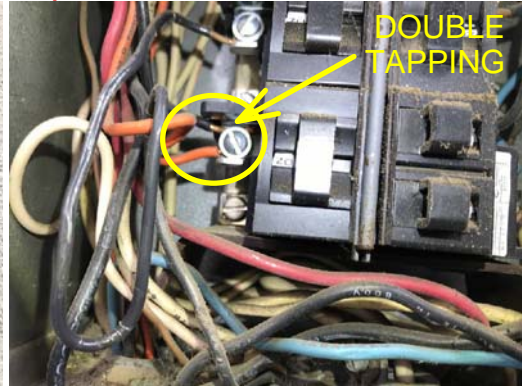
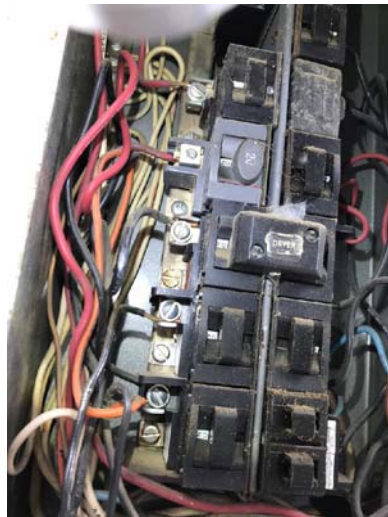
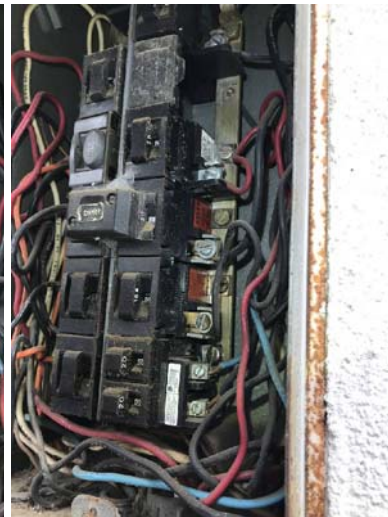
Breakers: Copper - 1. Double tap wiring-two or more wires on one or more breakers noted. This may cause overheating and start a fire, 2. Panel is undersized for the size of property or today's use. Recommend upgrade. Consult a qualified electrician.

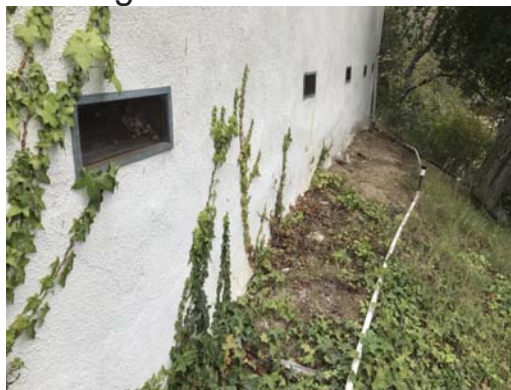
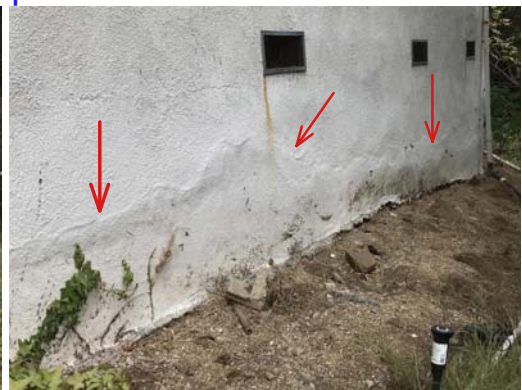
5. Needs Attention Bearing Walls: Frame - Past repairs close to foundation walls noted.

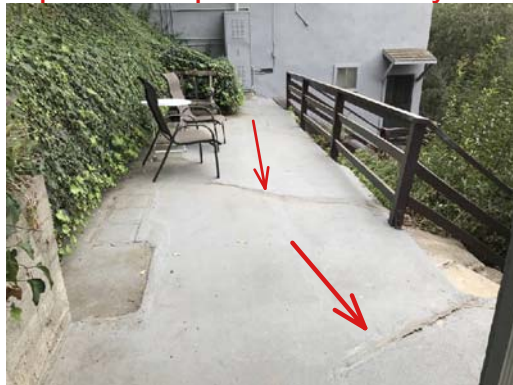
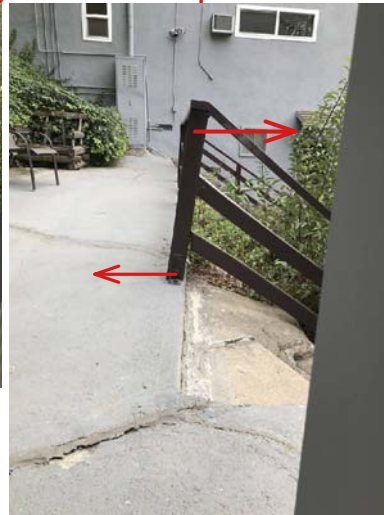
Floor/Slab: 1. Slabs at different areas show minor displacement and past repair, and after repair cracks. If these cracks have been here for longer than three years, then any soil movement progressions are very minute. A geologist can provide further evaluation and specialty opinion, 2. Some of the wooden or concrete stairs show displacement and deformation and some have been repaired. Some should be repaired at present as they may become trip and fall hazard.

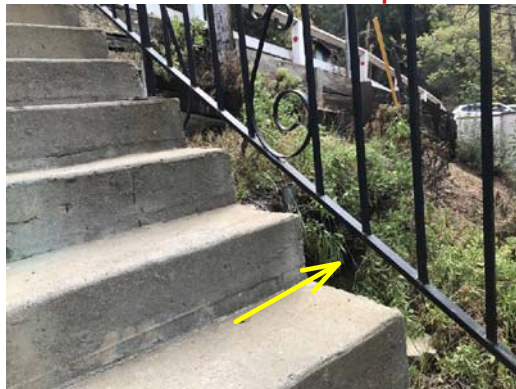
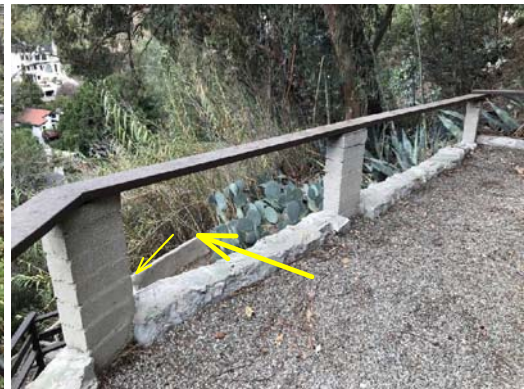
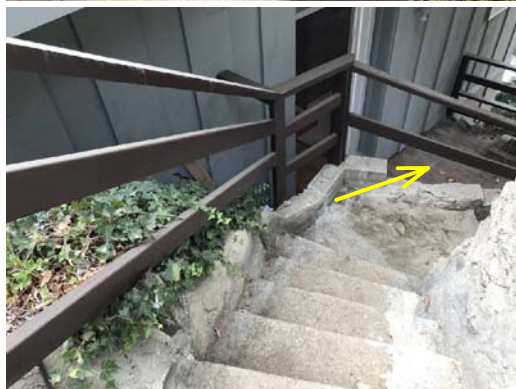
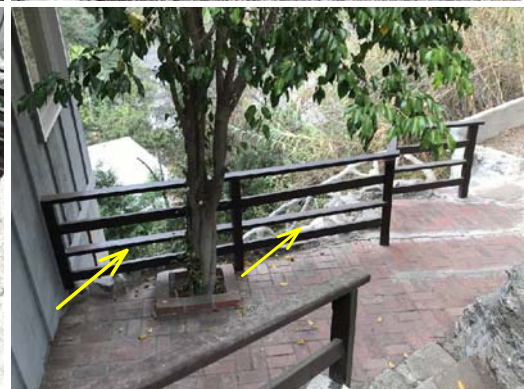
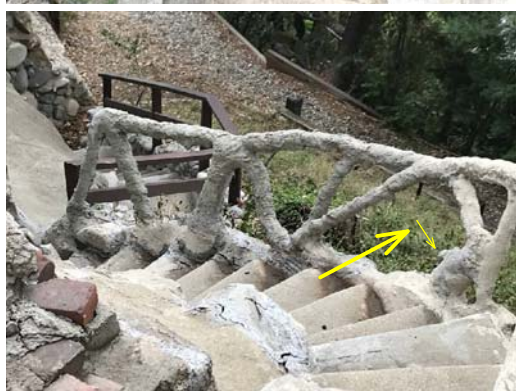
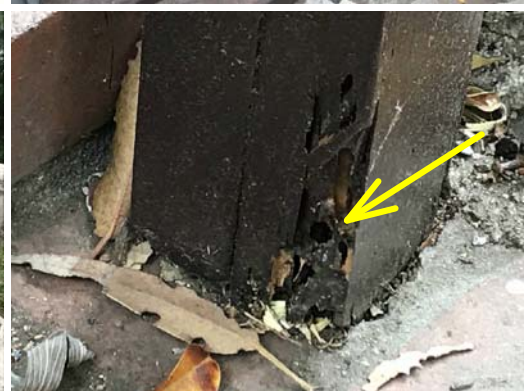
Stairs/Handrails: 1. Balusters / Frame bars are too far apart. At the time of original construction this may have not been a requirement. Child and pet safety. Consult a licensed contractor for remedy and cost, and inquire about your local code, 2. One or more posts show minor termite / rot and should be replaced, 3. Some spots should be equipped with guard rails (Left of water heater deck at main structure) for safety reasons, 4. Some are shorter or lower than standard and could become fall or trip hazard.

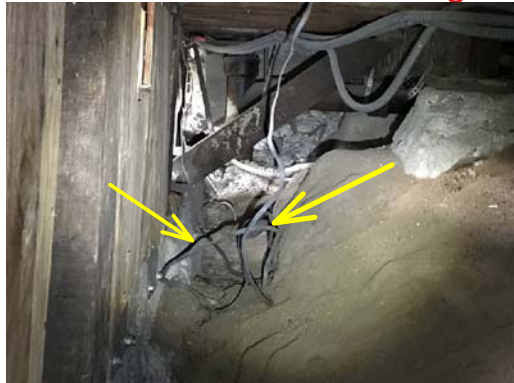
11. Serviceable Electrical: **Unsecured wiring is safety hazard.**

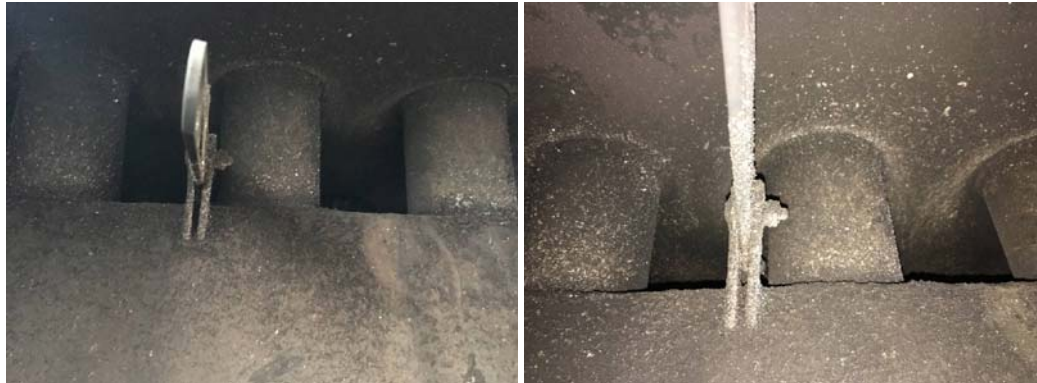
- 1. Not Inspected Freestanding Stove:
- 2. Acceptable Fireplace Construction: Prefab
- 3. Type: Wood burning
- 4. Acceptable Fireplace Insert: Standard
- 5. Acceptable Smoke Chamber: Metal
- 6. Serviceable Flue: Metal - Recommend cleaning and reinspection. Damper is old and stuck.

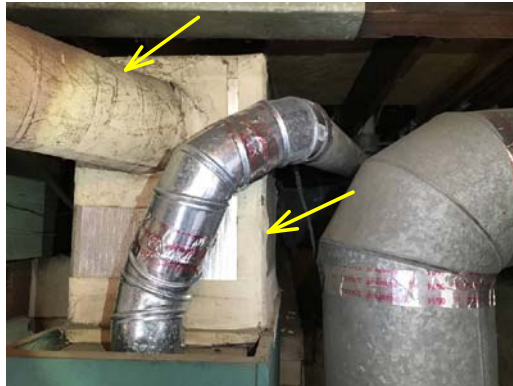
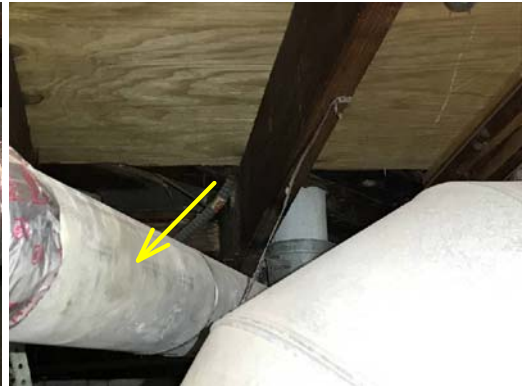
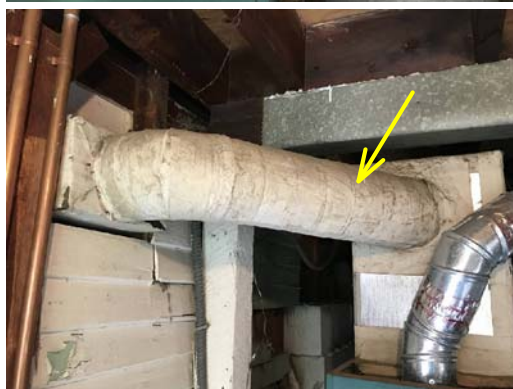
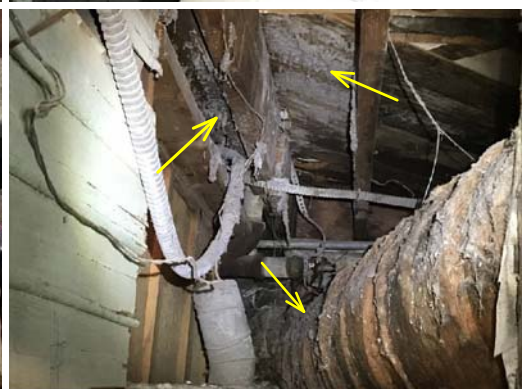
Flue Pipe: Double wall - **Laundry lint leakage noted here. Too much lint release could become fire hazard.**

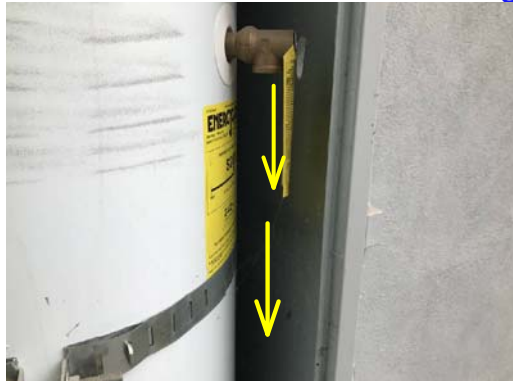
- 13. Needs Attention TPRV and Drain Tube: [Missing drain tube](#)

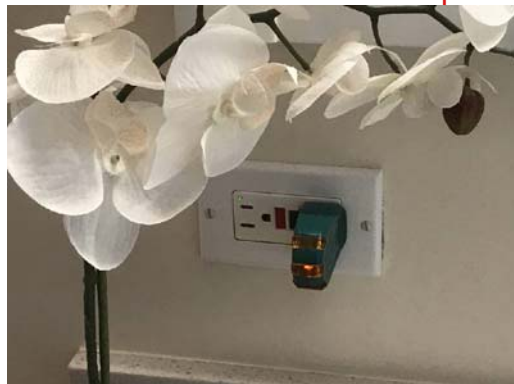
| 7. Serviceable | Electrical: 110 VAC - One or more faulty outlet with loose, unconnected or crossed wires. Consult with a qualified electrician. |

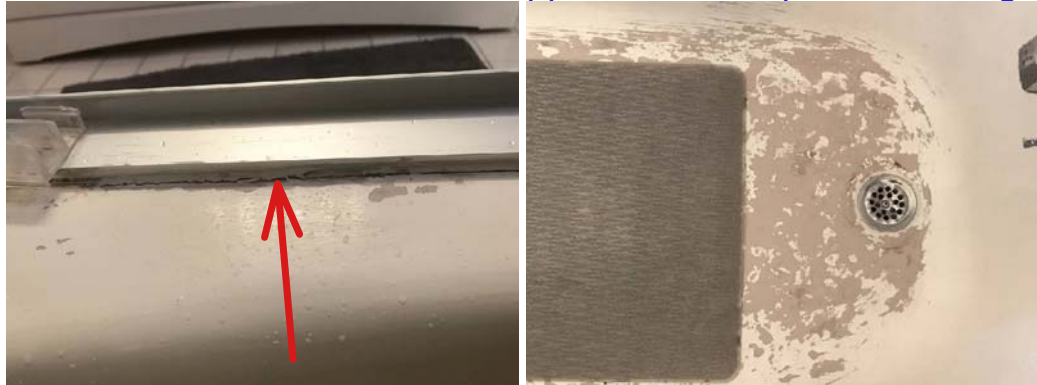
Sink/Basin: Porcelain
 Faucets/Traps: Delta fixtures with a PVC trap
 Tub/Surround: tile & tile - 1. Chipped tub, 2. Replace caulking

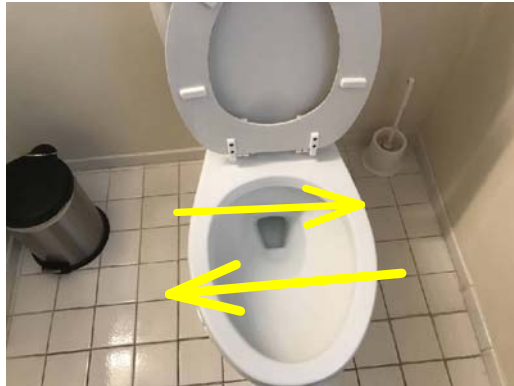
Shower/Surround: Tile and Tile
 Spa Tub/Surround:
 Toilets: Toilet is loose

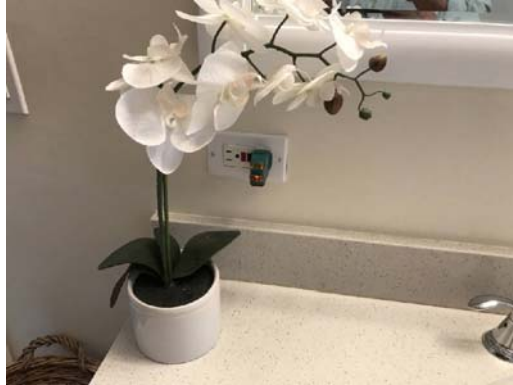
Electrical: 110 VAC - **One or more faulty outlet with loose, unconnected or crossed wires. Consult with a qualified electrician.**

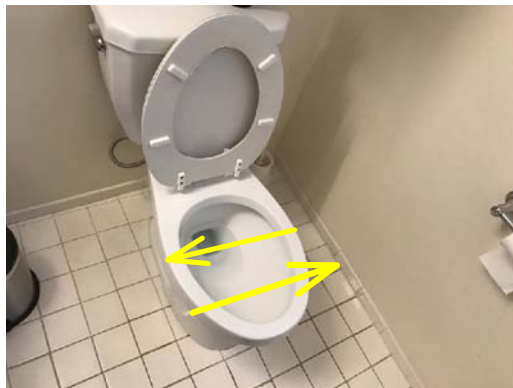
Counter/Cabinet: Granite and Wood
 Sink/Basin: Porcelain
 Faucets/Traps: Delta fixtures with a PVC trap
 Tub/Surround: tile & tile
 Shower/Surround: Tile and Tile
 Spa Tub/Surround:
 Toilets: **Toilet is loose**

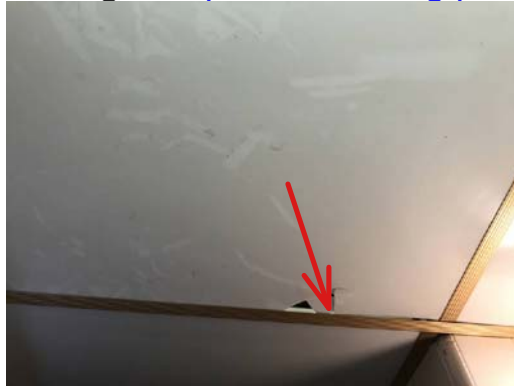
Ceiling: **Suspended ceiling panel damaged.**

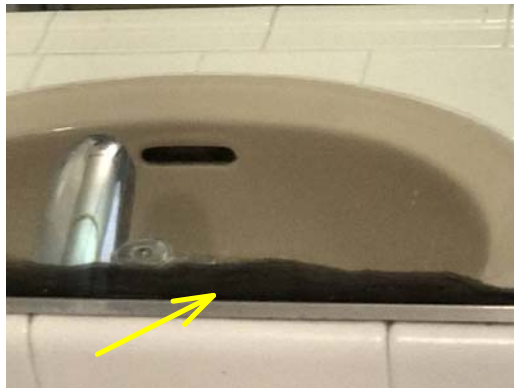
Walls: Wood - **Worn out mercury on mirror.**

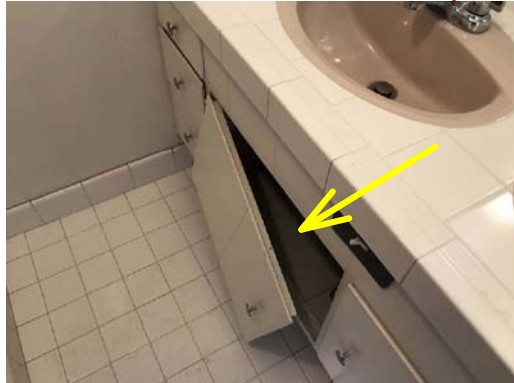
Sink/Basin: Porcelain - **Repair / Replace as necessary.**

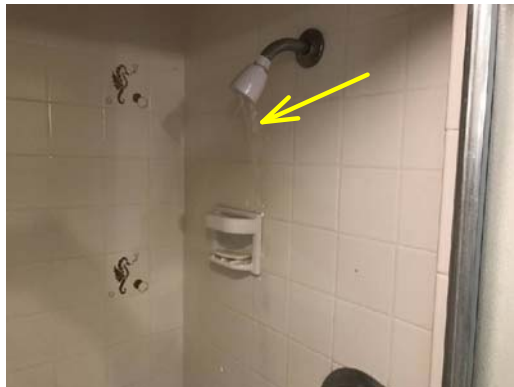
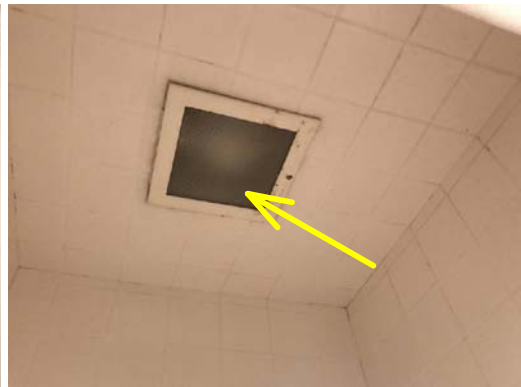
Shower/Surround: Tile and Tile - **1.Low flow, 2. Inoperative or burned bulb.**

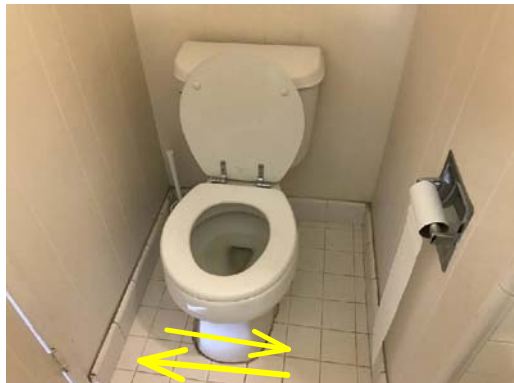
Toilets: **Toilet is loose**

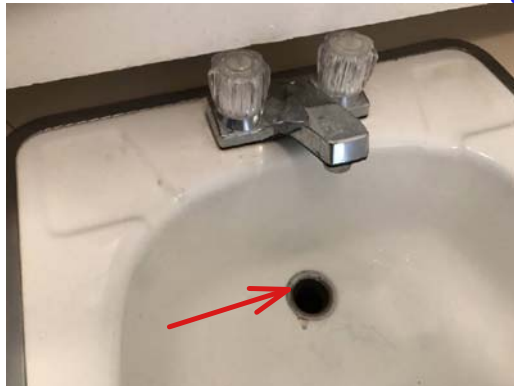
Counter/Cabinet: Composite and wood
Sink/Basin: Porcelain - **Missing stopper**

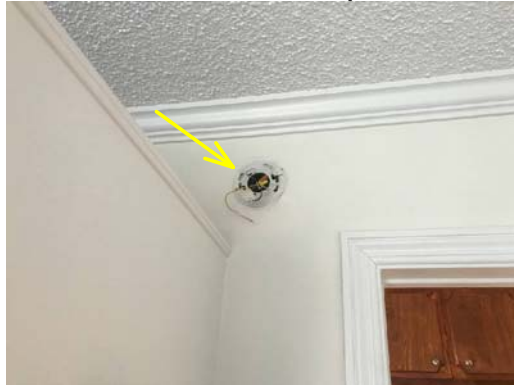
- 1. Acceptable Closet: Large
- 2. Acceptable Ceiling: Popcorn
- 3. Acceptable Walls: Paint and paneling, Wood
- 4. Acceptable Floor: Laminate
- 5. Acceptable Doors: Wood
- 6. Acceptable Windows: Alumimun, Slider
- 7. Acceptable Electrical: 110 VAC
- 8. Acceptable HVAC Source: Heating system register
- 9. Serviceable Smoke Detector: Inoperative or missing - **Inoperative or missing.**

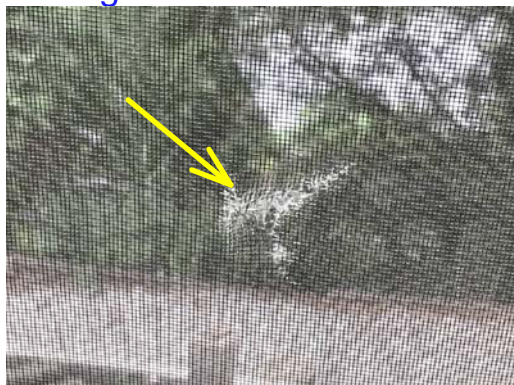
Closet: Small, Walk In
 Ceiling: Paint and Paneling
 Walls: Wood
 Floor: Carpet
 Doors: Wood
 Windows: Alumimun, Crank, Alumimun, Casement - **Missing or damaged screen**

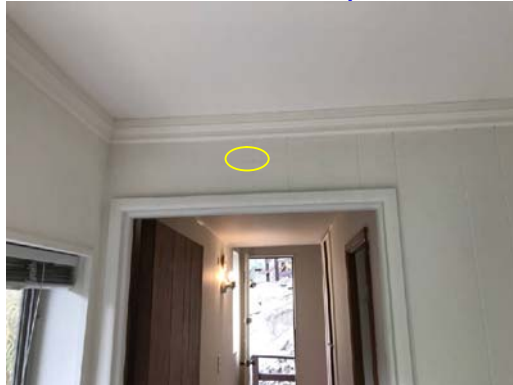
Electrical: 110 VAC
HVAC Source: Heating system register
Smoke Detector: **Inoperative or missing.**

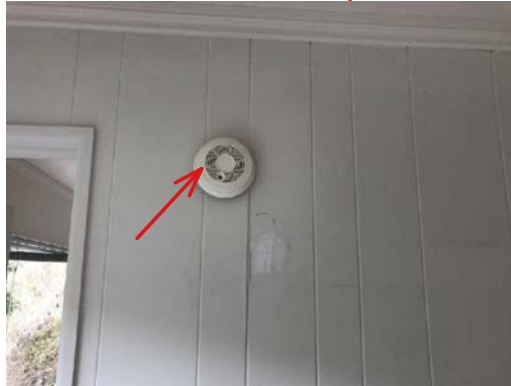
Smoke Detector: **Inoperative or missing.**

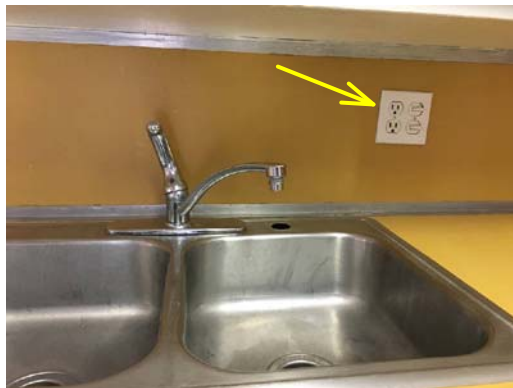
30. Serviceable Electrical: 110 VAC - **Non GFCI or GFCI labeled. Consult a qualified electrician.**

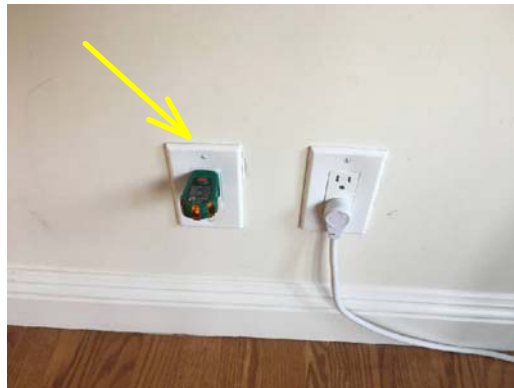
| 7. Serviceable | Electrical: 110 VAC - One or more faulty outlet with loose, unconnected or crossed wires. Consult with a qualified electrician. |

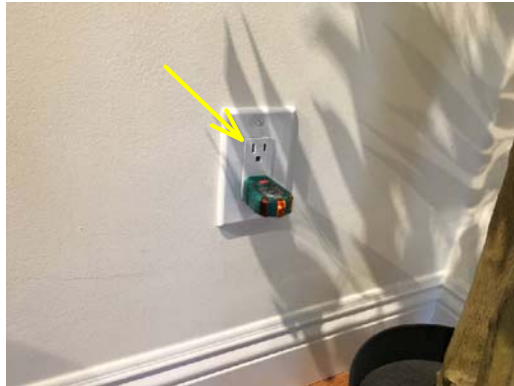
Electrical: 110 VAC - **One or more faulty outlet with loose, unconnected or crossed wires. Consult with a qualified electrician.**

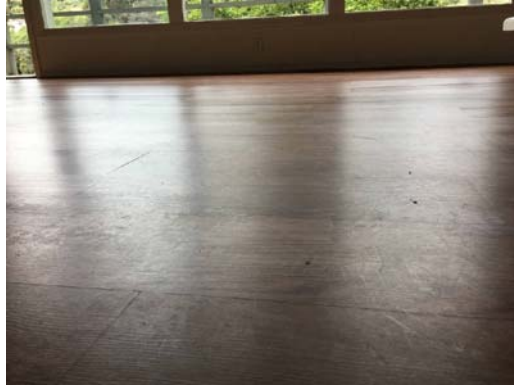
31. Serviceable Floor: Laminate - Uneven floor without floor covering deviation / deflection noted. A minor appearance issue.

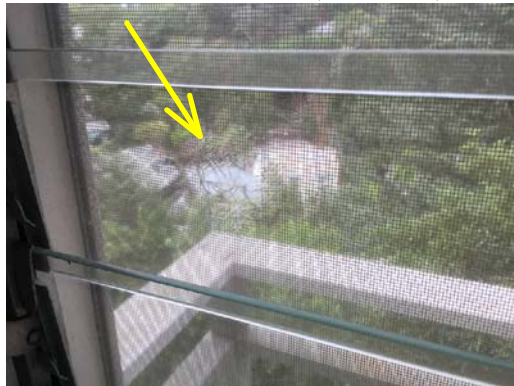
Windows: Jalousie, Wood, casement - Missing or damaged screen
