CITY PROPERTY SERVICES
Commercial & Residential Inspections

Property Inspection Report

Property Address

Prepared by: Shawn S. Azimi
Certified Master Inspector, or associates

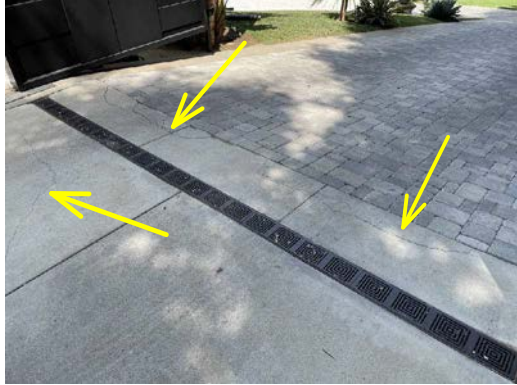
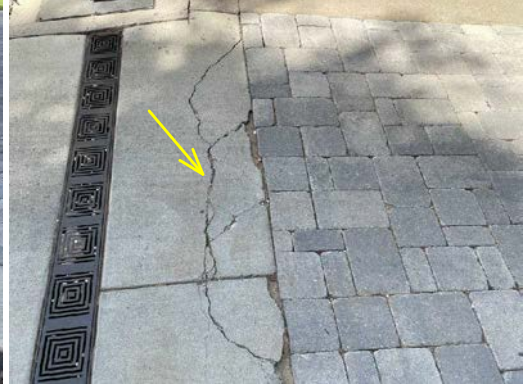
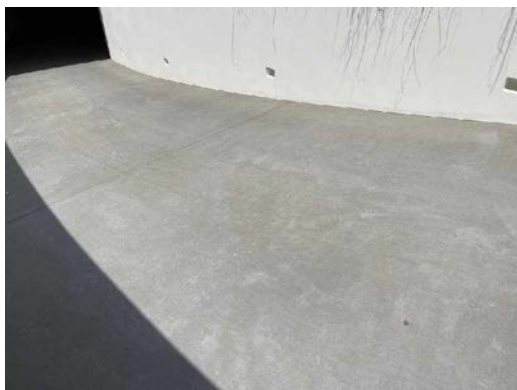
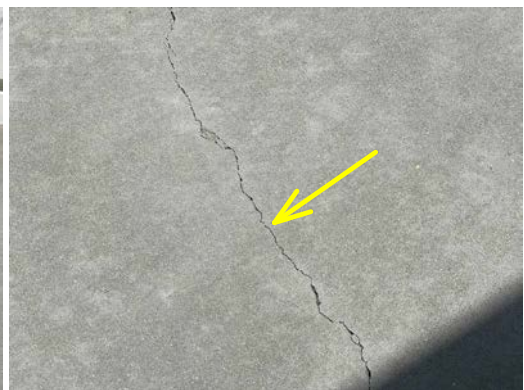
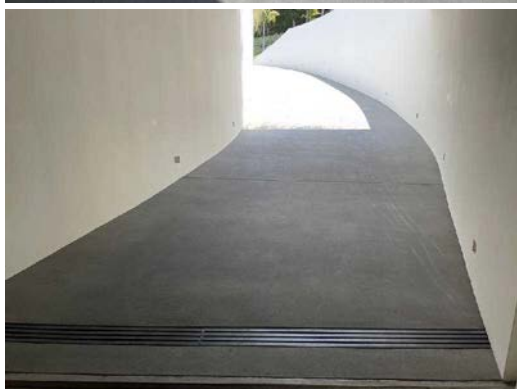
1. Needs Attention Driveway: Concrete, Brick / Paver - Cracks: Commonly noted in most properties. Fill, patch or repair as necessary.

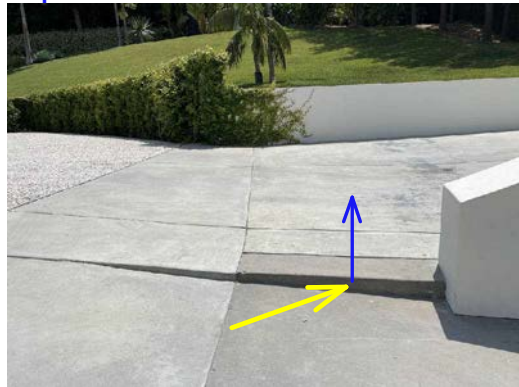
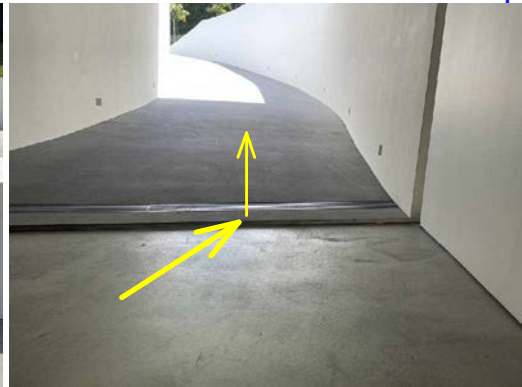
2. Needs Attention Walks: Concrete, Tile, Grass - Trip Hazard-Safety Notation: Any area or spot with level or grade differential, projected objects from ground and notable unevenness or slippery walk path, inside or outside the property should be repaired or improved to prevent trip and injury hazard. If improvement is not desired or not possible, use with caution and use night lighting. Photo(s) could be sample representative of other and similar condition at the time of inspection.

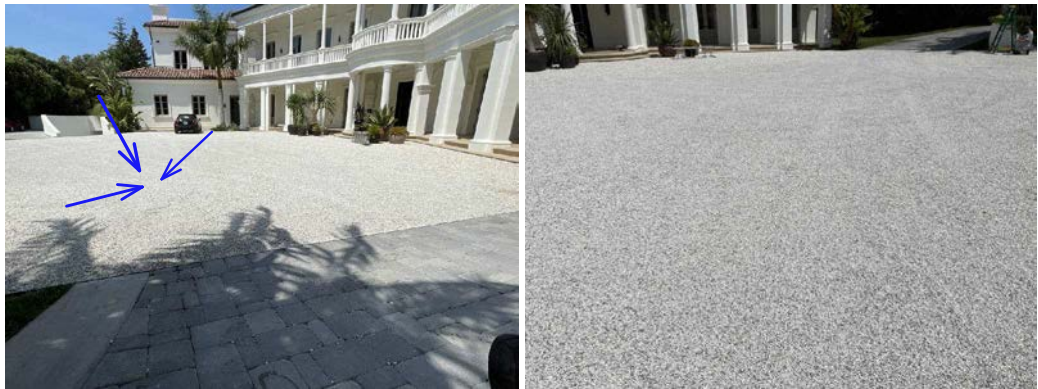
Exterior Surface Drain: Slope Drain, Covered drain - **Though, the front open port parking shows considerable slope for draining, at the center, low points or sagging areas could pool water. If there are no covered drains installed under the existing gravel, then recommend installation of proper drain pipe. Consult a drain expert for further evaluation.**

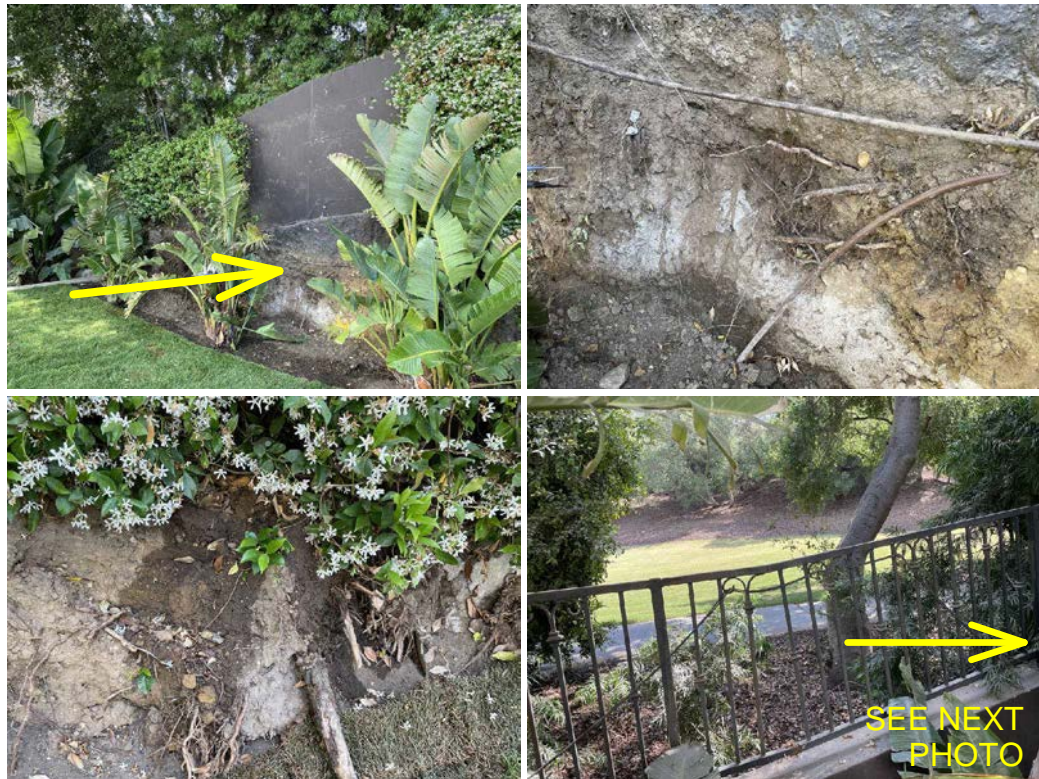
16. Needs Attention Fences: Metal - 1. Metal Fence: Due for protective coating, 2. Concrete fence at right side: Soil under the fence structure is showing erosion with roots visible. Soil moisture at this area (the entire right side of lot with irrigation lines) needs attention and improvement, to prevent any cracks, displacement or damage to the concrete fence. This is a long term maintenance matter that must be addressed. Consult with a drain and foundation expert for further evaluation, remedy and cost.

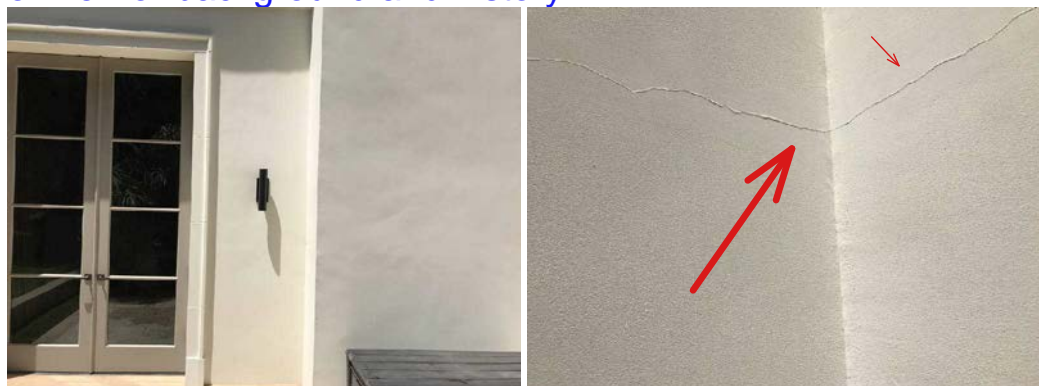
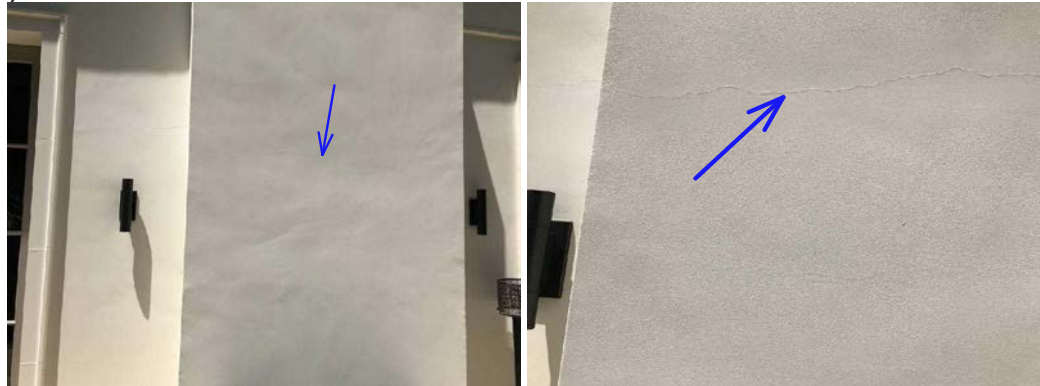
1. Needs Attention Type: Stucco - Past repair with cosmetic cracks noted. Inquire with owner for background and history

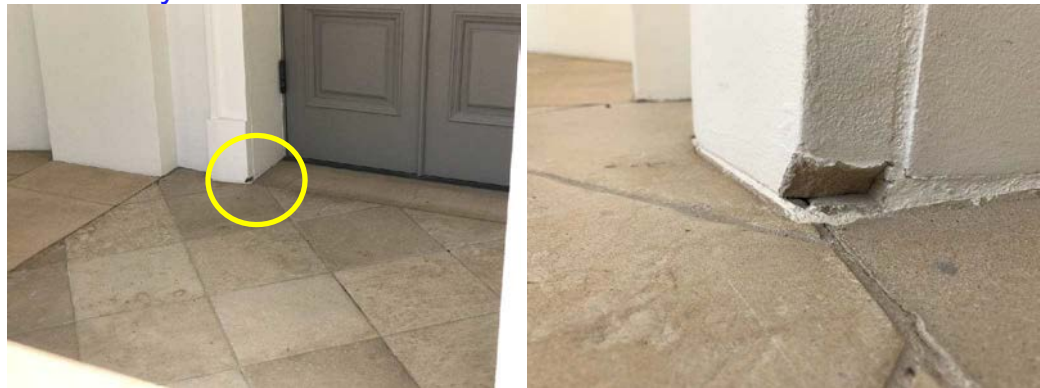
2. Needs Attention Trim: Stucco Coverd - **Chipped edge noted. Repair and paint as necessary.**

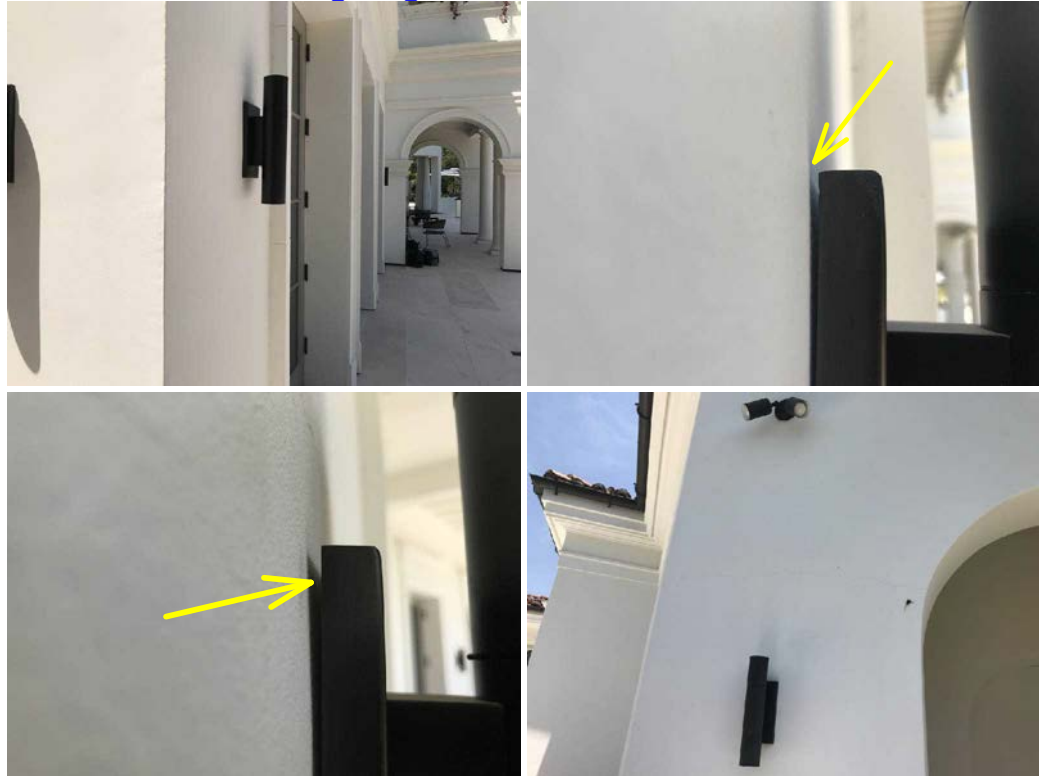
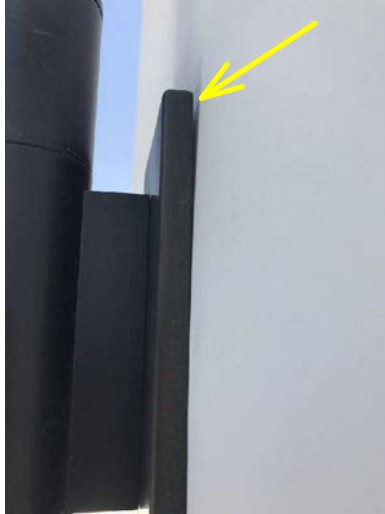
Exterior Lighting: Surface mount - Water Preenable: Opening, separation or looseness admits water or insects . One or more. Recommend sealing edges.

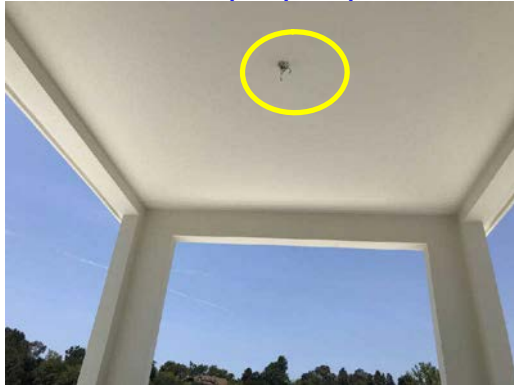
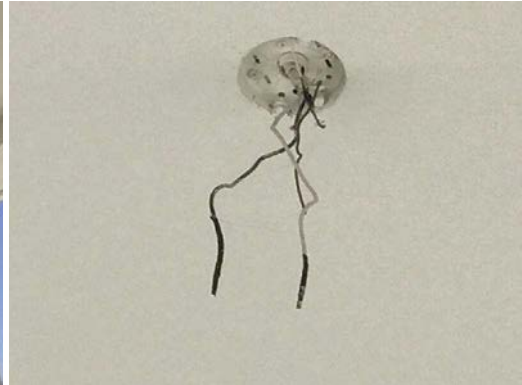
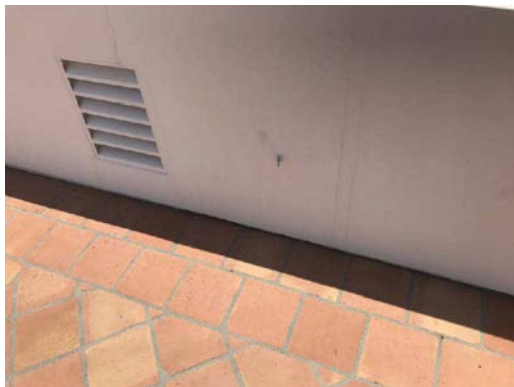
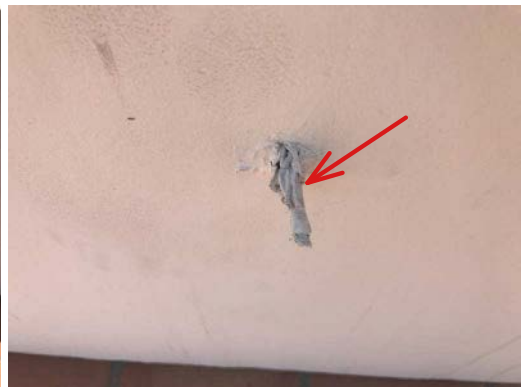
13. Needs Attention Exterior Electric Outlets: 110 VAC GFCI - Exposed Wiring: Recommend proper protection

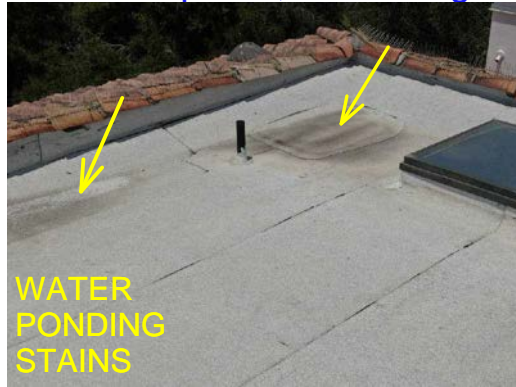
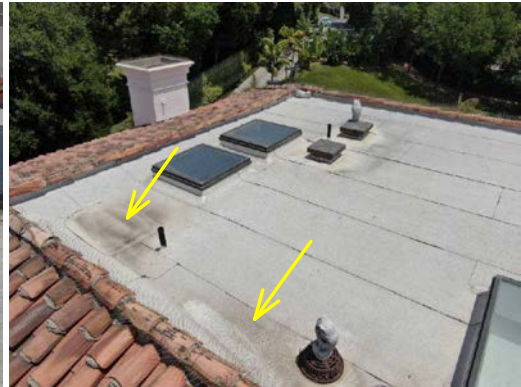
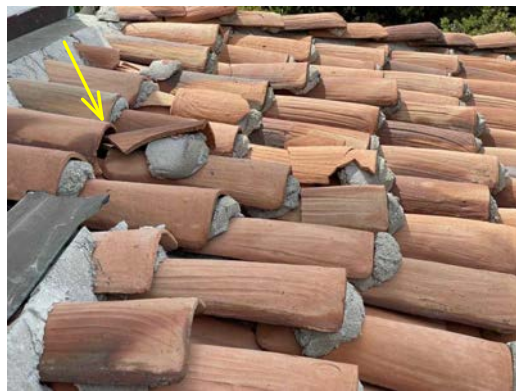
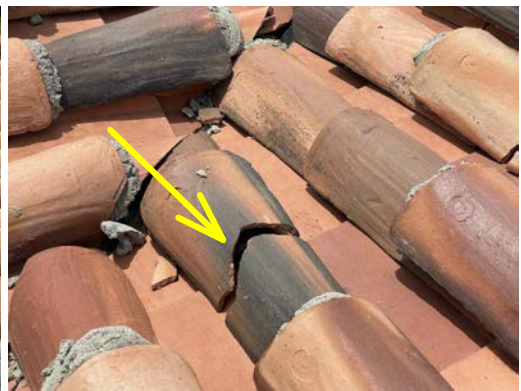
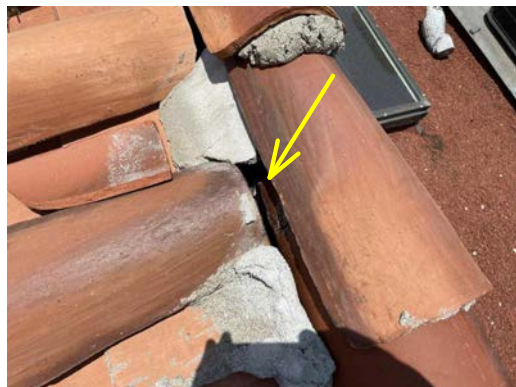
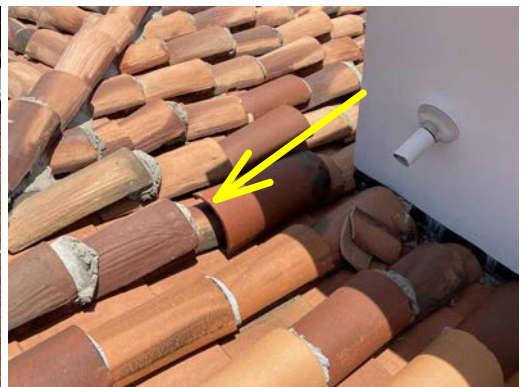
Material: Clay tile, Rolled roof torched material, build up - 1. Some need repair or replacement. Consult a roofer for remedy and cost, 2. Water ponding (or stains) evident on flat roof section. Monitor to take preventive action. Water ponding can cause less life for the roof material, at areas that hold water longer., 3. Moss build up on roof material surfaces noted. Moss build up at shady areas of the roof are not unusual. Periodic monitoring could verify if pressure washing and sealing is needed: Moss could damages tiles or shingles and make them leak prone, in the long run.

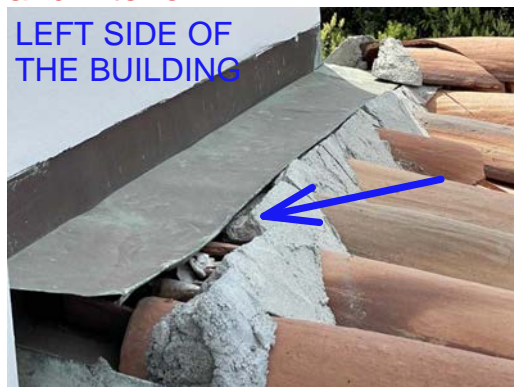
6. Serviceable Flashing: Aluminum - **Water pregnable opening at left side flashing noted. Recommend repair to prevent water intrusion to under side and interior.**

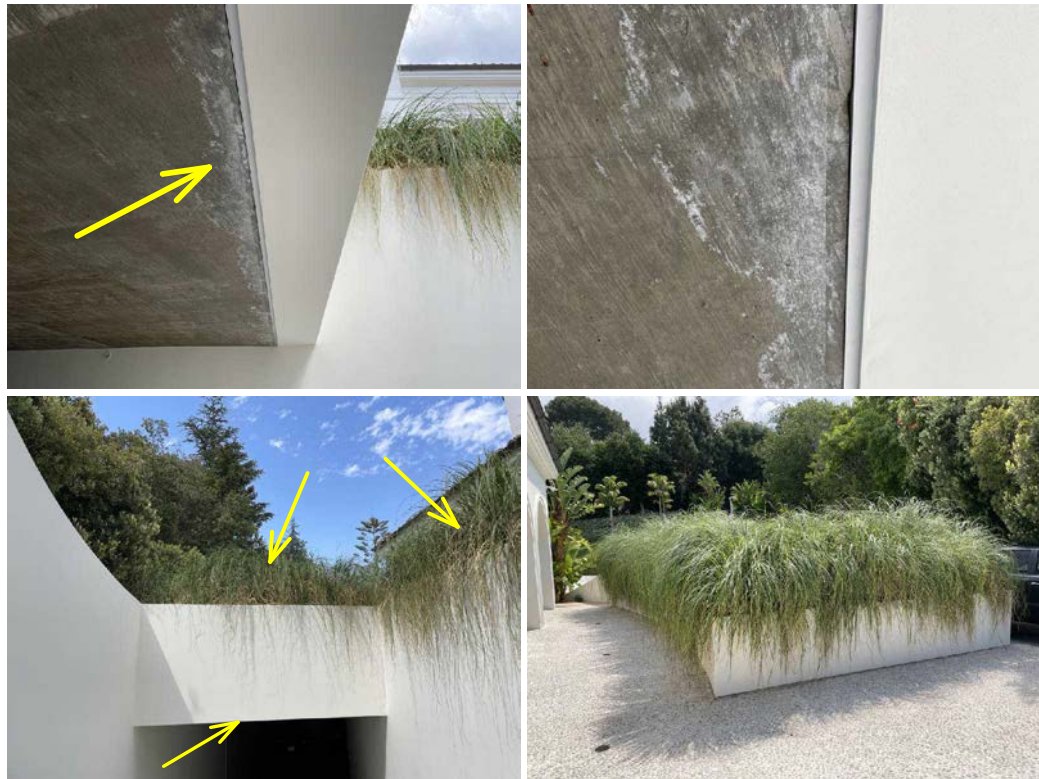
9. Needs Attention Ceiling: Concrete - Ceiling at garage entry shows efflorescence (Salty residue due to moisture seepage through concrete) The affected area is directly under the retained concrete vegetation box structures. Recommend further evaluation by a drain expert to verify if there are any drain or leakage issues from the said vegetation box structures.

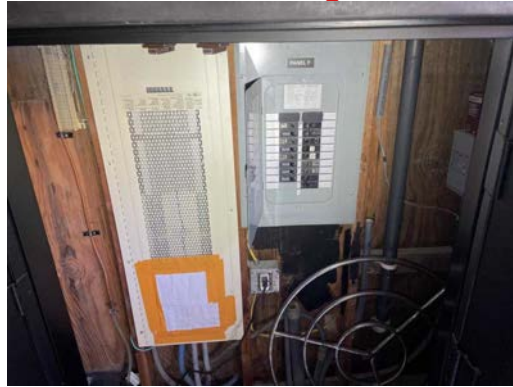
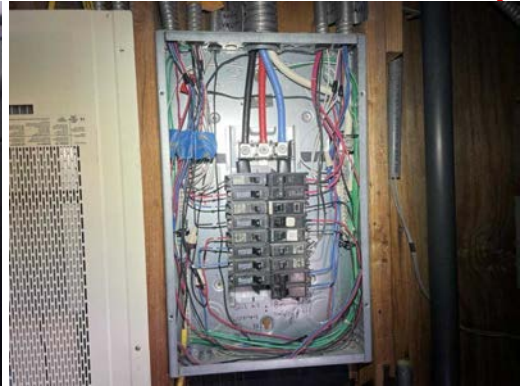
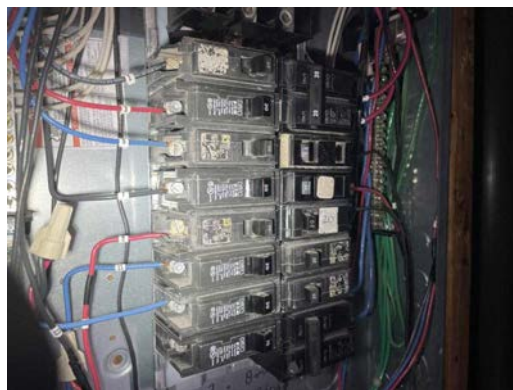
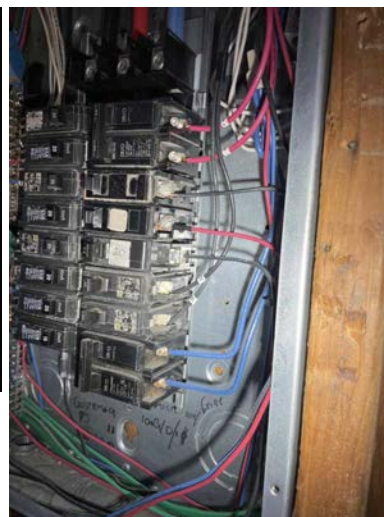
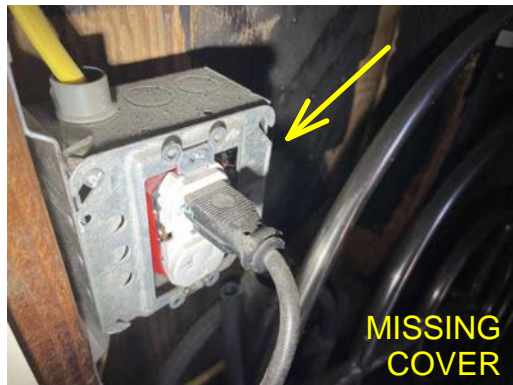
Breakers: Copper - Breakers in acceptable condition. Outlet, inside the closet is missing cover. Recommend installation for safety.

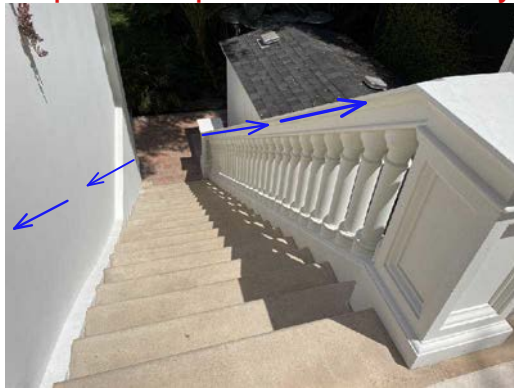
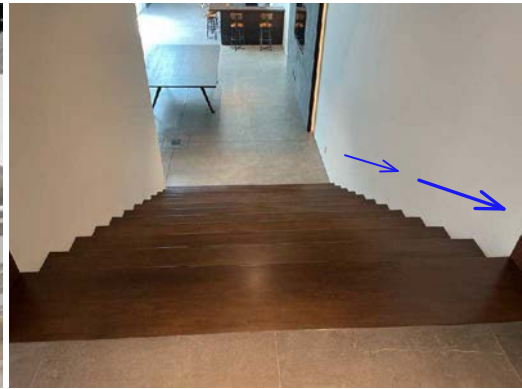
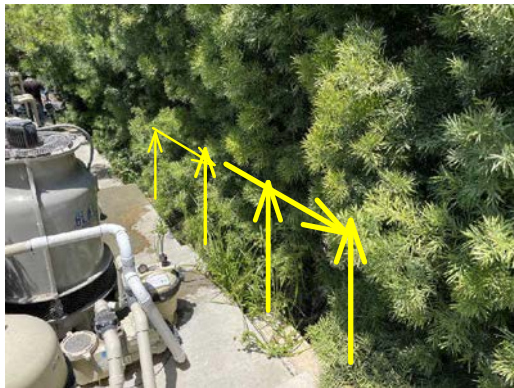
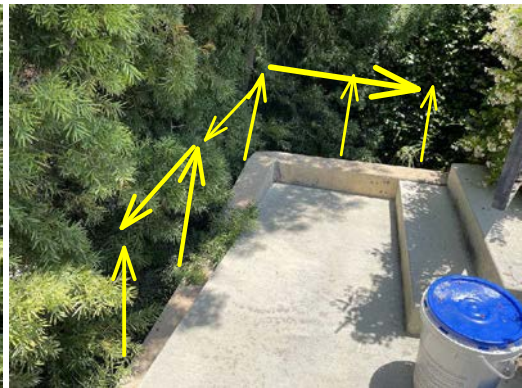
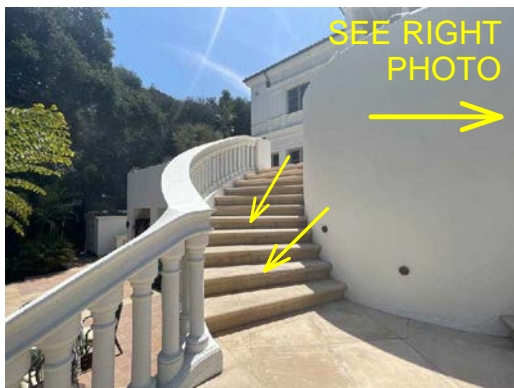
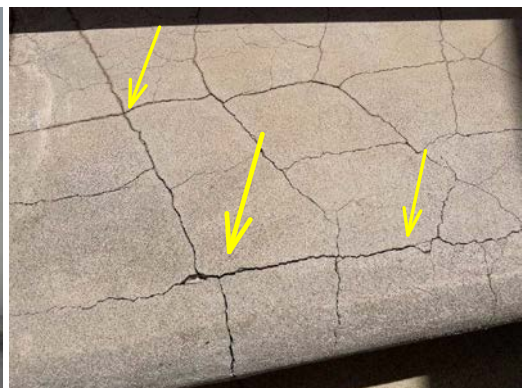
Stairs/Handrails: 1. Safety handrails or guard rails not installed or insufficient at some sections, inside or outside: Recommend installation, 2. One or more exterior concrete stairs are cracked. Repair / Replace as necessary.

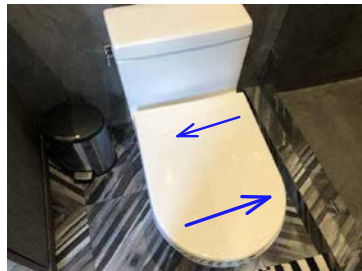
| 13. Serviceable | Toilets: Seat cover is loose. |

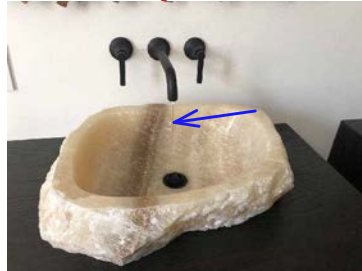
Sink/Basin: Molded single bowl - **Low flow. Repair / Replace as necessary.**

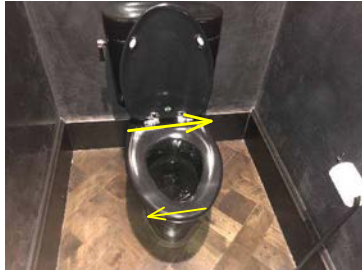
4 Hallway, Left Side Half Bathroom

- 45. Not Inspected Closet: Not Applicable
- 46. Acceptable Ceiling: Mirror, Paint and Paneling
- 47. Acceptable Walls: Paint and paneling
- 48. Acceptable Floor: Hardwood
- 49. Acceptable Doors: Wood
- 50. Not Inspected Windows: Not Applicable
- 51. Acceptable Electrical: 110 VAC GFCI
- 52. Acceptable Counter/Cabinet: Composite and wood
- 53. Acceptable Sink/Basin: One piece sink/counter top
- 54. Acceptable Faucets/Traps: Metal and PVC
- 55. Serviceable Toilets: [Seat cover is loose.](#)

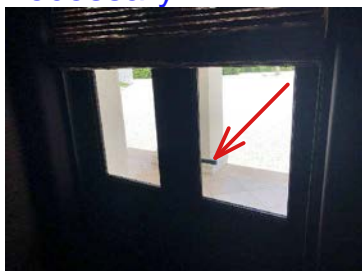
5, Hallway Half Bathroom

- 58. Not Inspected Closet: Not Applicable
- 59. Acceptable Ceiling: Paint and Paneling
- 60. Acceptable Walls: Insulated wallpaper
- 61. Acceptable Floor: Hardwood
- 62. Acceptable Doors: Wood
- 63. Serviceable Windows: Door Window - [Hard operation. Repair / Replace as necessary.](#)

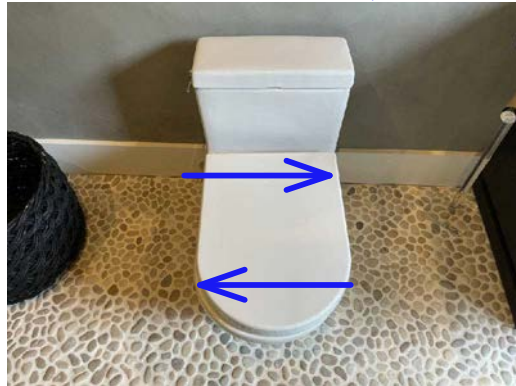
Toilets: Toilet is loose, Seat cover is loose.

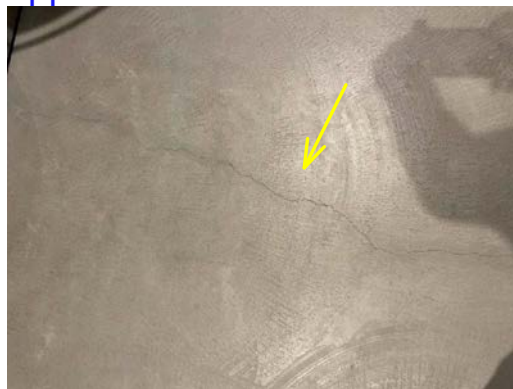
Floor: Concrete - Surface cracks, abrasion or wear out noted. An appearance notation.

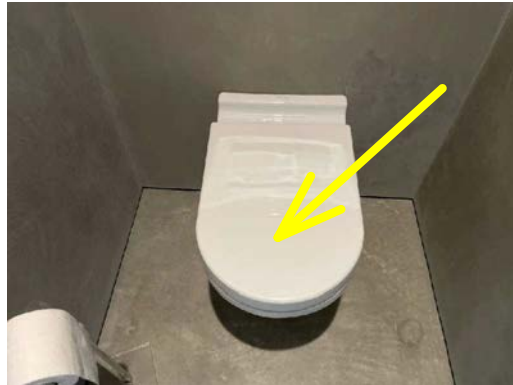
- 121. Not Inspected
 - 122. Acceptable
 - 123. Acceptable
 - 124. Acceptable
 - 125. Acceptable
 - 126. Not Inspected
 - 127. Acceptable
 - 128. Not Inspected
 - 129. Serviceable
- Windows: Not Applicable
 - Electrical: 110 VAC GFCI
 - Counter/Cabinet: Wood
 - Sink/Basin: Molded single bowl
 - Faucets/Traps: Metal and Metal
 - Tub/Surround: Not Applicable
 - Shower/Surround: Pebble rock and concrete
 - Spa Tub/Surround: Not Applicable
 - Toilets: **Seat cover is loose.**

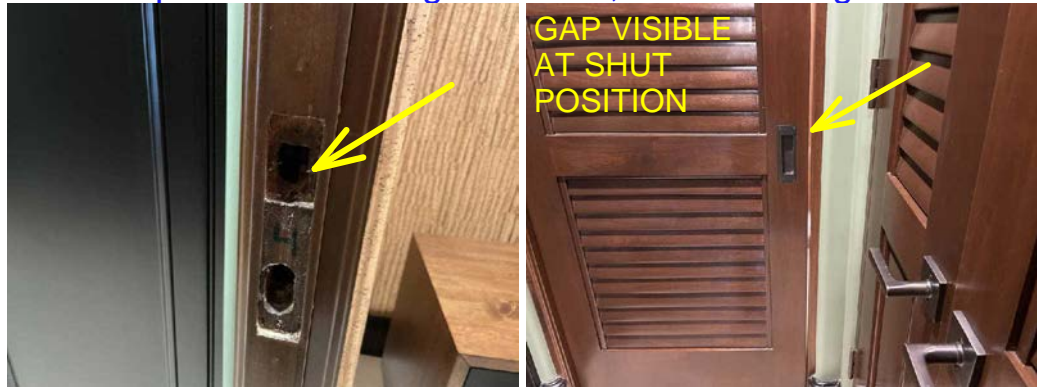
11 Guest house Bathroom

- 145. Acceptable Closet: Single, Shelves
- 146. Acceptable Ceiling: Paint and Paneling
- 147. Acceptable Walls: Paint and paneling
- 148. Acceptable Floor: Tile
- 149. Serviceable Doors: Wood, Pocket Slider - 1.Hardware Issue: Loose , inoperable, hard to operate or missing hardware, 2. Needs Alignment

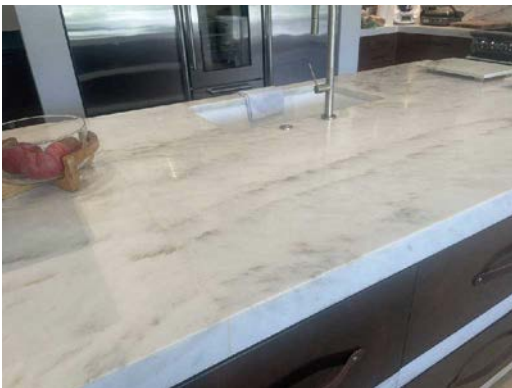
- 3. Acceptable Disposal:
- 4. Acceptable Dishwasher:
- 5. Air Gap Present? No **Not visible on counter. Consult a qualified plumber if connections under the sink satisfy the air gap functionality. Air gap is a re-route drain line that if food particles are clogged in the dish washer, water will not back up and over flow onto the floor.**

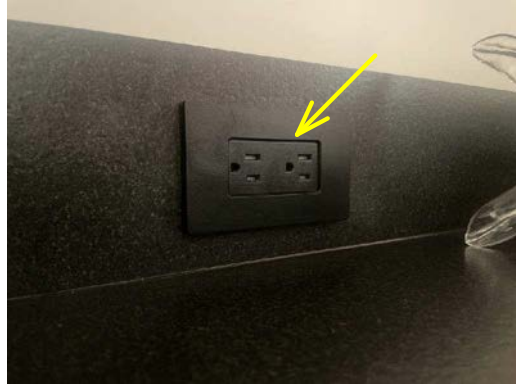
Electrical: 110 VAC GFCI - **Not all receptacles labeled as GCFI**

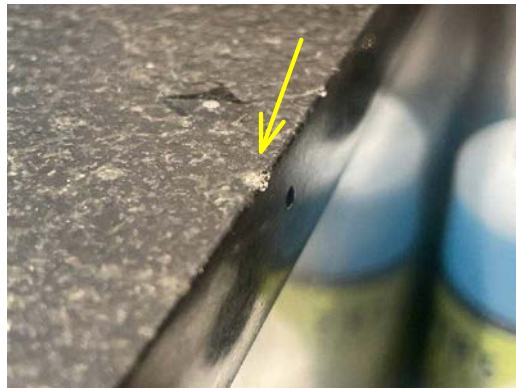
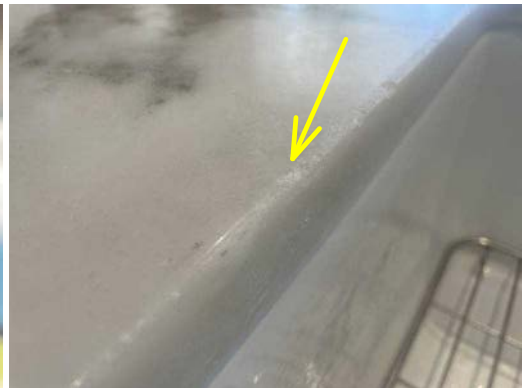
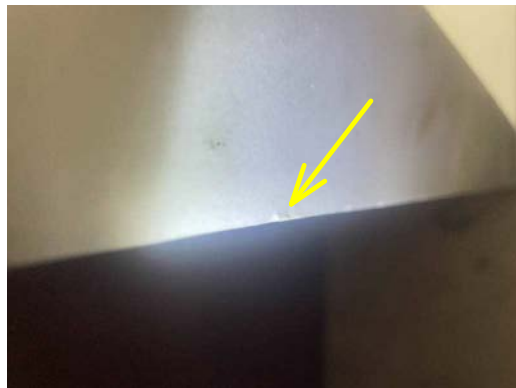
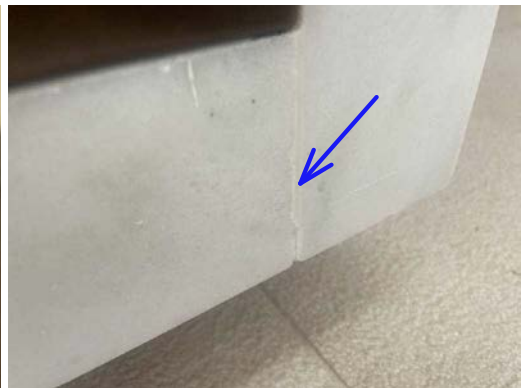
Plumbing/Fixtures: Metal-PVC
Counter Tops: Marble, Composite - **Minor wear out or damage noted on counter and waterfalls.**

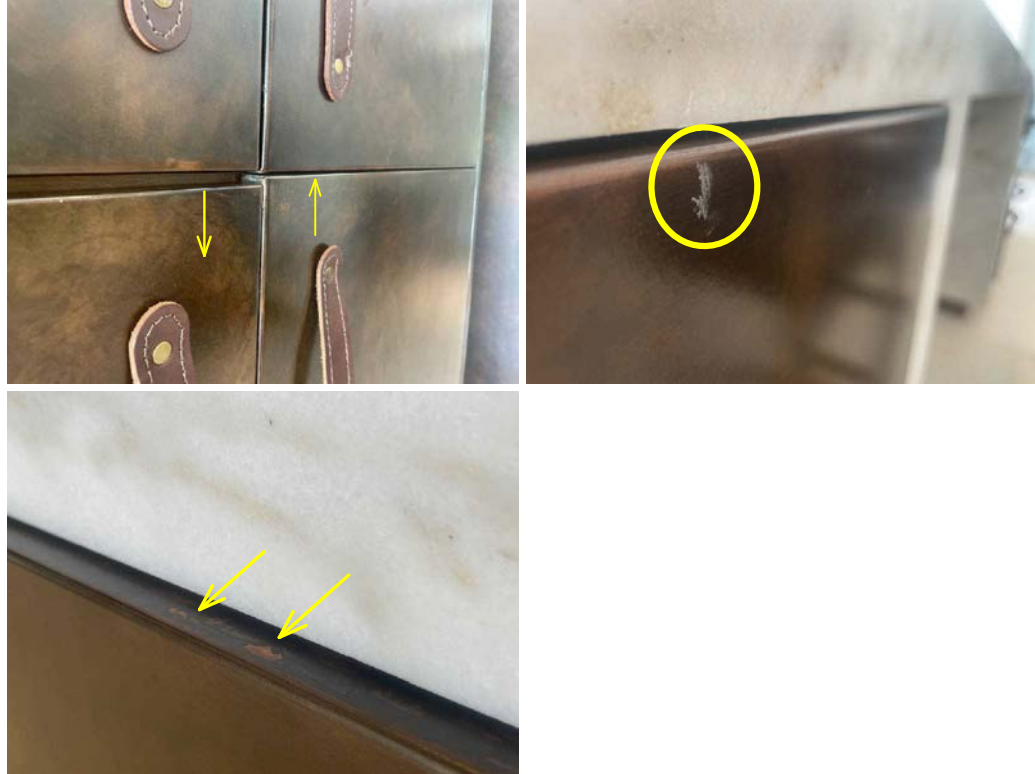
Cabinets: Wood - One or more cabinet doors or drawers need adjustment, repair or resurfacing.

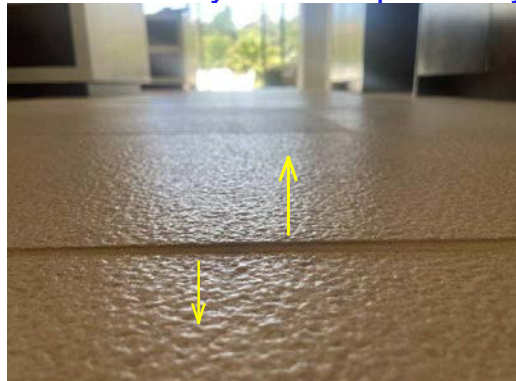
Pantry: Single, Walk in, Large
Ceiling: Exposed framing, Bricks
Walls: Paint and paneling, Marble
Floor: Tile - Minor differential noted on some tiles. Repair / Replace as necessary. Some spots may cause trip hazard.

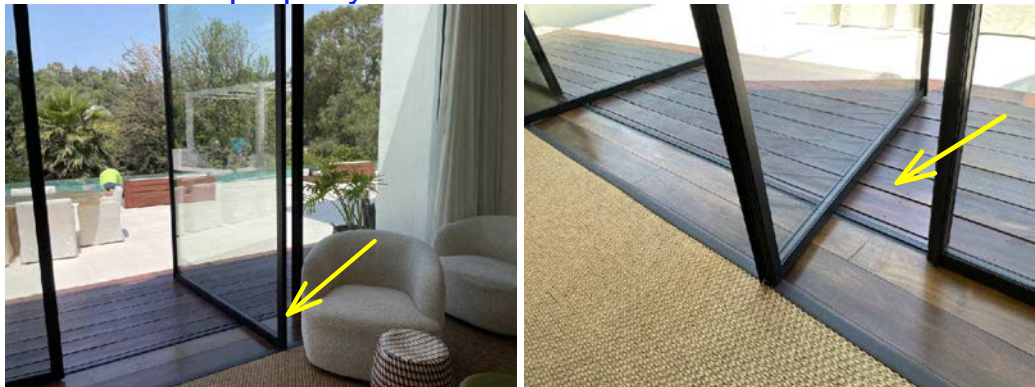
- 76. Acceptable Floor: Hardwood
- 77. Needs Attention Doors: Metal - Pivot Type: Use caution operating this door when children or pets are present, as gap in open position could cause injury to a child or a pet. This notation applies to all similar doors in this property.

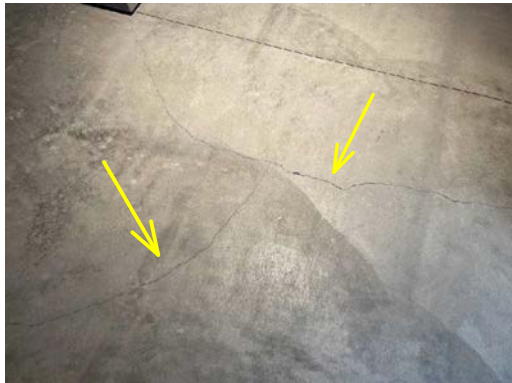
Lower level center hallway Living Space

- 82. Not Inspected Closet: Not Applicable
- 83. Acceptable Ceiling: Paint and Paneling
- 84. Acceptable Walls: Paint and paneling
- 85. Needs Attention Floor: Concrete - Surface cracks, abrasion or wear out noted

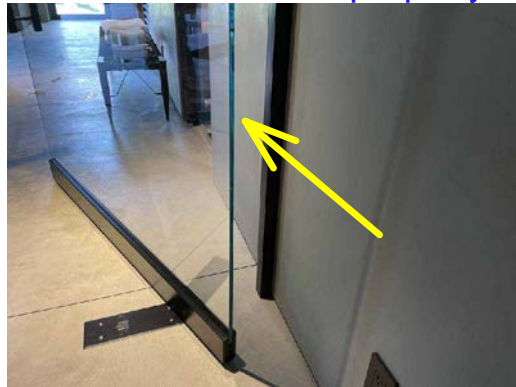
86. Needs Attention Doors: Aluminum Swing glass - Pivot Type: Use caution operating this door when children or pets are present, as gap in open position could cause injury to a child or a pet. This notation applies to all similar doors in this property.

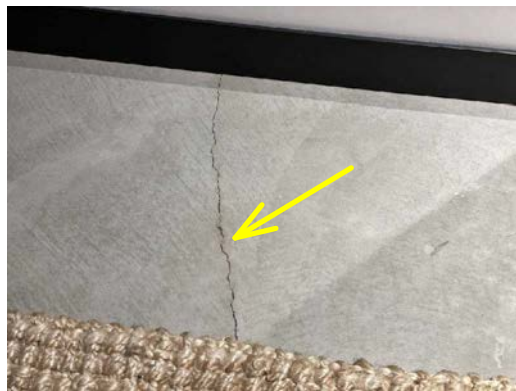
Lower level massage room Living Space

91. Acceptable Closet: Shelves
92. Acceptable Ceiling: Paint and Paneling
93. Acceptable Walls: Paneling
94. Needs Attention Floor: Concrete - Surface cracks, abrasion or wear out noted

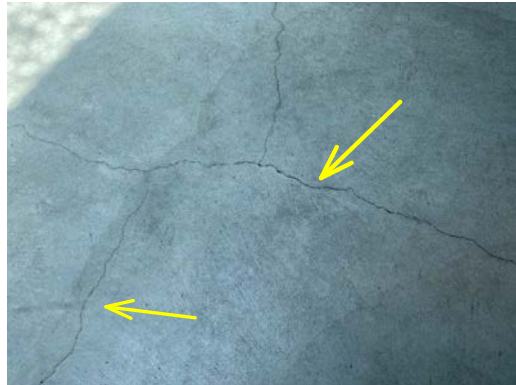
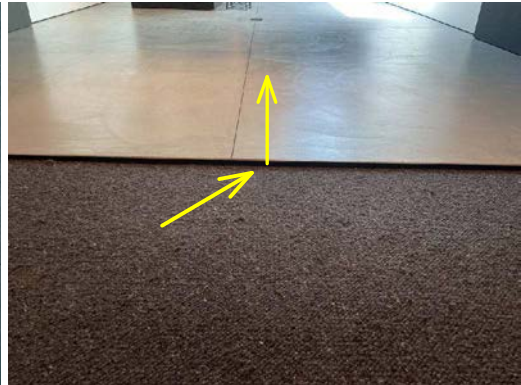
Basement entertainment and game room Living Space

- 136. Not Inspected Closet: Not Applicable
- 137. Acceptable Ceiling: Paint and Paneling, Skylight
- 138. Acceptable Walls: Paint and paneling
- 139. Needs Attention Floor: Concrete, Carpet - 1.Surface cracks, abrasion or wear out noted 2. Trip Hazard-Safety Notation: Any area or spot with level or grade differential, projected objects from ground and notable unevenness inside or outside the property should be repaired or improved to prevent trip and injury hazard. If improvement is not desired or possible, use with caution and use night lighting. Photos could be sample representative, as all areas may not have been visible or there are numbers of such conditions

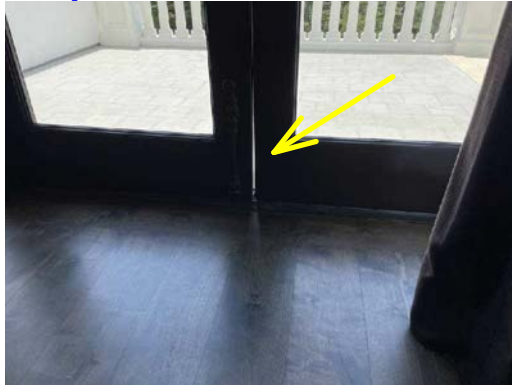
Doors: Wood - Daylight visible from inside. Recommend installation of weather seal or other improvement, to prevent insect and moisture entry

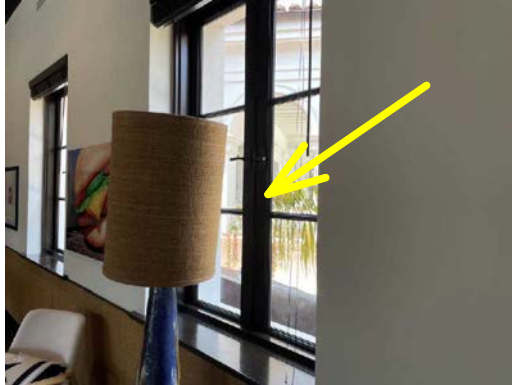
Windows: Wood, Swing - Hard operation. Repair / Replace as necessary.

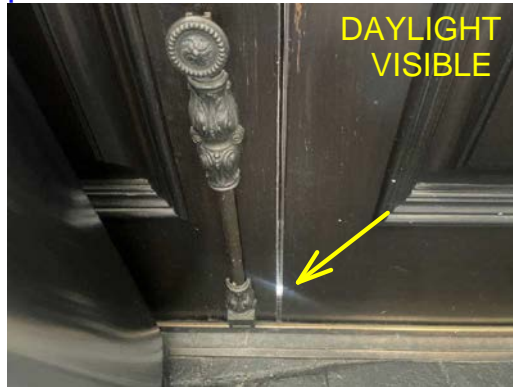
Doors: Wood, Also, entry door - Daylight visible from inside.

Recommend installation of weather seal or other improvement, to prevent insect and moisture entry

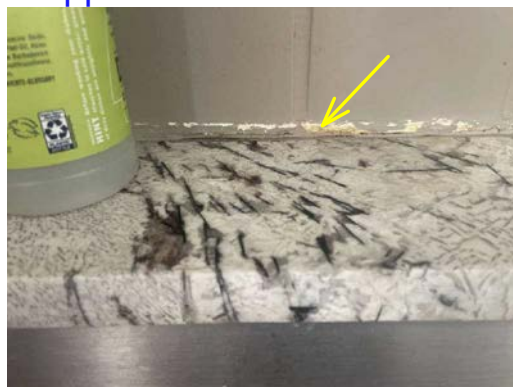
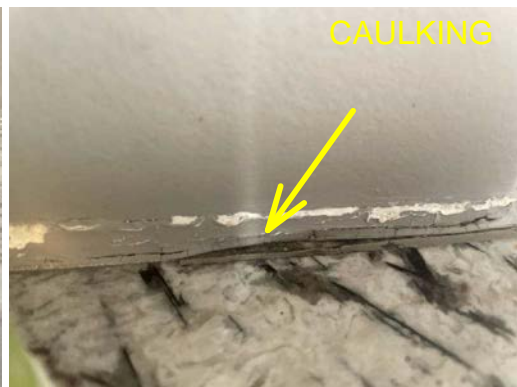
Laundry Tub: Tile, Stainless Steel - 1. Caulking or re caulking will prevent water migration to underside., 2. Loose fixture noted, 3. Chipped tiles noted.

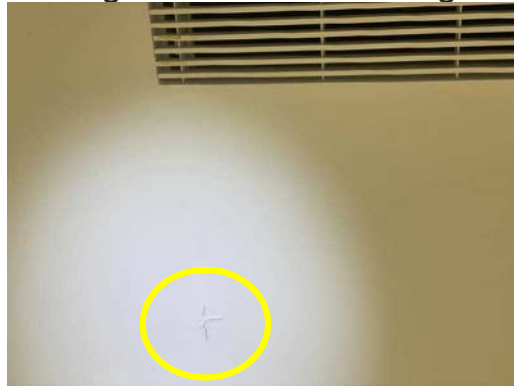
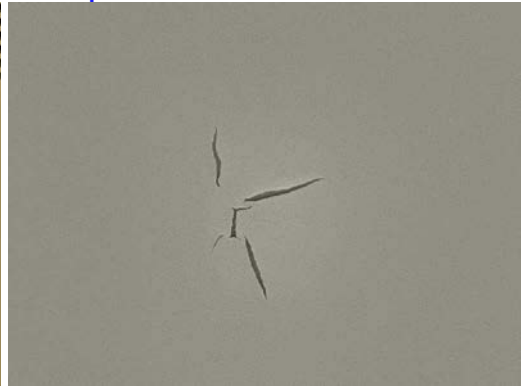
Ceiling: Paint and Paneling - [Minor paint cracks noted.](#)

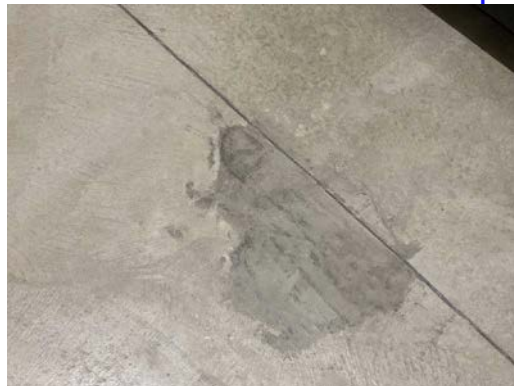
21. Needs Attention Floor: Concrete - [Passed repairs noted.](#)
