CITY PROPERTY SERVICES
Commercial & Residential Inspections

Property Inspection Report

Beach property

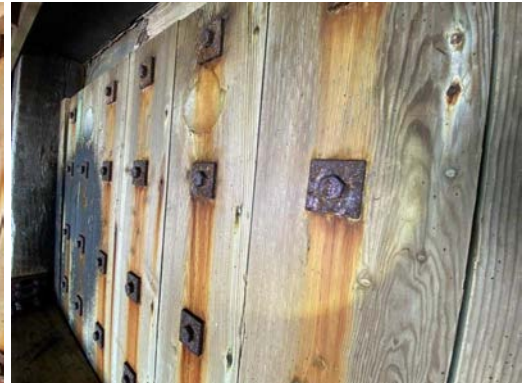
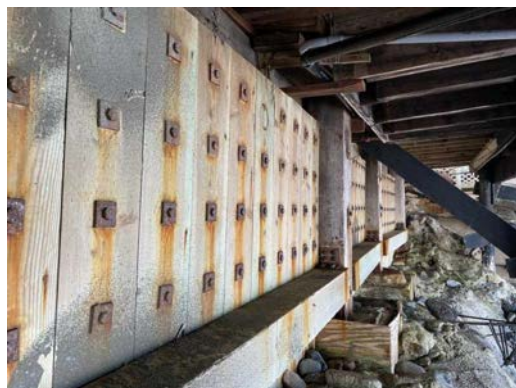
| 5. Needs Attention | Retaining Walls: Wood and Steel bolts |

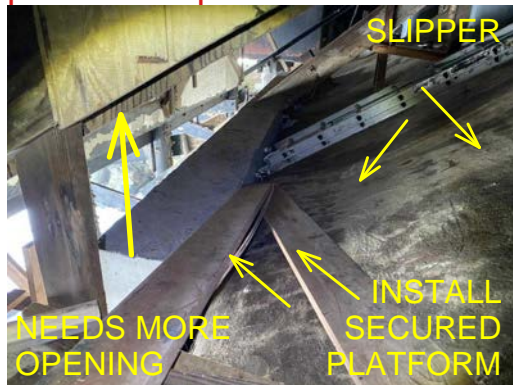
- 1. Method of Inspection: In the crawl space.
- 2. Acceptable Unable to Inspect: 10%
- 3. Serviceable Access: Open side access by the left stairs - **1. The slope concrete dam is slippery and could become fall hazard for service persons. Recommend pressure washing, periodically as this may be due sea moisture / water contact, for safe walking / stepping, and to prevent liability, 2. Access from left half to right half is semi obstructed by wooden plank at mid section. Recommend more opening, 3. Lose planks for floor access may cause injury. Recommend affixed and permanent platform here.**

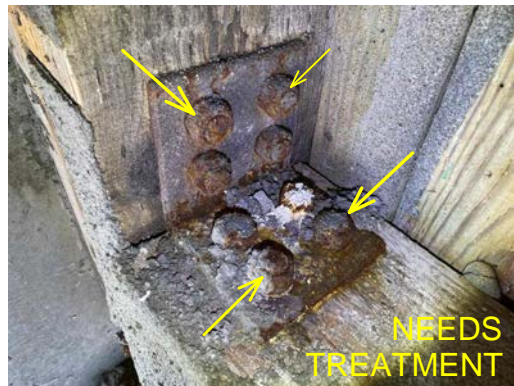
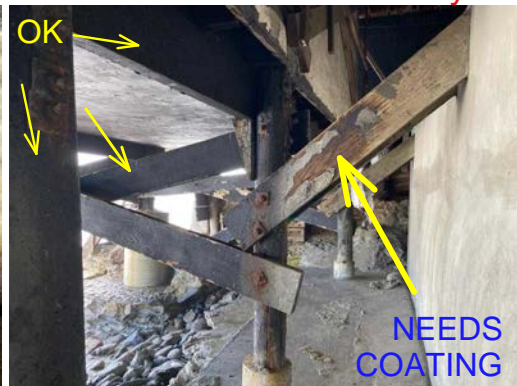
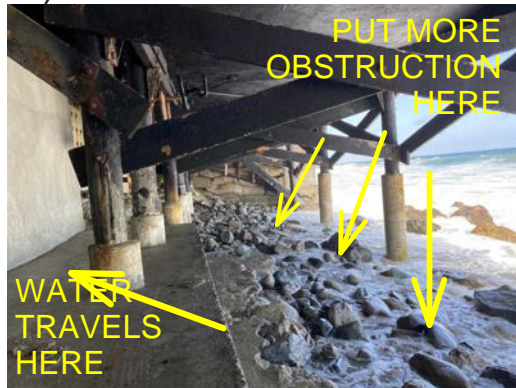
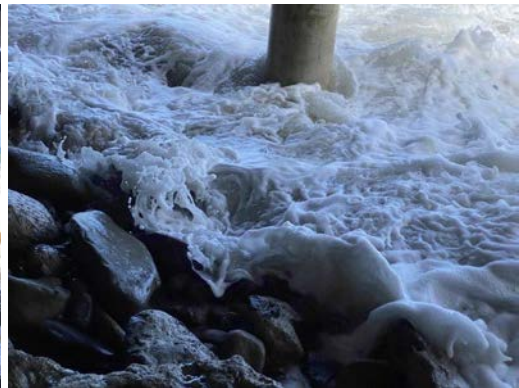
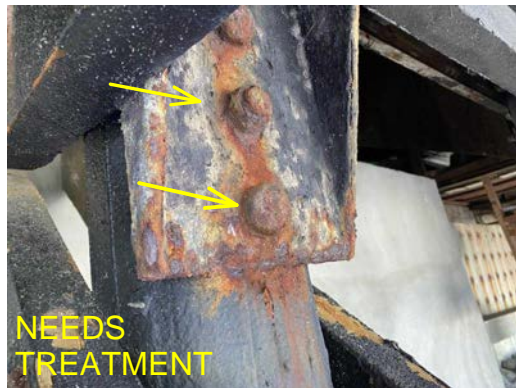
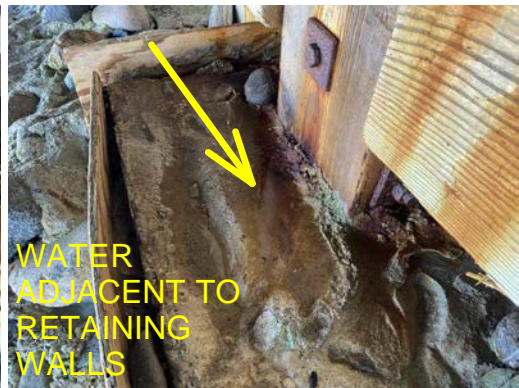
Beams: Solid wood, Metal beam - **As the foundation of this property is at the beach shore and moisture and water splash and contact on foundation components are constant, recommend a regular and continuous monitoring of all components of foundation which include: Metal, wood and concrete: Slopes, beams, bolts, braces and piles. The following were observed and recommended: 1. Past repairs that are OK and acceptable, 2. Need of application of anti moisture / corrosion on some wooden and metal structural beams (Some show black coating and are satisfactory), 3. Corrosion on nuts and bolts of the support beams at anchor points and on retaining walls.**

Recommend sand blasting and sealing with anti corrosion material, and check periodically: Once or twice a year. This is of highest importance, as majority of upper framing and floor are resting on the said beams, piles, etc, 4. Sea water, with strong waves migrates almost to below retaining walls. As a long term plan, recommend adding more obstruction at center between the concrete piles, to prevent no or less water travel to far rear, close to retaining walls. Additional obstruction could be more rocks laid on the way of water.

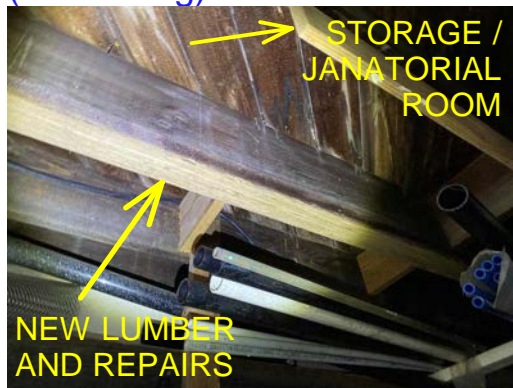
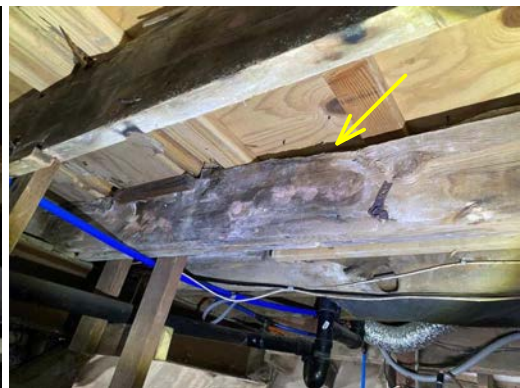
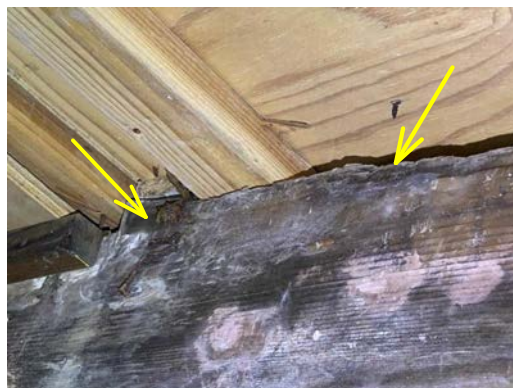
Joists/Trusses: 2x12 - Some of the floor joists show minor and sporadic dry rot. Consult a termite expert to verify if sistering (reinforcing) is needed.

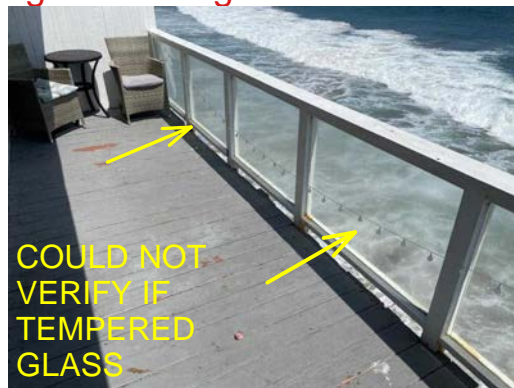
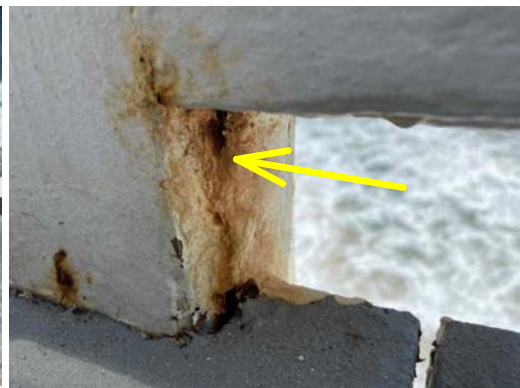
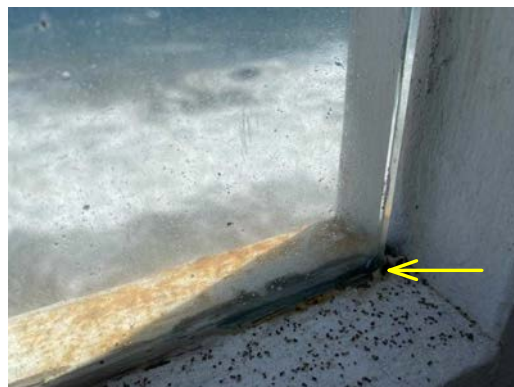
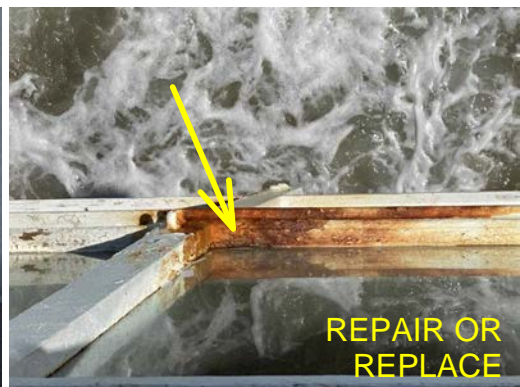
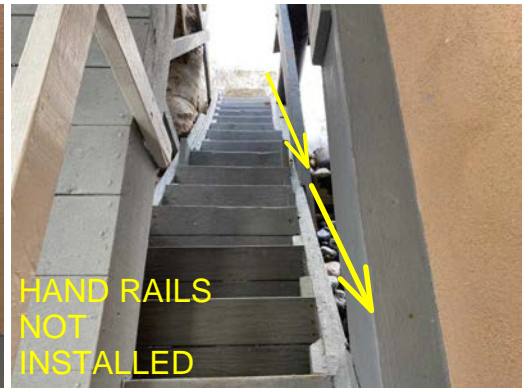
Stairs/Handrails: 1. Balusters / Frame bars are too far apart. At the time of original construction this may have not been a requirement. Child and pet safety. Consult a licensed contractor for remedy and cost, and inquire about your local code, 2. No hand rails installed on stairs leading to beach, 3. Corrosion on balcony metal / wood framing, in different units, noted. Recommend further evaluation by a welder or contractor for any required revitalization, 4. Glass panels close to balcony floors should be tempered glass (safety glass) No print or etching is visible on the glass for verification. Consult a glass installer / expert to verify and take appropriate action if necessary, 5. One or more runs (steps) on stairs to the beach are short in depth and may cause injury hazard. Recommend correction. If correction is not possible, use with caution, install alarming tape /stripe and keep lighted during dark hours.

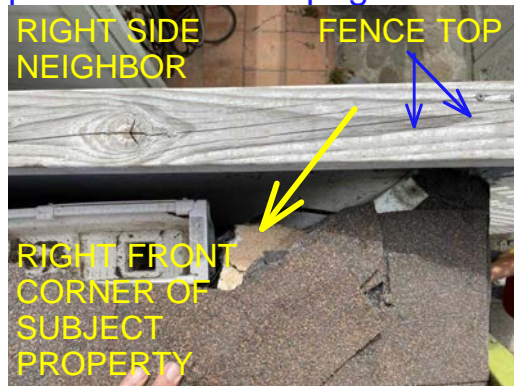
Material: Asphalt shingle - Repair at right side edge is needed to prevent water seepage into the interior.

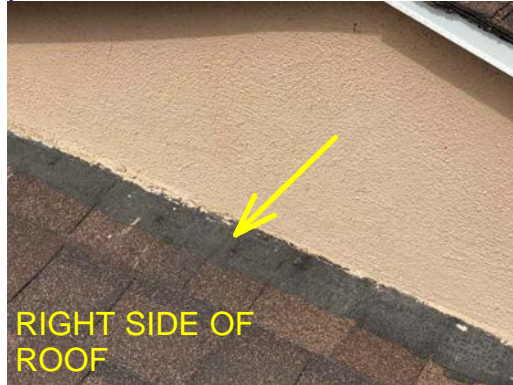
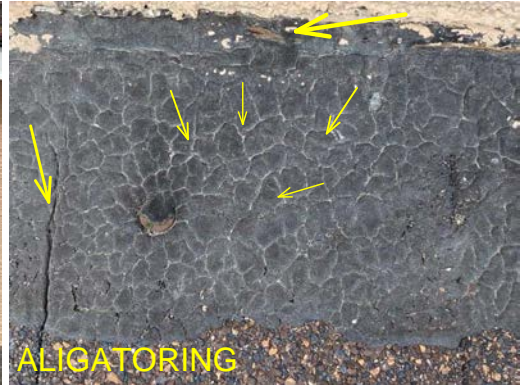
Flashing: Aluminum - Prone to possible leaks soon. Repair and patch.

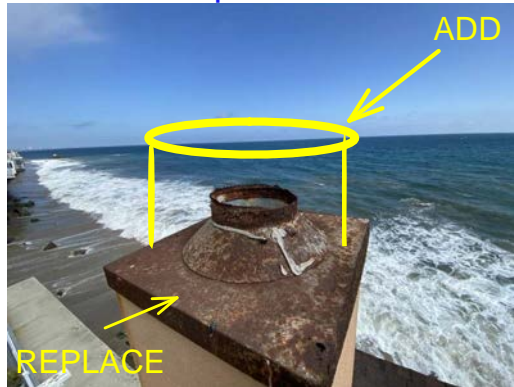
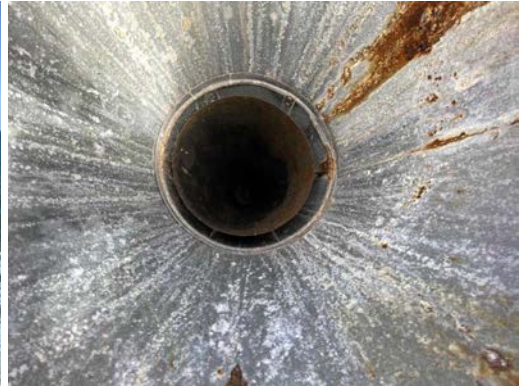
Flue/Flue Cap: 1. Rain cap , Spark Arrester or both are missing. Recommend installation to prevent spark spread as well as blocking water entry into the interior, 2. Metal crown cap is corroded and should be replaced.

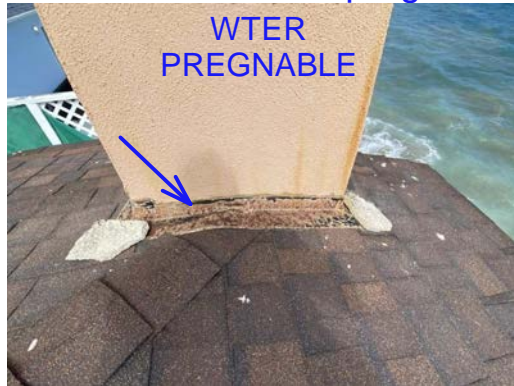
Chimney Flashing: Patching, repair or replacement needed due to: Damage , Opening, Separation. Doing so will prevent water migration to underside. Water pregnable at present.

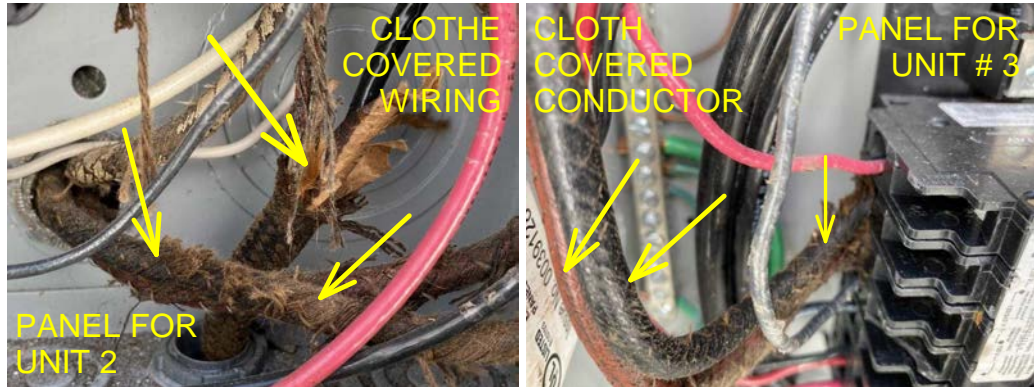
Conductor Type: Non-metallic sheathed cable - **Two of the panels, Unit 2 and 3, show cloth covered insulation which are old and not acceptable by today's safety standards. Consult with a qualified electrician further evaluation.**

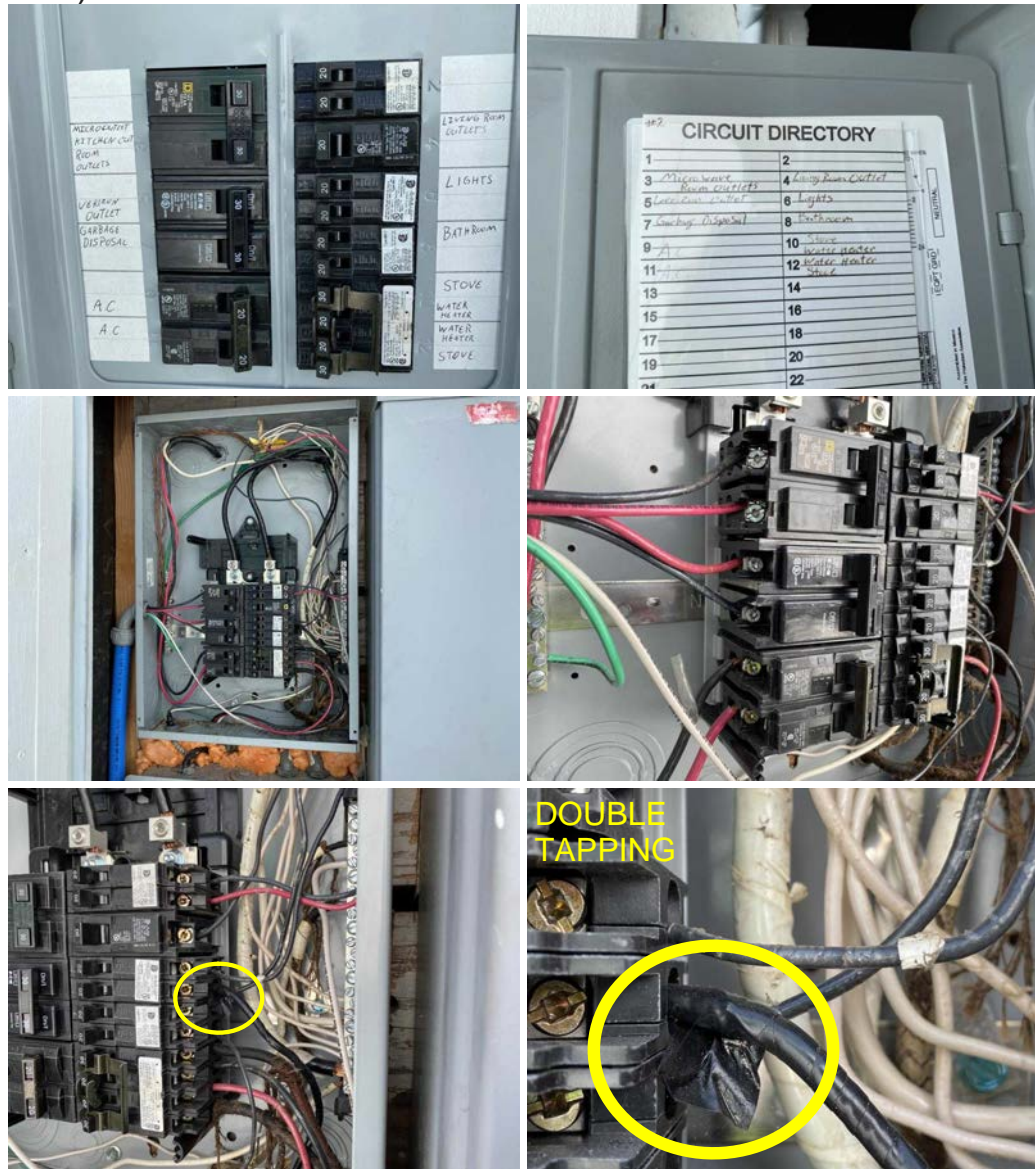
- 18. Maximum Capacity: 125 Amps
- 19. Acceptable Main Breaker Size: None
- 20. Serviceable Breakers: Copper - **Double taps are present at breakers. These circuits need to be moved to their own circuit breaker and cannot share a breaker. It is recommended that a qualified electrician inspect the new circuits and properly connect the new circuits to an individual breaker for each circuit**

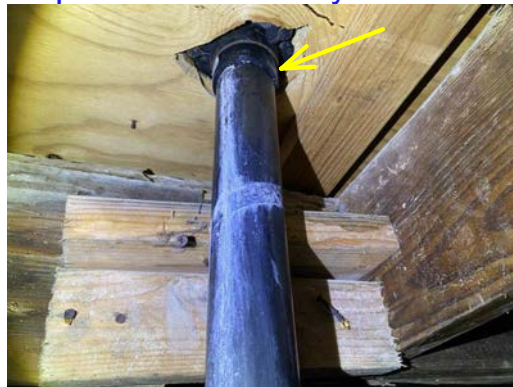
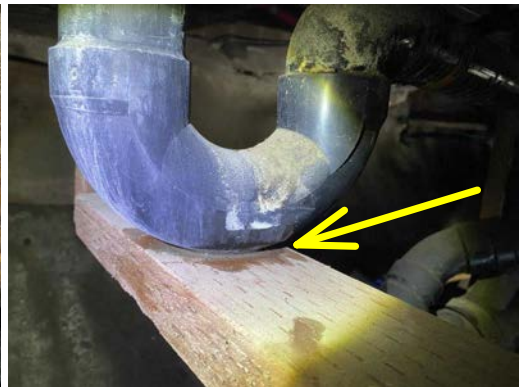
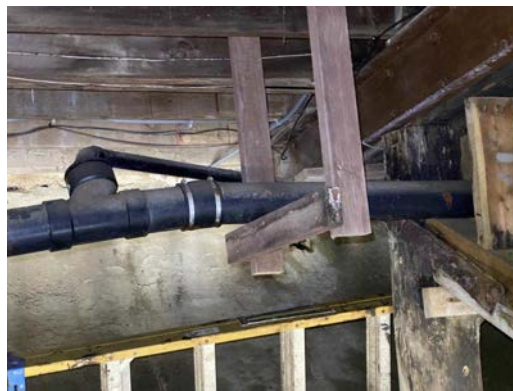
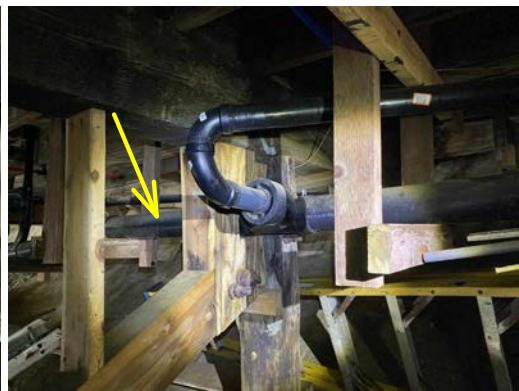
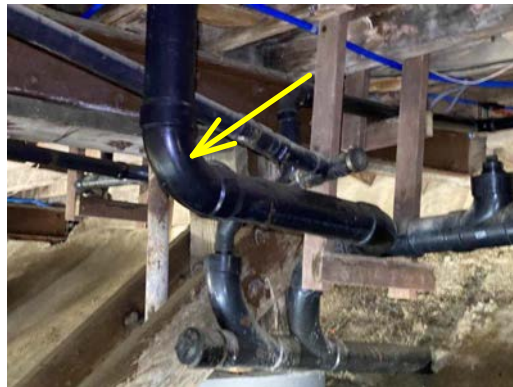
Service Line: Copper
Main Water Shutoff: Front
Water Lines: Copper for what is visible
Drain Pipes: ABS or Cast Iron - **Minor leakage at center, noted. Repair as necessary.**

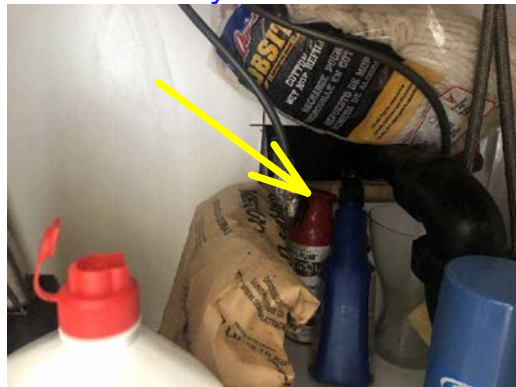
- 12. Acceptable Cooking Appliances:
- 13. Acceptable Ventilator:
- 14. Not Inspected Disposal: Not applicable
- 15. Not Inspected Dishwasher: Not applicable
- 16. Air Gap Present? No
- 17. Not Inspected Trash Compactor: Not applicable
- 18. Not Inspected Refrigerator: Not applicable
- 19. Acceptable Microwave:
- 20. Acceptable Sink: fiberglass
- 21. Acceptable Electrical: 110 VAC GFCI
- 22. Acceptable Plumbing/Fixtures: Chrome /Brass, PVC
- 23. Acceptable Counter Tops: Granite
- 24. Needs Attention Cabinets: Wood - **Open hole noted under the sink. Repair and patch as necessary.**

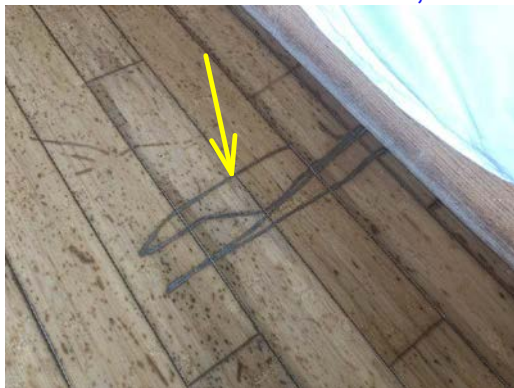
Floor: Hardwood - **Worn, surface damaged or abraded floor.**

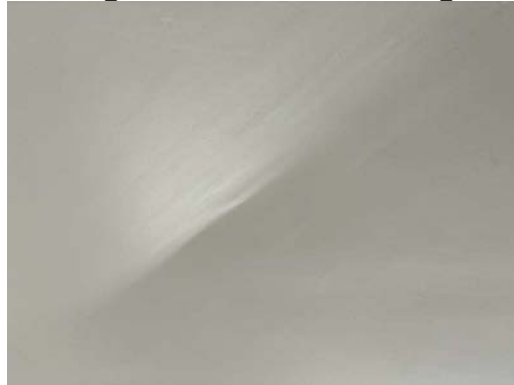
Ceiling: Paint and Paneling - Evidence of past repair

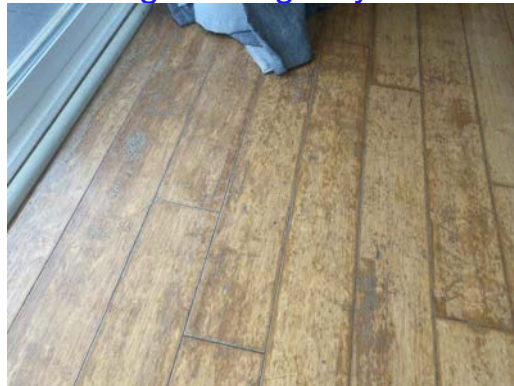
6. Needs Attention Floor: Hardwood - Traffic erosions and cracks noted. Consider re surfacing for longevity and better appearance

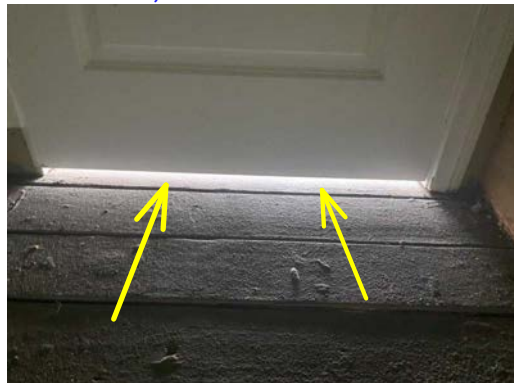
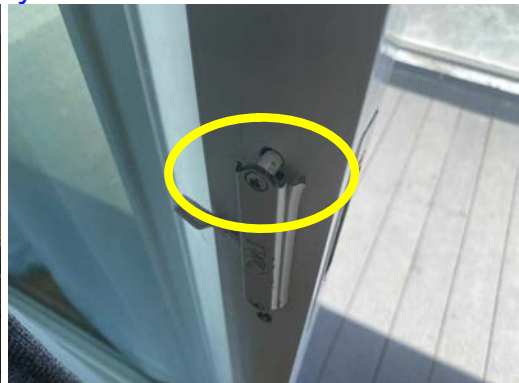
Doors: Wood and Vinyl - 1. Hardware missing, inoperable or loose, 2. Daylight is visible from inside. Install weather seal to prevent moisture, insect and rodent entry.

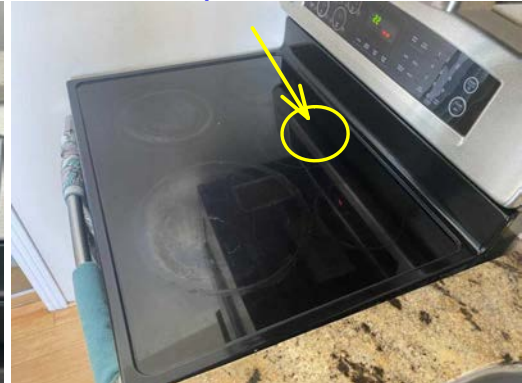
- 12. Serviceable Cooking Appliances: 1.No anti tip is installed (Comes with the new units from manufacturer). Anti tip is an inexpensive bracket that holds the unit from tipping in case the front door is opened and weight is applied on it or a person (child) stands on the door. It secures the Oven Range to the wall or floor. This was tested simply by pulling back on the unit. A safety notation, 2. One plate not functional.

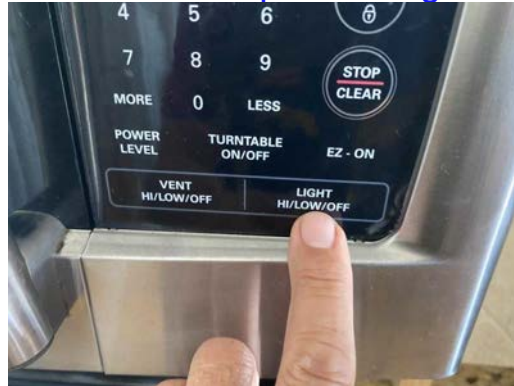
Microwave: **Inoperative light**

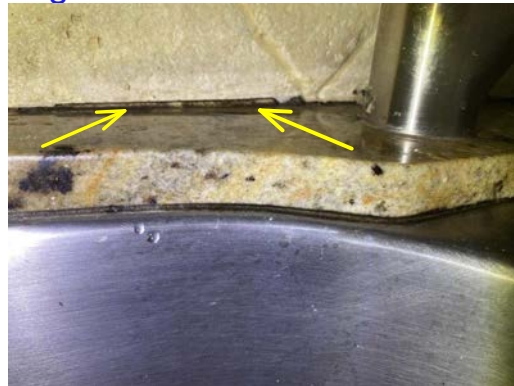
Counter Tops: Granite - **Caulking or re caulking will prevent water migration to counter underside.**

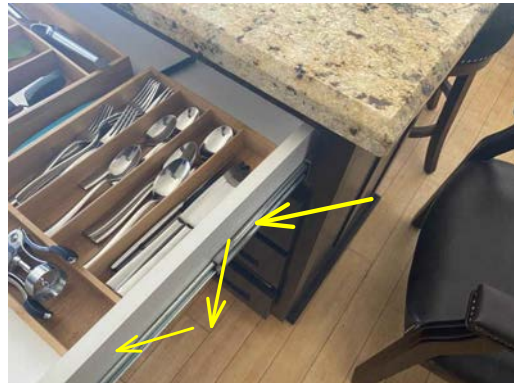
Cabinets: Wood - **Draws crooked. Repair / Replace as necessary.**

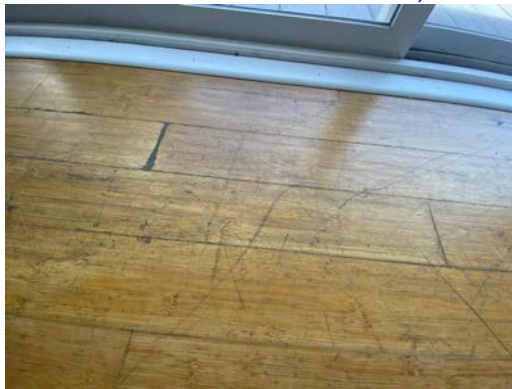
- 3. Acceptable Closet: Single
- 4. Acceptable Ceiling: Paint and Paneling
- 5. Acceptable Walls: Paint and Paneling
- 6. Needs Attention Floor: Hardwood - **Worn, surface damaged or abraded floor.**

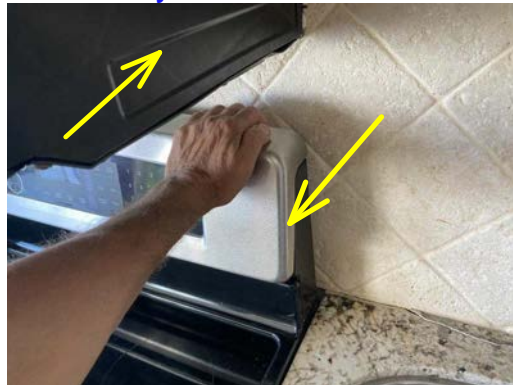
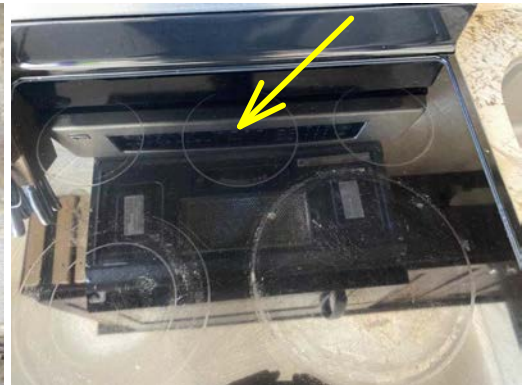
12. Needs Attention Cooking Appliances: 1.No anti tip is installed (Comes with the new units from manufacturer). Anti tip is an inexpensive bracket that holds the unit from tipping in case the front door is opened and weight is applied on it or a person (child) stands on the door. It secures the Oven Range to the wall or floor. This was tested simply by pulling back on the unit. A safety notation, 2. One hot plate not functional or with delay.

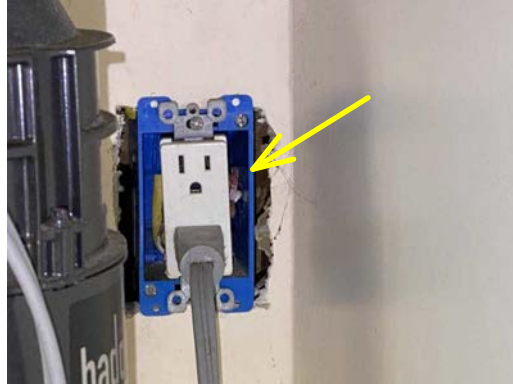
Electrical: 110 VAC - **Exposed wiring, missing or loose cover.**

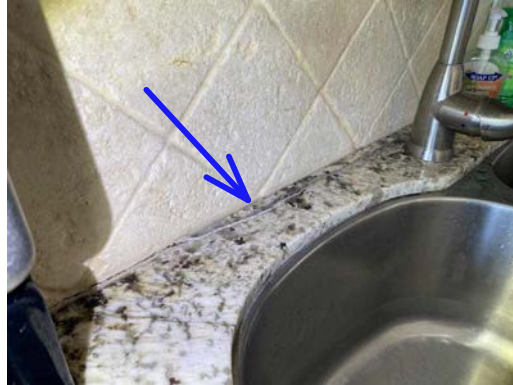
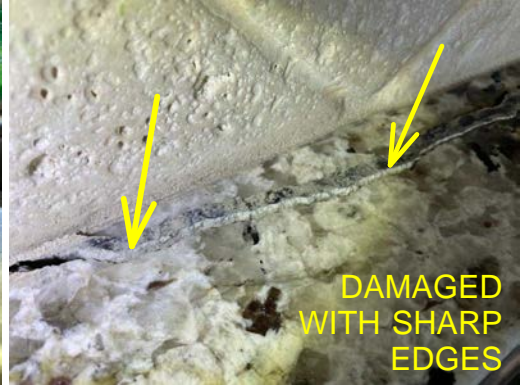
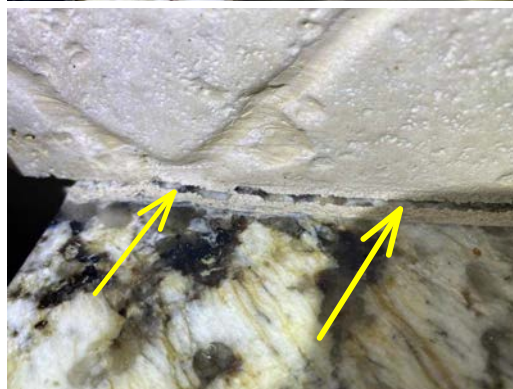
Plumbing/Fixtures: Metal-PVC
Counter Tops: Granite - **1.Damaged counter top could admit water to underside or become safety hazard, 2. Caulking or re caulking will prevent water migration to counter underside.**

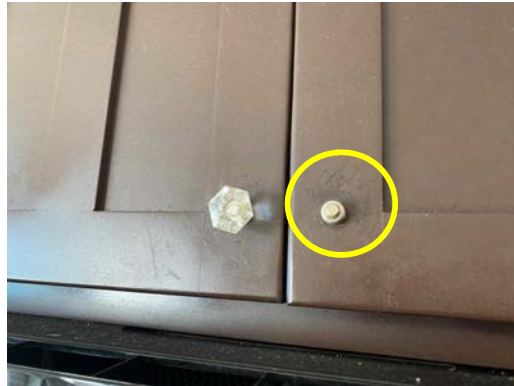
24. Needs Attention Cabinets: Wood - Knob missing.

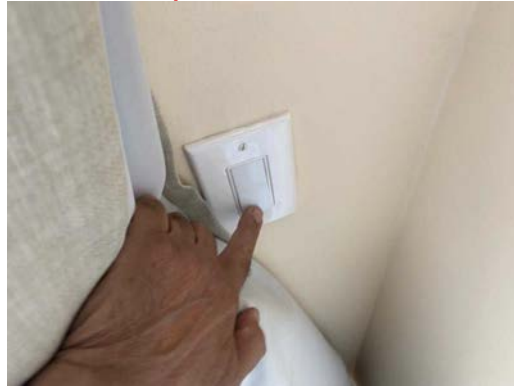
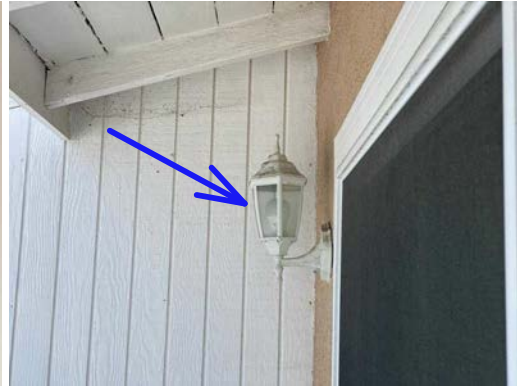
Balcony Ceilings: Stucco or siding
 Balcony Walls: Wood
 Balcony Electrical & Safety Railings: 120 VAC - **Light burned out or switch inoperable.**

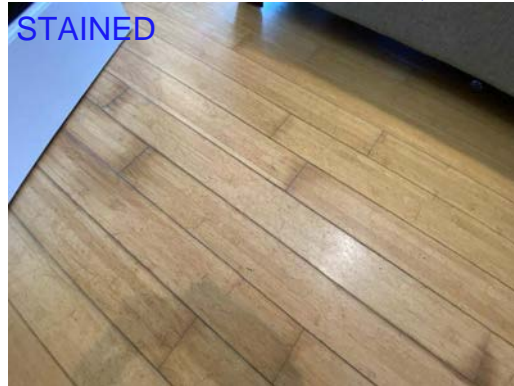
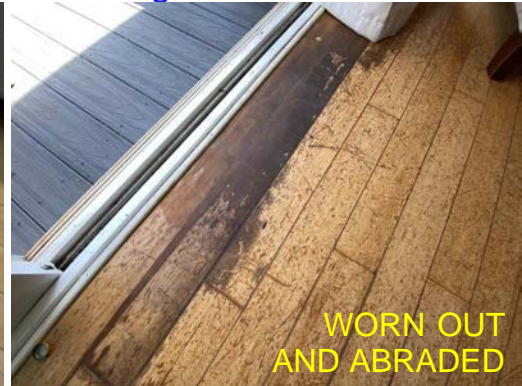
Floor: Hardwood - Worn, surface damaged or abraded floor.

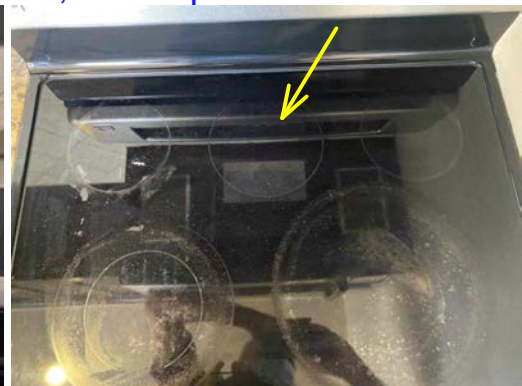
Cooking Appliances: 1. No anti tip is installed (Comes with the new units from manufacturer). Anti tip is an inexpensive bracket that holds the unit from tipping in case the front door is opened and weight is applied on it or a person (child) stands on the door. It secures the Oven Range to the wall or floor. This was tested simply by pulling back on the unit. A safety notation, 2. Hot plate issue

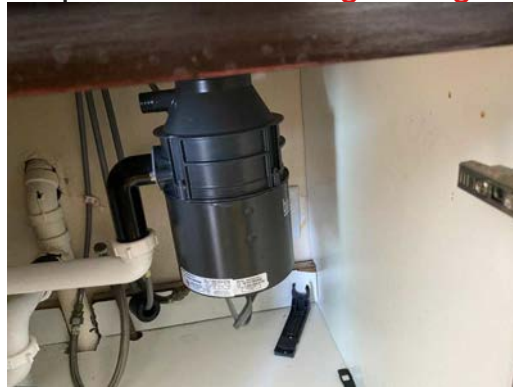
Disposal: **Loud and grinding. Repair / Replace as necessary.**

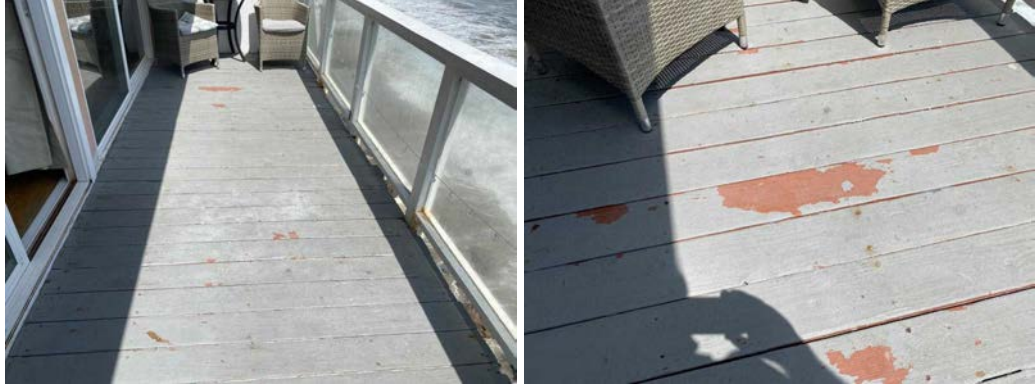
63. Needs Attention Balcony Floors: Wood and resin - Baloney floors, here and in other units are due for resurfacing and protective coating.
