**CITY PROPERTY SERVICES**  
Commercial & Residential Inspections

# Property Inspection Report

**Sample Report Address**

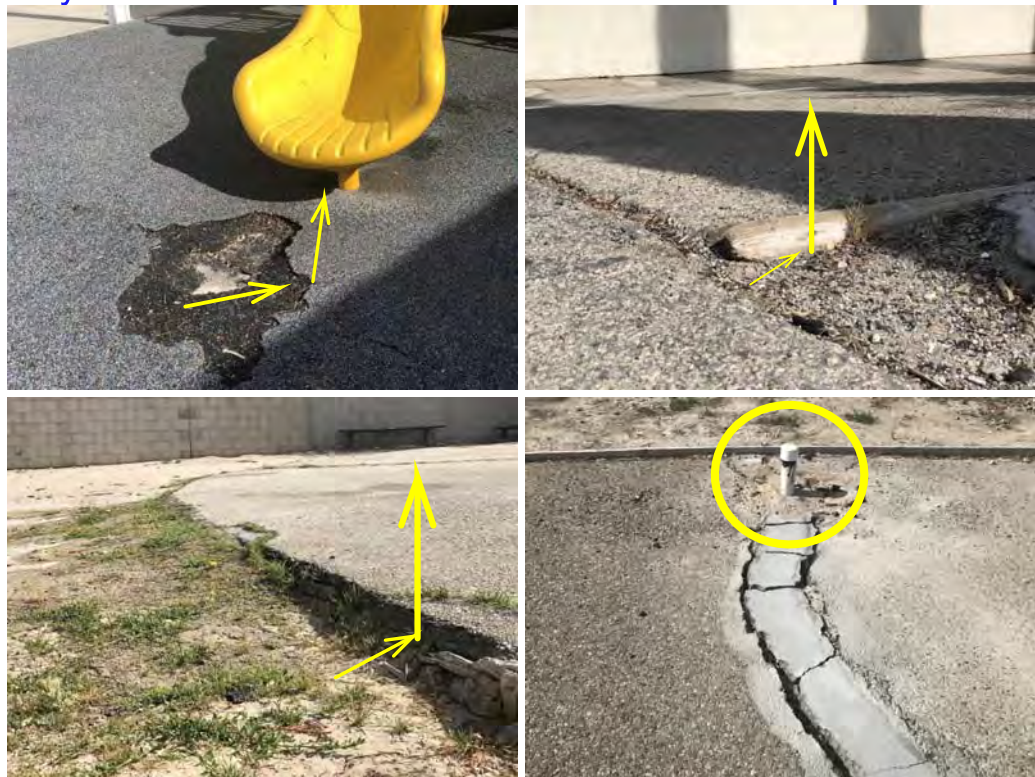
1. Needs Attention Walks: Concrete, Paver, Earth, Asphalt, Pebble top - **Safety Notation:** Any area or spot with level or grade differential, projected objects from ground and notable unevenness inside or outside the property should be repaired or improved to prevent trip and injury hazard. If improvement is not desired or not possible, use with caution and use night lighting. Photos could be sample representative, as all areas may not have been visible or accessible to the inspector.

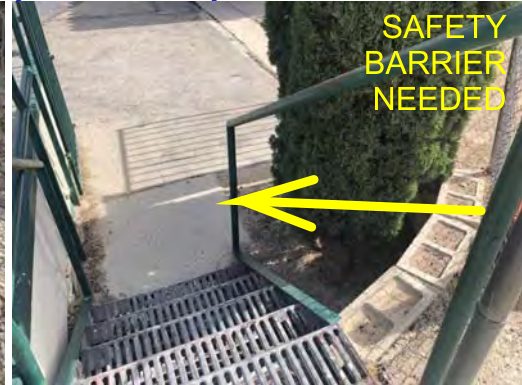
Steps/Stoops: Metal - Recommend installation of safety barriers at stairs and steps to prevent injury and liability.

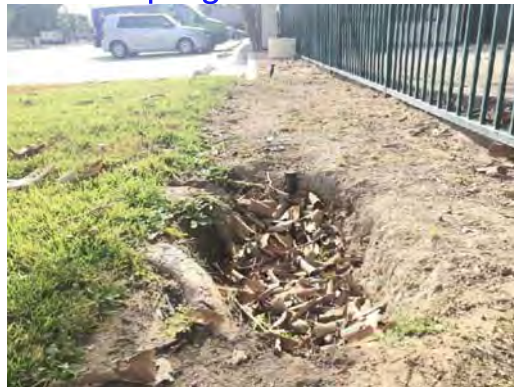
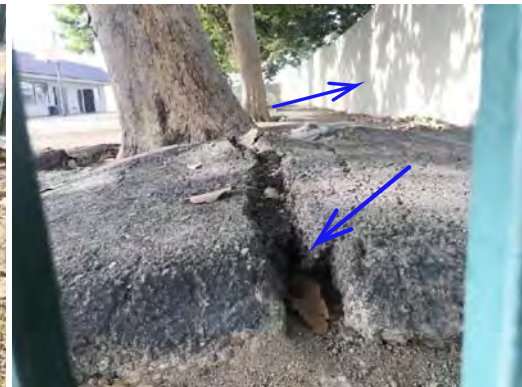
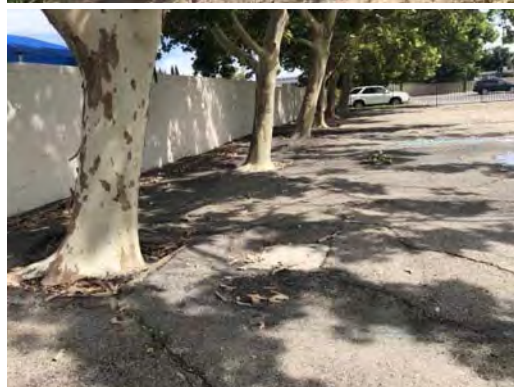
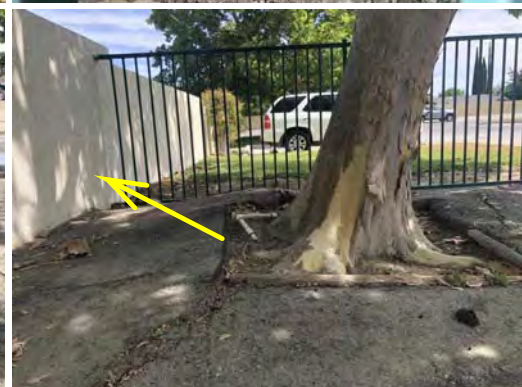
Vegetation: Trees, Grass, Schrub - Vegetation roots have caused asphalt heaving and block fence cracks. Monitor to take corrective action if progression is observed.

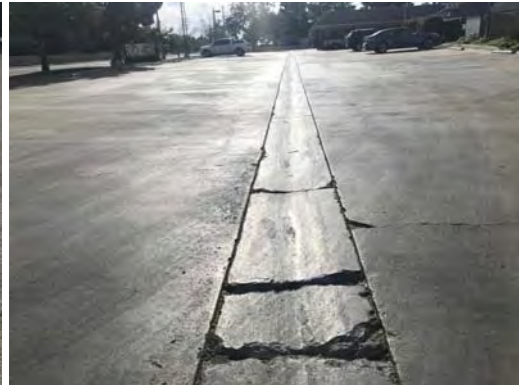
Retaining Walls: Brick, Block - **Cracks noted.**  
 Basement Stairwell: Not Applicable  
 Grading: Moderate slope, Negative slope  
 Swale: Adequate slope and depth for drainage - **Recommend improvements be made to the grade, swale slope and depth to improve water control. Cracks should be filled/patched and any trip hazards should be corrected.**

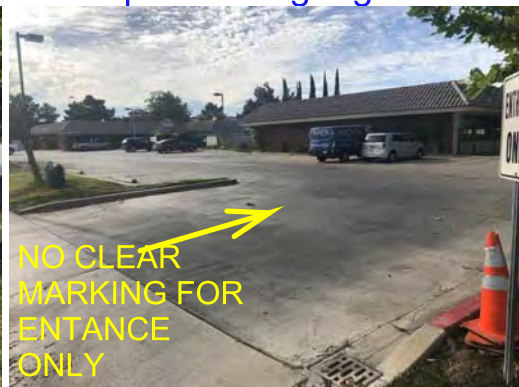
Window Wells: Not Applicable  
 Basement Stairwell Drain: Not Applicable  
 Exterior Surface Drain: Surface drain, Slope drain  
 Driveway: Asphalt - **Missing or inconspicuous signage.**

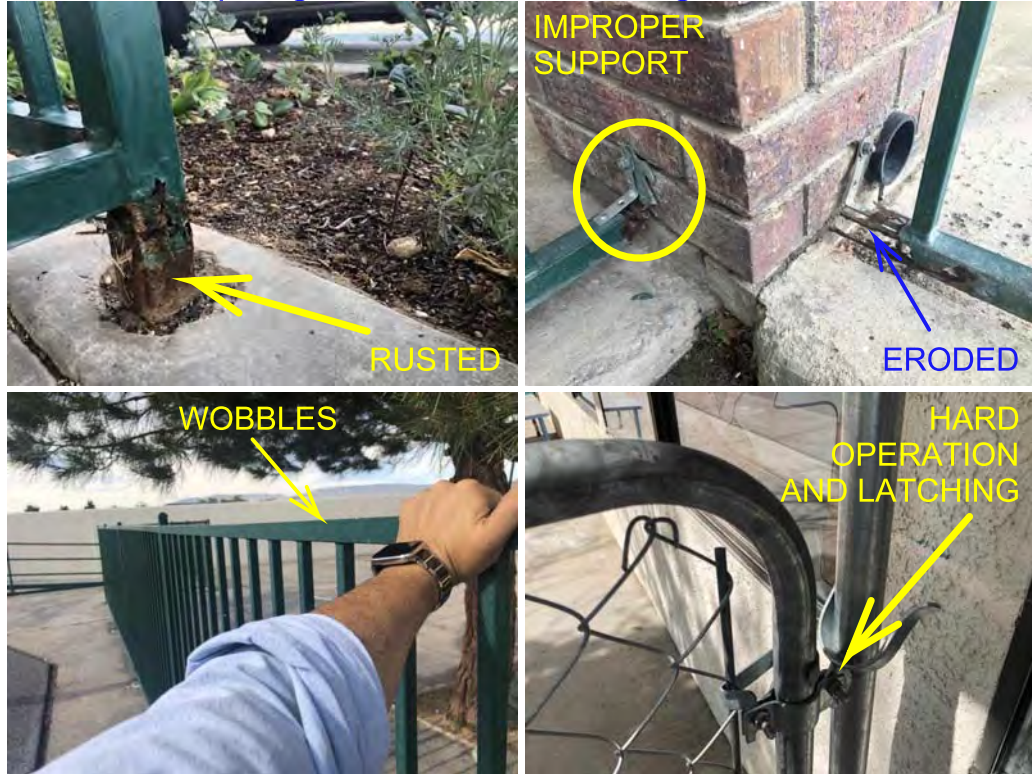
Fences: Chain link, Block - Fences need attention or repair due to: Cracks, sharp edges, corrosion, wobbling or erosion.

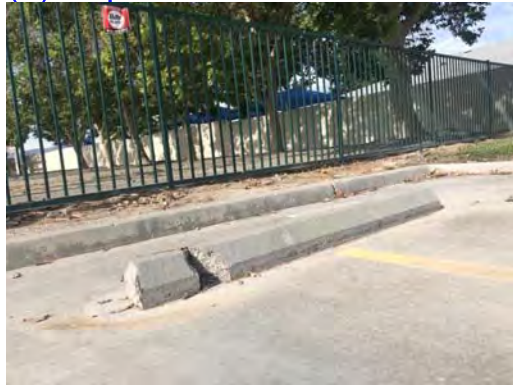
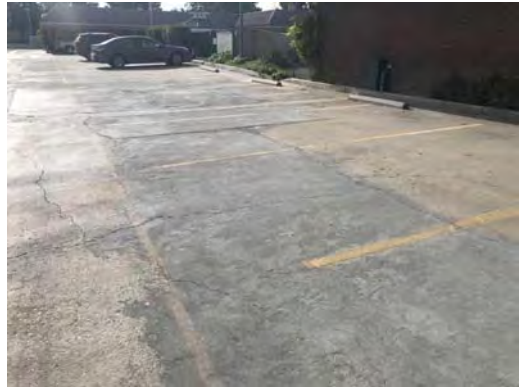
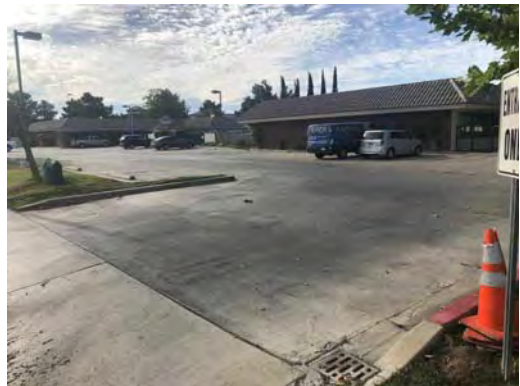
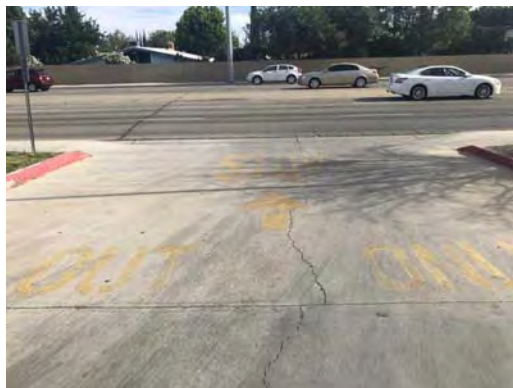
18. Needs Attention Parking Lot: Concrete, Asphalt - (1) Needs to be resurfaced, (2) Lines need to be re-striped (3) Trip hazards & Cracks noted.

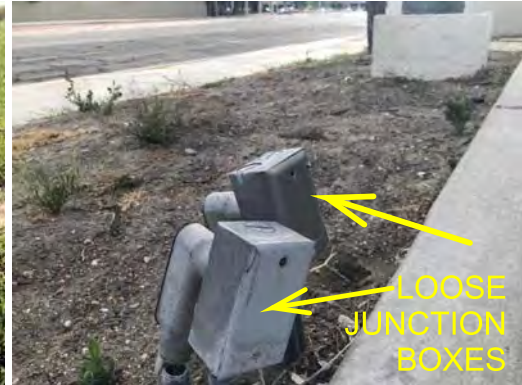
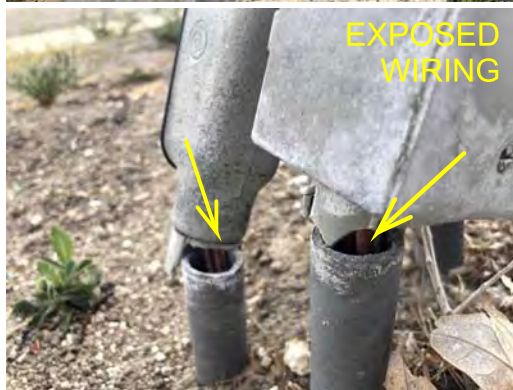
Parking Lot Lighting: Pole light - Exposed wiring, water pregnable junction boxes / fittings and corrosion noted.

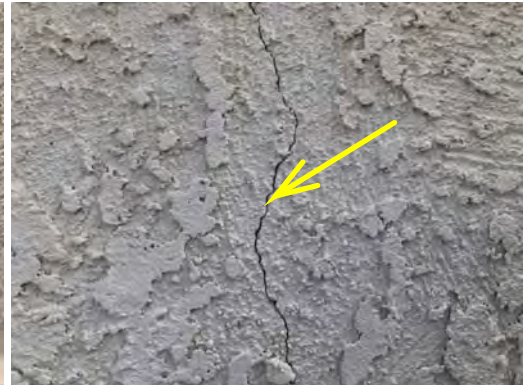
Type: Stucco - (1) Past repairs noted (2) Any cracks or opening should sealed and patched and painted to prevent further decay and water entry into the interior.

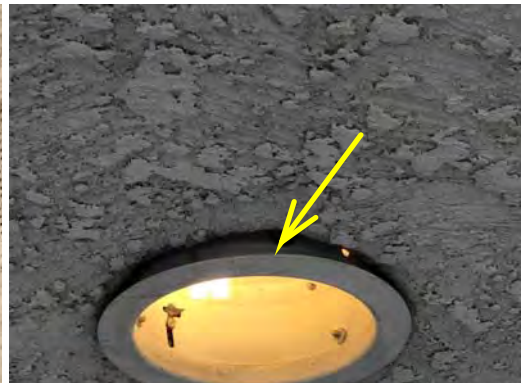
Exterior Lighting: Surface mount - Many are missing lens cover. Some are loose.

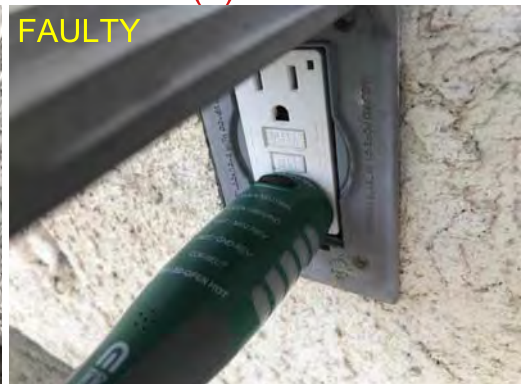
Exterior Electric Outlets: (1) One or more are not GFCI or GFCI labeled outlets. Consult a qualified electrician for remedy and cost. Faulty outlet with unconnected, loose or crossed wires (2) One or more are exposed and should have cover (3) One or more are faulty.

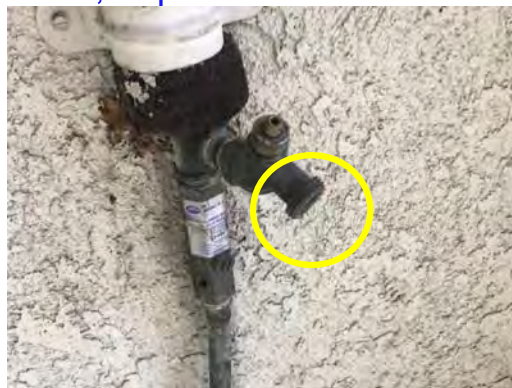
13. Needs Attention Hose Bibs: Rotary - Recommend installation of anti siphon, one way valve, to prevent contamination of water.

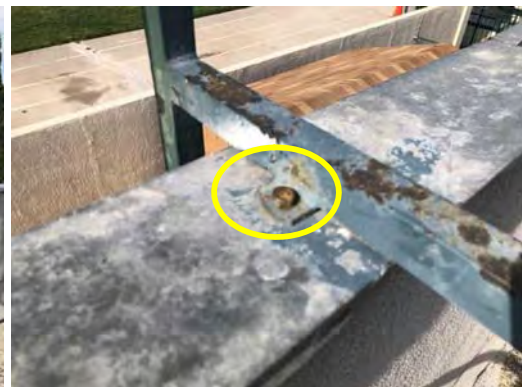
2. Serviceable Roof Access Ladder Safety and Liability Notation: Both of the attached metal roof ladders wobble slightly: The bolts are loose due to unattached lower bar extensions and applied force by weight of the user. Recommend installing filler of some sort, between the lower section and the roof parapet walls to prevent wobbling and looseness progression. Timely sanding and painting of these components prevent corrosion and decay.

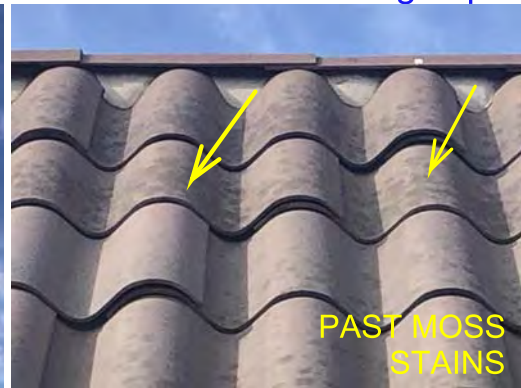
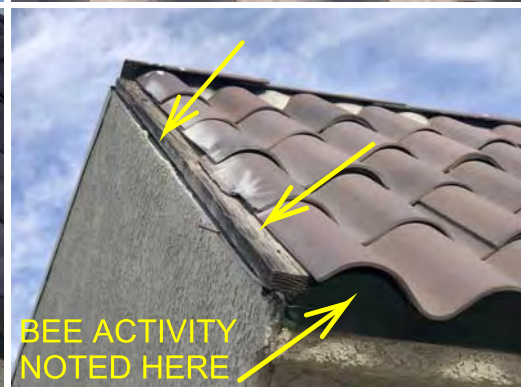
Material: Tar and gravel and Roll Asphalet sheathing - (1) Missing cap tiles noted. Install to prevent water migration to underside (2) Roof tiles show past moss build up stains. If excessive moss activity is noted in the future, pressure washing is recommended. Roof should be checked for routine maintenance and repairs on yearly basis, before rain season (3) Parapet wall asphalt sheathing show creases that could break and become water pregnable. Monitor to take corrective action as necessary (4) Damage and water pregnable spots on asphalt sheathing material noted. Repair and seal to prevent water intrusion into the interior (5) Exposed tar material on roof deck is evident at many areas. Recommend repair by a professional roofer (6) Recent improper repairs that pond water noted (7) Roof is spongy when walked on. Reinforcement of the roof framing or deck may be required. Consult with a professional roofer or a framing expert.

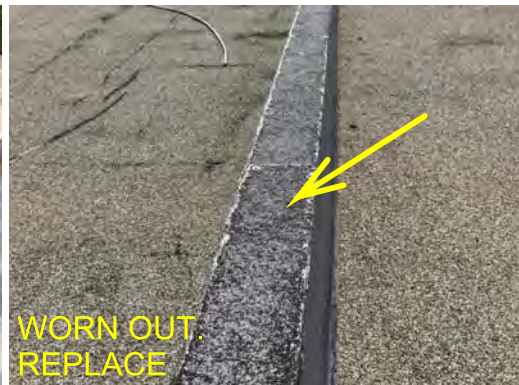
8. Serviceable Flashing: Aluminum - (1) Some need patching (2) Some are worn out and due for replacement

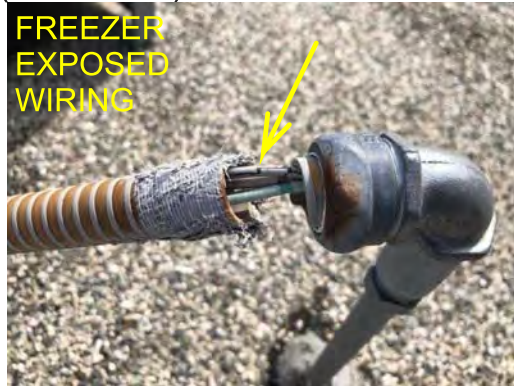
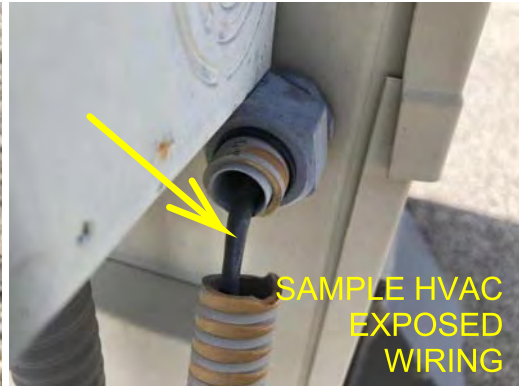
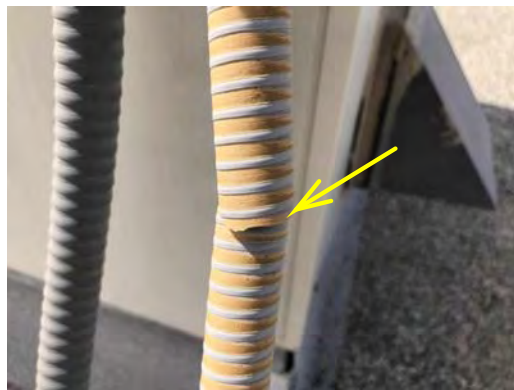
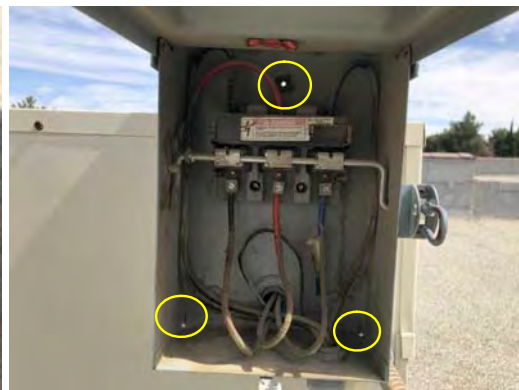
Other Electrical (1) The freezer and HVAC unit conduits are old, brittle and worn out and show exposed wiring. Recommend replacement of the conduit tubing, as necessary (2) Some of the disconnect boxes show holes that can admit water and insects into the box. Recommend sealing.

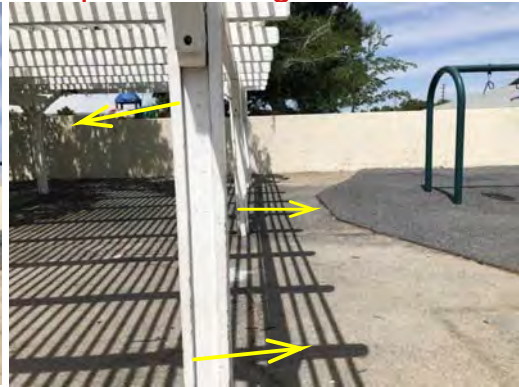
Beams: Solid wood - (1) **Safety and Liability Notation: The overhang structure at right side play ground is not plumb and wobbles slightly. Consult with a framer to verify if reinforcement is needed** (2) This structure is due for resurfacing and paint coating.

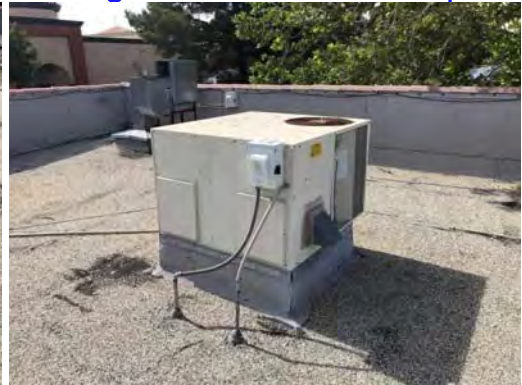
A/C System Operation: Functional at the time of inspection - HVAC package units (cold and heat in one closet) are aged and require attention and yearly tune up, as a long term maintenance plan.

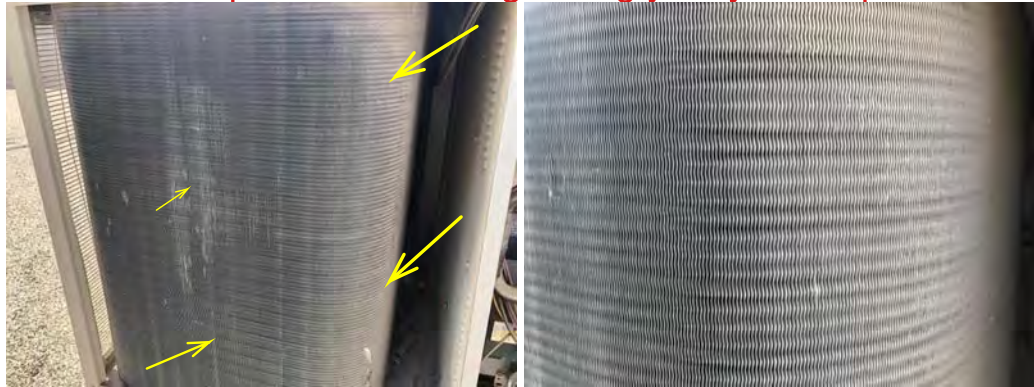
Visible Coil: Copper coil with aluminum fins - Coils should be damage, calcium, dust or debris free for proper functioning. Recommend pressure washing during yearly tune up.

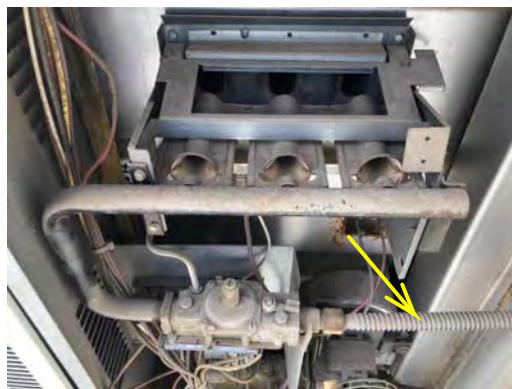
- 2. Manufacturer: Carrier
- 3. Type: Forced air Capacity: 65000 BTUHR
- 4. Area Served: Interior Approximate Age: 15 to 20 Years.
- 5. Fuel Type: Natural gas
- 6. Serviceable Heat Exchanger: 3 Burner - Flex gas tubes inside the heat exchange, are not compliant with today's safety standards. Recommend replacement with rigid steel pipe. 18 out of 19 package units have flex tubes adjacent to burners, and one is newer unit with rigid pipe connection.

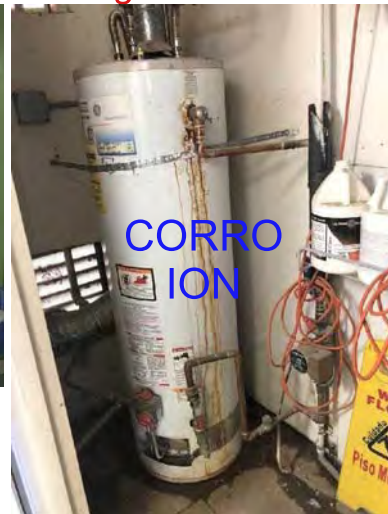
Water Heater Operation: Functional at time of inspection - (1) Evidence of past or present water leakage in drain tube from pressure relief valve. (2) Earthquake support straps missing or not properly installed (3) Water heater is due for replacement as it is aged and shows signs of malfunction and leakage.

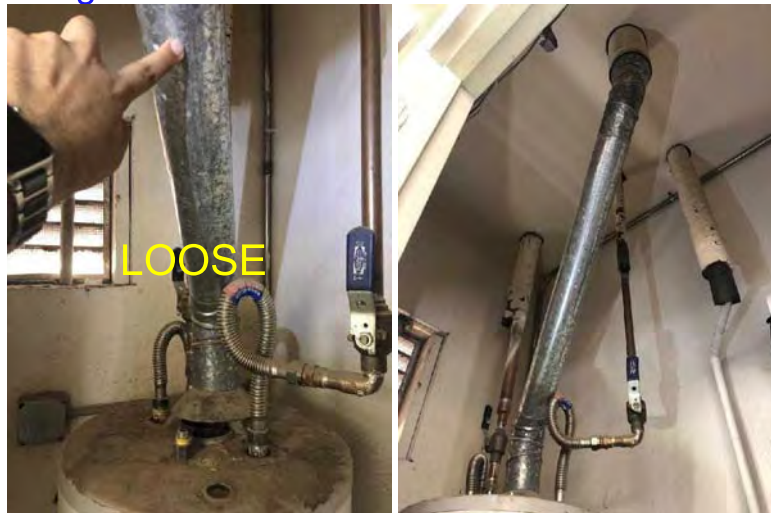
18. Serviceable Flue Pipe: Double wall - **Loose. Install screws at exhaust vent piping fittings**

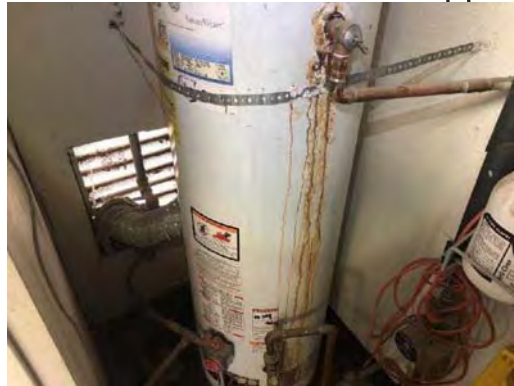
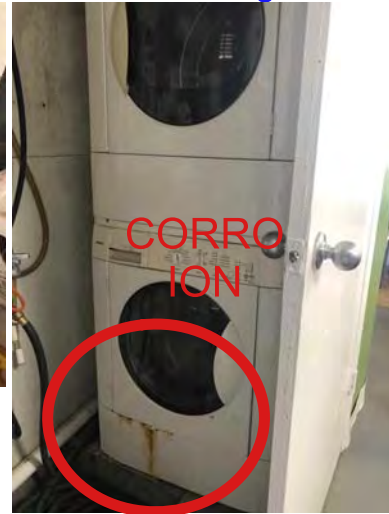
19. Needs Attention TPRV and Drain Tube: Copper - Past Leaking Noted

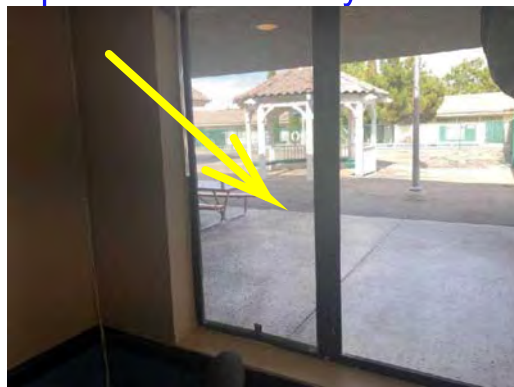
- 1. Not Inspected    Closet: Not applicable
- 2. Acceptable        Ceiling: Suspended ceiling
- 3. Acceptable        Walls: Paint and paneling
- 4. Acceptable        Floor: Carpet
- 5. Acceptable        Doors: Wood
- 6. Serviceable       Windows: Aluminum slider - **Hard operation. Lubricate, repair or replace as necessary.**

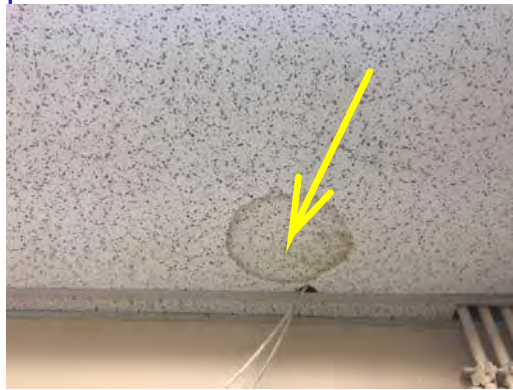
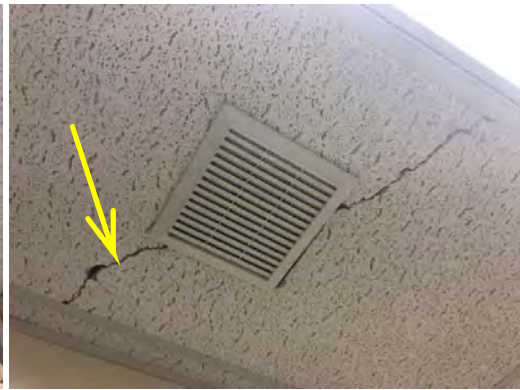
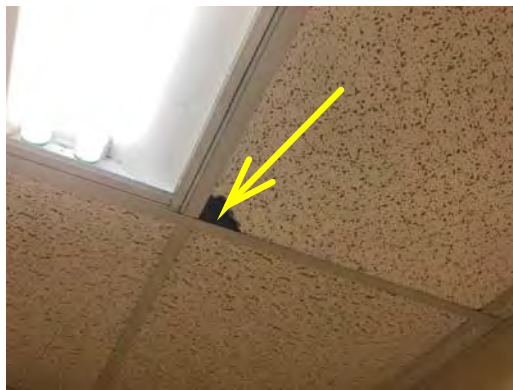
- 37. Not Inspected Closet: Not applicable
- 38. Serviceable Ceiling: Suspended ceiling - (1) Water stains present (2) Damaged panel

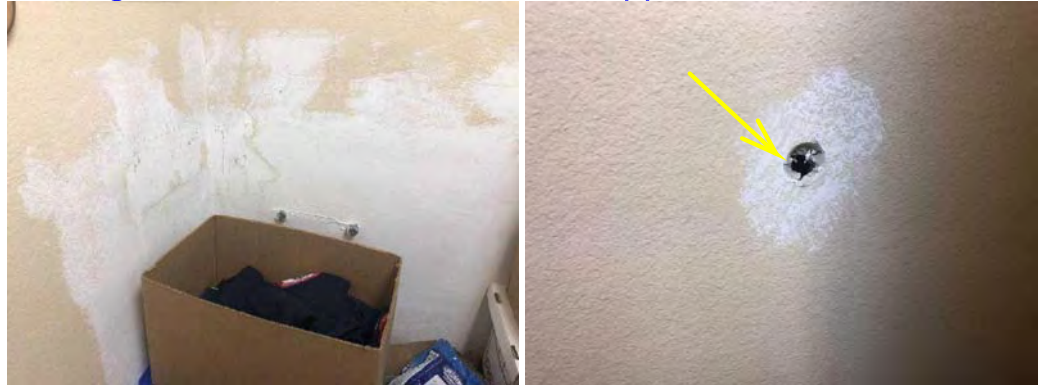
Walls: Paint and paneling - (1)Evidence of past repair or damage (2) Damaged wall due to lack of door stopper.

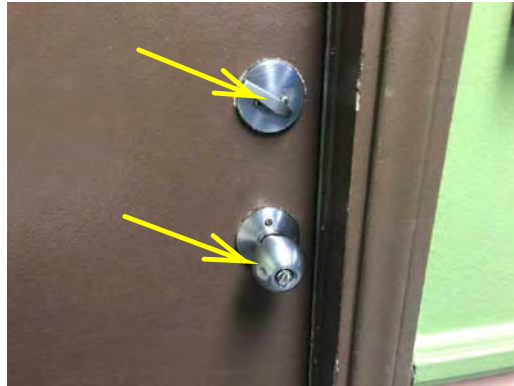
Doors: Wood - Loose or missing hardware

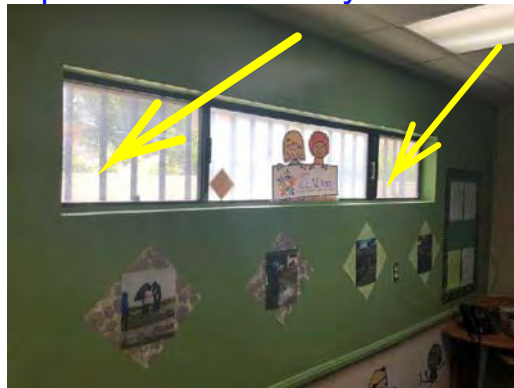
Windows: Aluminum slider - Hard operation. Lubricate, repair or replace as necessary.

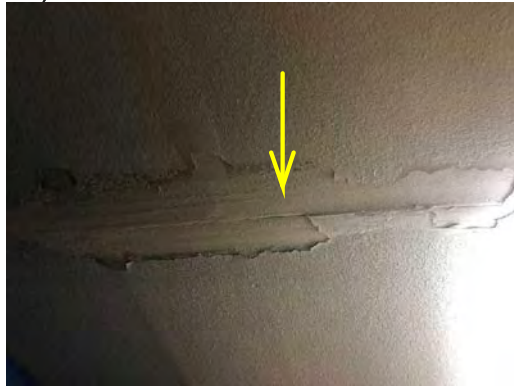
Ceiling: Paint and Paneling - [Evidence of past repair or damage. Inquire with owner regarding any past repair for back ground and history.](#)

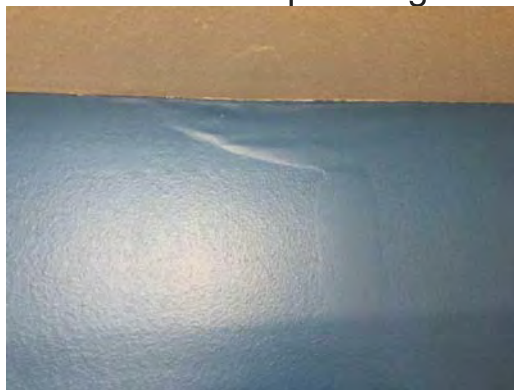
20. Needs Attention Walls: Paint and paneling - Evidence of past repair

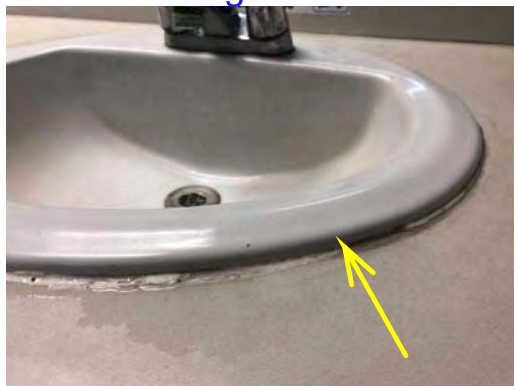
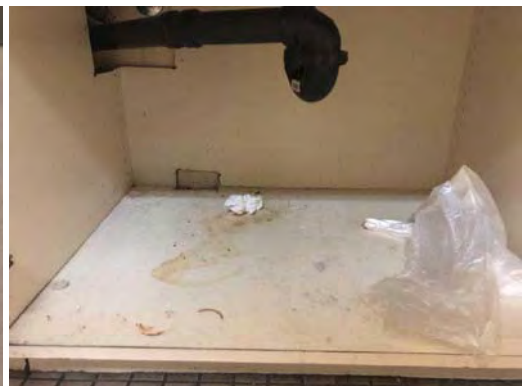
Counter/Cabinet: Composite and wood - (1)Needs caulking (2) Water staining under the counter noted.

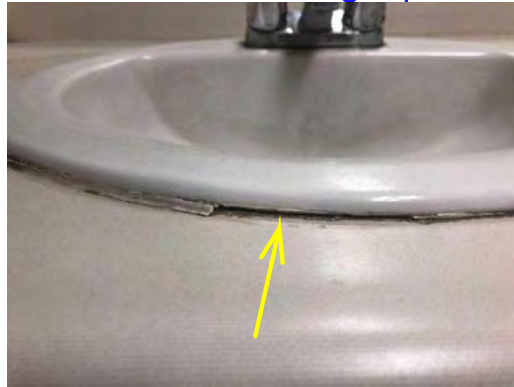
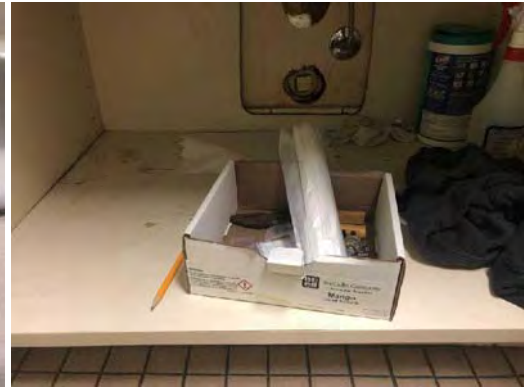
Windows: Not applicable  
 Electrical: 110 VAC GFCI  
 Counter/Cabinet: Composite and wood - (1)Needs caulking (2) Water stains / damage, present under the counter.

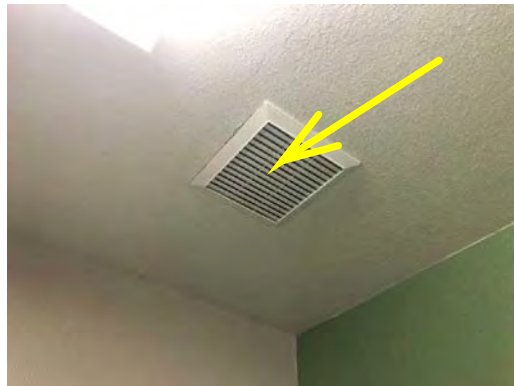
Sink/Basin: Porcelain  
 Faucets/Traps: Metal / Metal  
 Shower/Surround: Not applicable  
 Urinals: American Standard  
 Toilets:  
 Grab Bars: **Missing, ADA non-compliance**  
 Partitions: None  
 HVAC Source: Not applicable  
 Ventilation: Electric ventilation fan - **Fan inoperative**

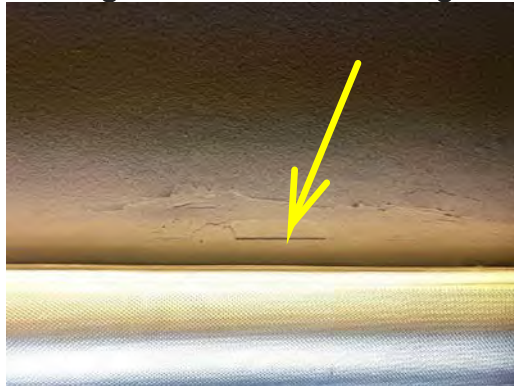
55. Needs Attention Ceiling: Paint and Paneling - Evidence of past repair

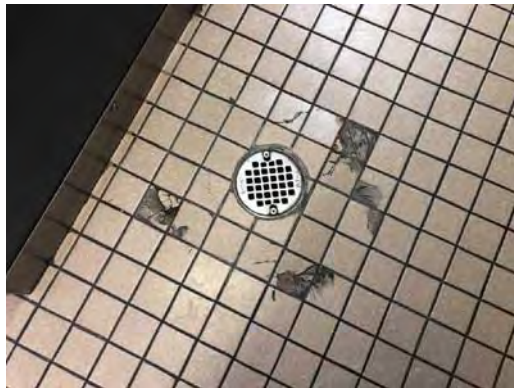
57. Needs Attention Floor: Tile - Cracked tiles

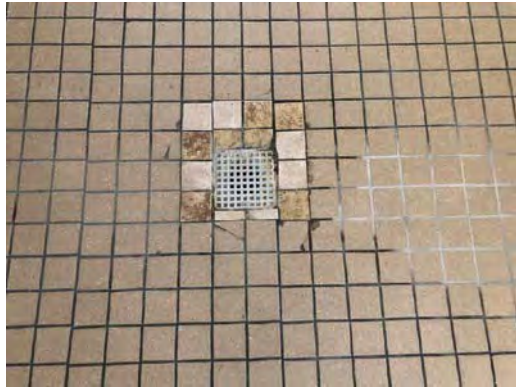
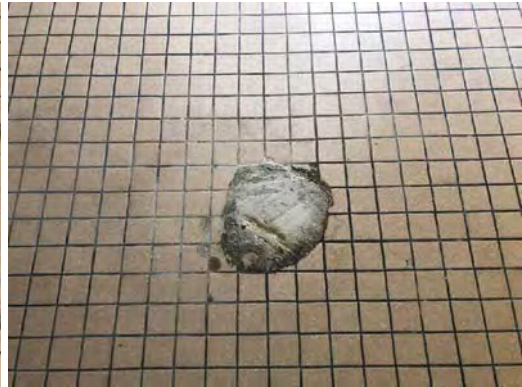
- 109. Acceptable Ceiling: Paint and Paneling
- 110. Acceptable Walls: Paint and paneling
- 111. Needs Attention Floor: Tile - **Cracked tiles and filled drain intake.**

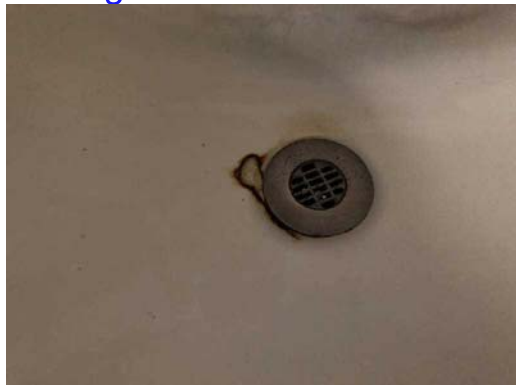
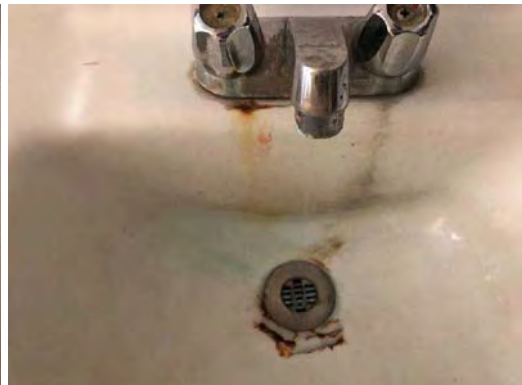
- 112. Acceptable Doors: Wood
- 113. Not Inspected Windows: Not applicable
- 114. Acceptable Electrical: 110 VAC
- 115. Not Inspected Counter/Cabinet: Not applicable
- 116. Serviceable Sink/Basin: Porcelain - **(1)Chipped (2) Low water pressure and leaking faucet: One or more**

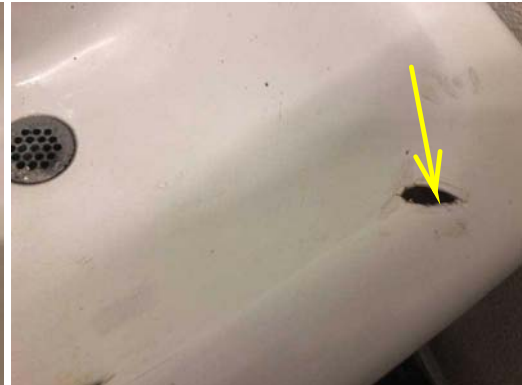
- 125. ADA Compliant No
- 126. Emergency lighting present? No  
Z4 (Class rooms at right side of the property) for room 14 and 15 boys Room Rest Room -
- 127. Acceptable Ceiling: Paint and Paneling
- 128. Acceptable Walls: Paint and paneling
- 129. Acceptable Floor: Tile
- 130. Acceptable Doors: Wood
- 131. Not Inspected Windows: Not applicable
- 132. Acceptable Electrical: 110 VAC
- 133. Not Inspected Counter/Cabinet: Not applicable
- 134. Serviceable Sink/Basin: Porcelain - **Chipped / Corroded. Prone to leakage at any time.**

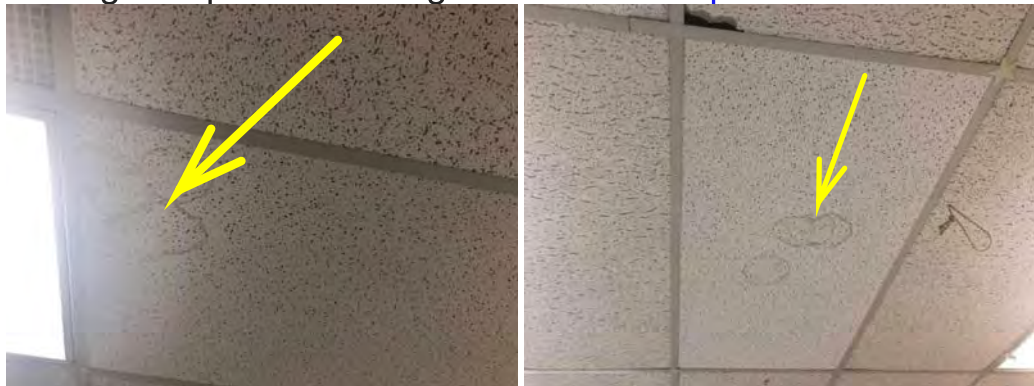
- 1. Note: Work Areas Refer to Class Rooms  
Room 1 / Z3 , Northeast Work Area
- 2. Note: Work Area Refers to each Room
- 3. Acceptable Closet: Shelves
- 4. Needs Attention Ceiling: Suspended ceiling - **Water stains present**

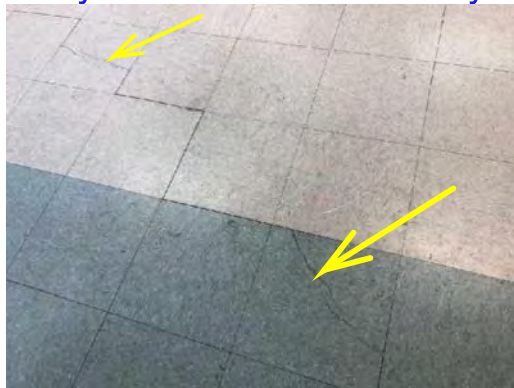
Floor: Linoleum - (1) Damaged floor (2) Asbestos Presence Possibility Here or in other rooms: The adhesion mastic under vinyl tiles may contain asbestos. Any change or modification here should be done cautiously and properly. Consult with an asbestos expert to verify if removal is necessary.

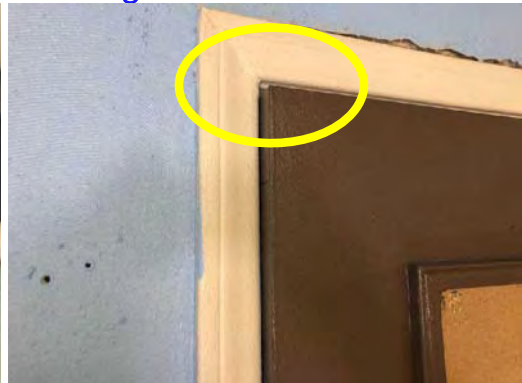
Doors: Wood - (1) Loose or missing hardware (2) Door sticks and partially damaged (3) Wall edge damaged.

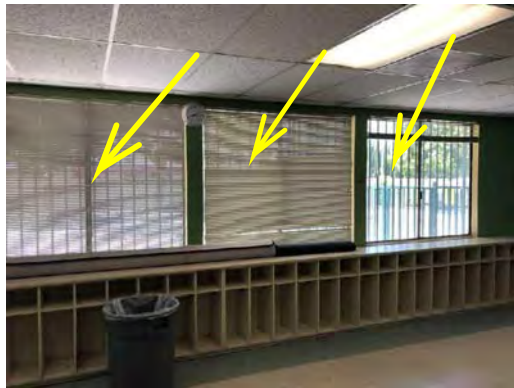
Windows: Aluminum slider - (1) Hard operation. Lubricate, repair or replace as necessary (2) Missing screen here and in the other classrooms

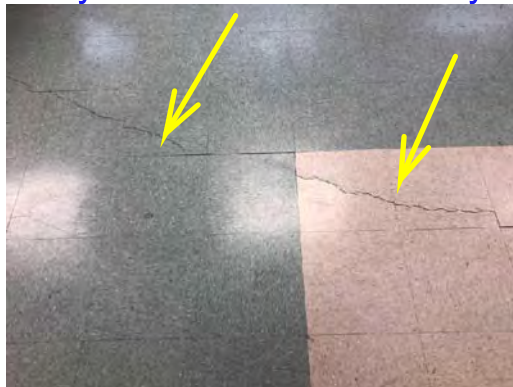
Floor: Linoleum - (1) Damaged floor (2) Asbestos Presence

Possibility Here or in other rooms: The adhesion mastic under vinyl tiles may contain asbestos. Any change or modification here should be done cautiously and properly. Consult with an asbestos expert to verify if removal is necessary.

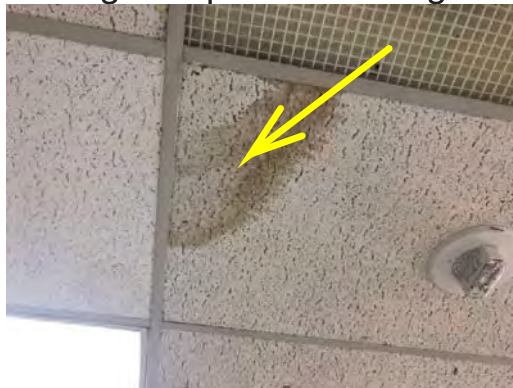
113. Needs Attention Ceiling: Suspended ceiling - [Water stains present](#)

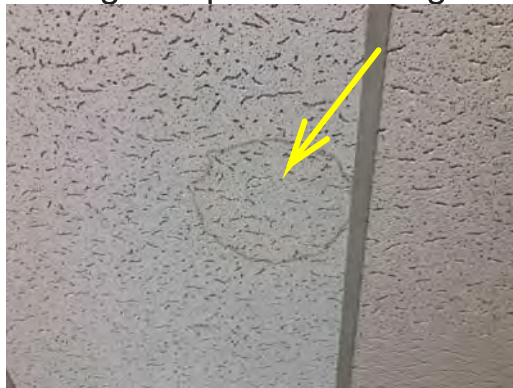
- 121. Acceptable      Closet: Shelves
- 122. Needs Attention Ceiling: Suspended ceiling - **Water stains present**

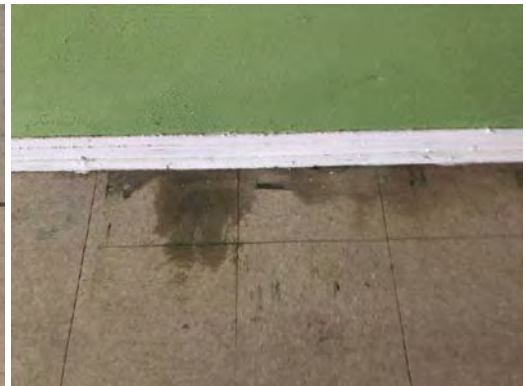
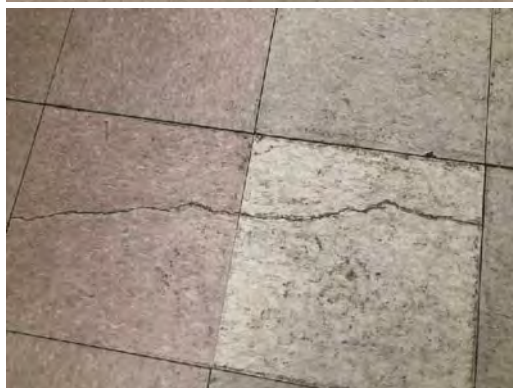
Floor: Vinyl - Damaged floor. See notations regarding asbestos in other areas.

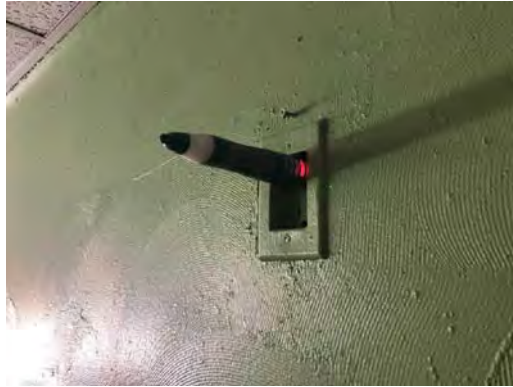
Electrical: 110 VAC - **Faulty outlet with loose, disconnected or crossed wires.**

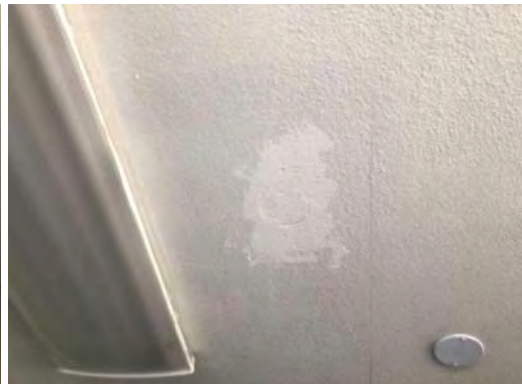
149. Needs Attention Ceiling: Paint and Paneling - **(1) Paint damage due water seepage noted (2) Evidence of past repair**
