CITY PROPERTY SERVICES
Commercial & Residential Inspections

Property Inspection Report

Munlti Unit-Income Property

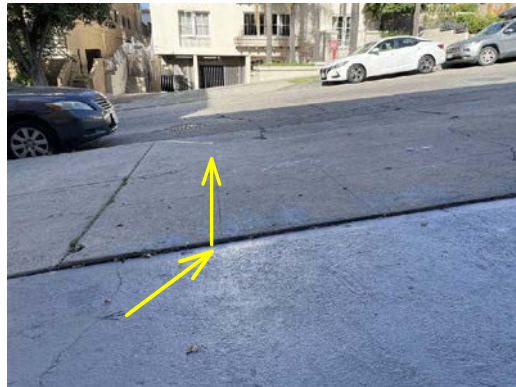
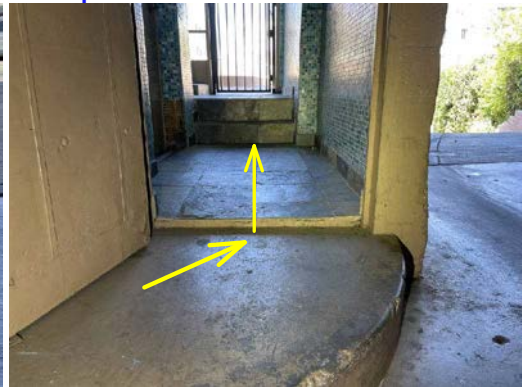
1. Needs Attention Walkways: **Safety Notation: Any area or spot with level or grade differential, projected objects from ground, openings on walk path and notable unevenness inside or outside the property should be repaired or improved to prevent trip and injury hazard. If improvement is not desired or not possible, use with caution and use night lighting. Photos could be sample representative, as all areas may not have been visible or accessible to the inspector.**

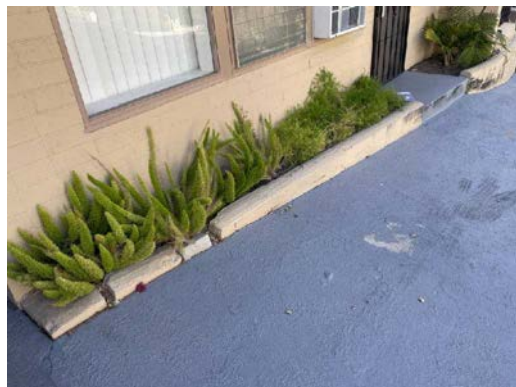
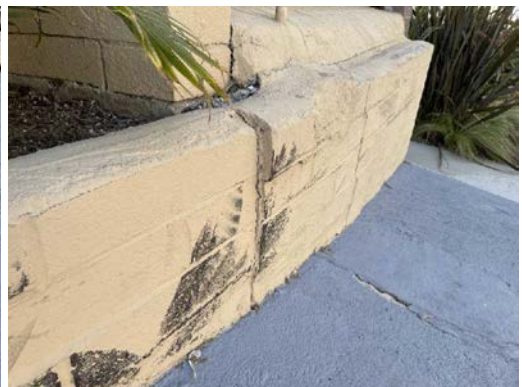
2. Acceptable Walkway Drainage: Slope Drain
3. Acceptable Steps/Stairs: Concrete, Wood
4. Not Inspected Vegetation: Not Applicable
5. Needs Attention Retaining Walls: **Minor cracks and separation noted. Monitor and maintain.**

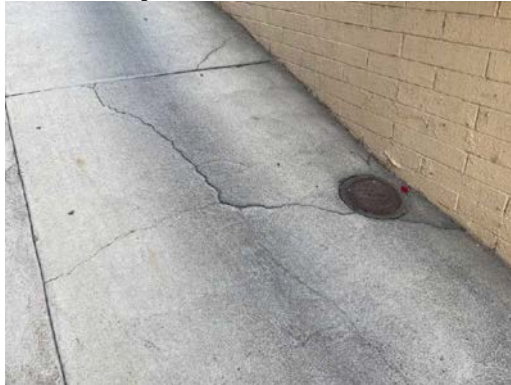
Driveway: Concrete - Cracks commonly seen, noted.

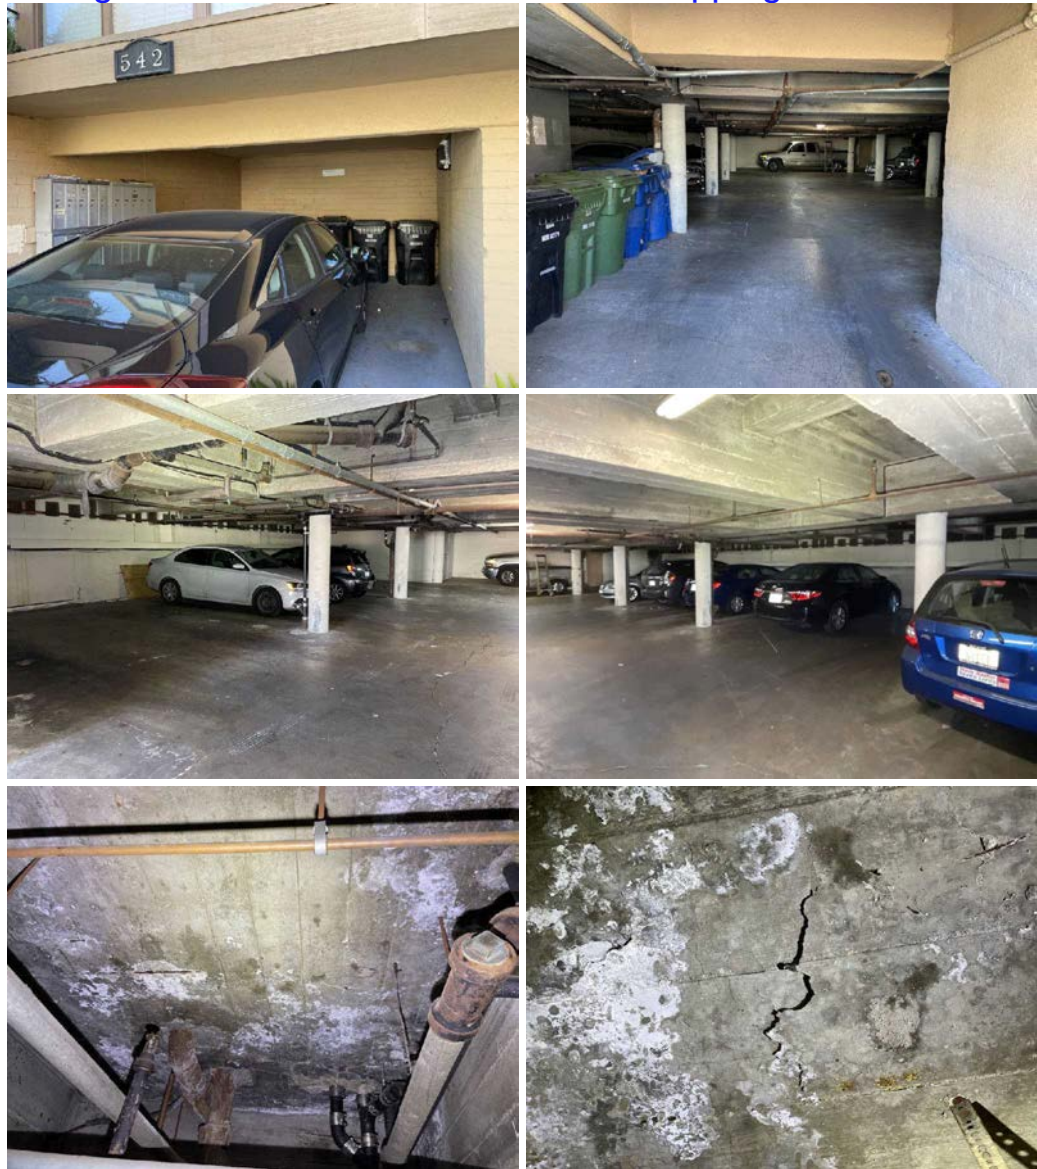
10. Needs Attention Parking Lot: Monitor and maintain per following reasons:
1. Crack on floor without displacement, 2. Moisture affects, efflorescence (salty residue due to moisture seepage) on concrete ceilings is evident and minor concrete chipping are evident.

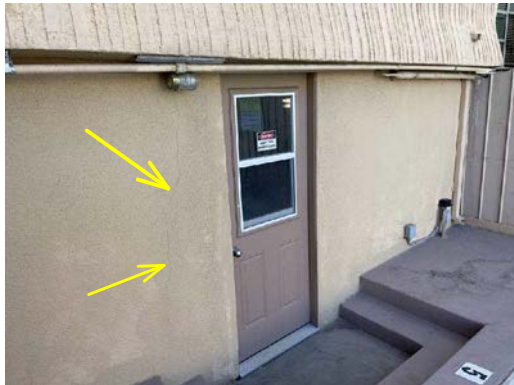
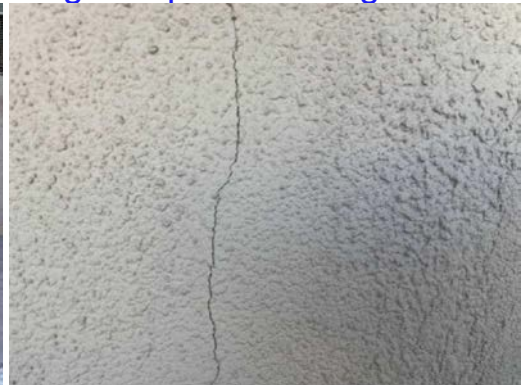
1. Needs Attention Type: Stucco - 1. Any opening, separation, or crack on the exterior walls should be sealed patched and painted as necessary, to prevent further decay and admittance of water, insect or rodent traffic, 2. Entire exterior is due for resurfacing and paint coating

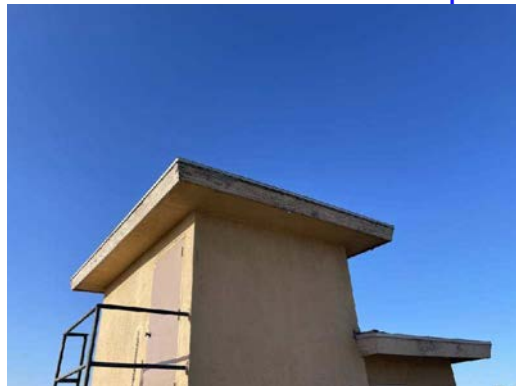
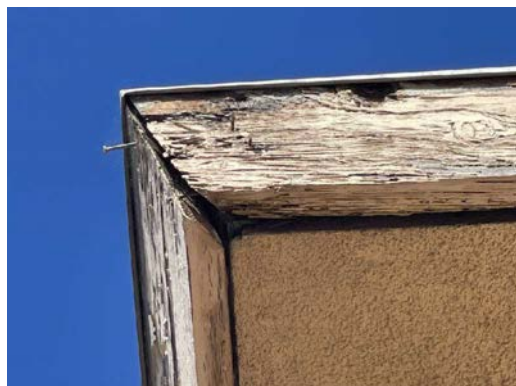
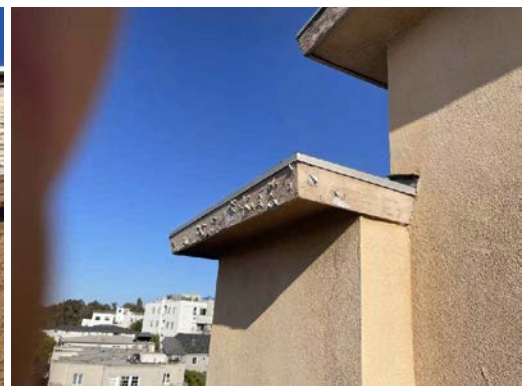
- 2. Acceptable Main Entry:
- 3. Main Entry Access ADA Compliant: No
- 4. Not Inspected Secondary/Other Entry:
- 5. Secondary/Other Entry Access ADA Compliant: **Not applicable**
- 6. Not Inspected Rear Entry: Not Applicable
- 7. Serviceable Trim: Wood - **Due for repair and painting.**
- 8. Serviceable Fascia: Wood - **Due for repair and painting.**

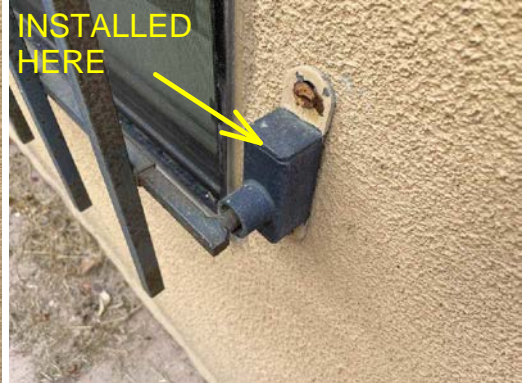
Windows: **Some of the window security bars are not equipped with release mechanism from inside, for emergency existing.**

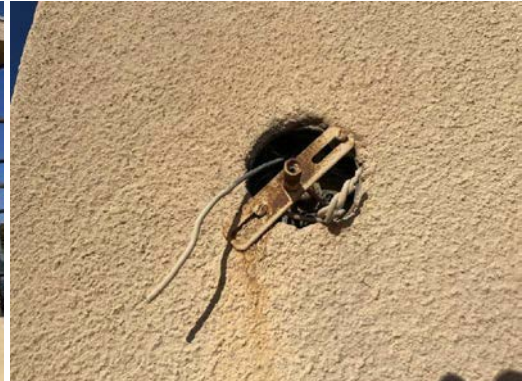
Exterior Lighting: **Exposed wiring at different areas noted. Cover and secure as possible. Consult an electrician.**

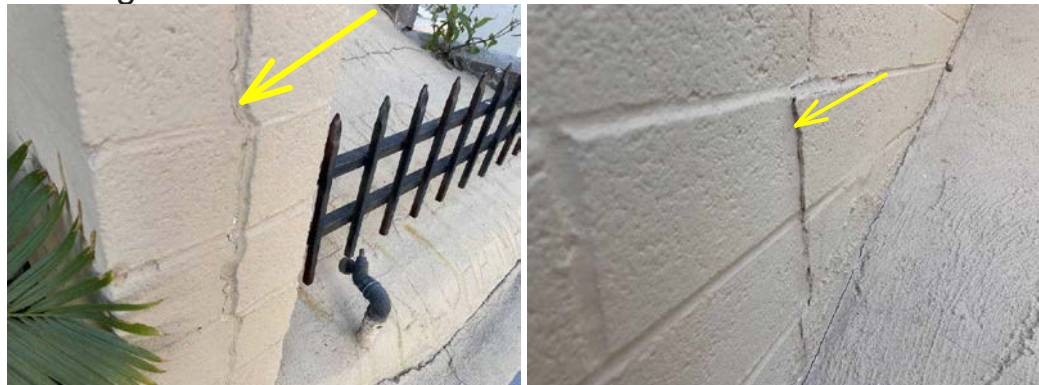
Structure Type: Anchored Wood Framing
 Foundation: Formed Concrete
 Differential Movement: Not Applicable
 Beams: Metal and Wood
 Bearing Walls: **Minor cracks noted. Monitor and maintain.**

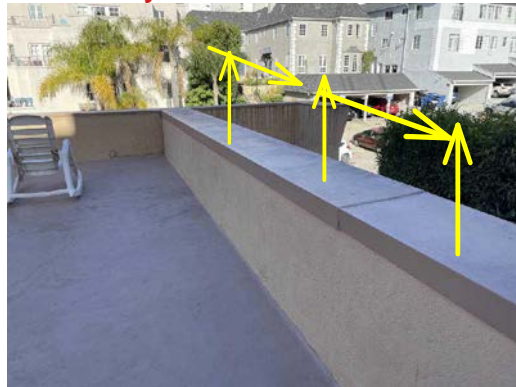
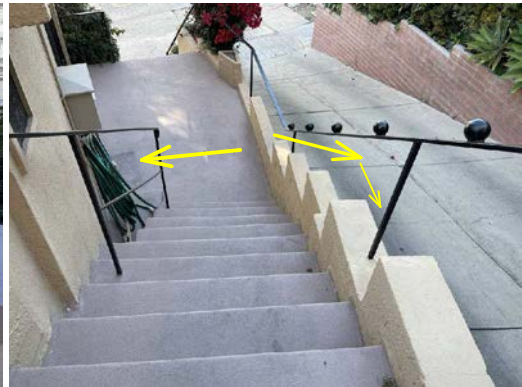
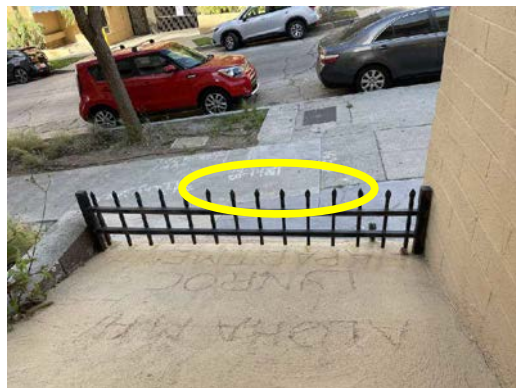
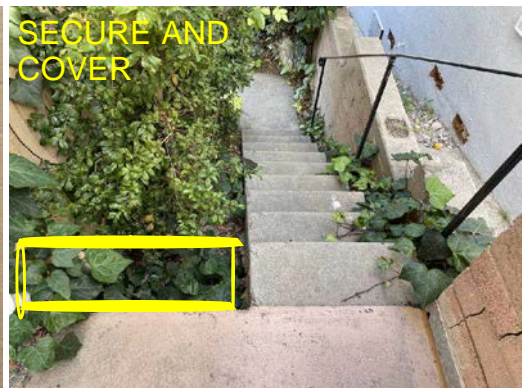
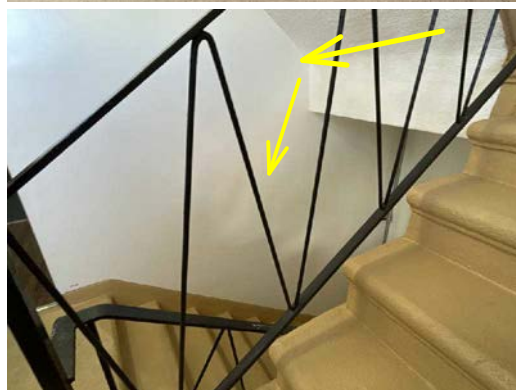
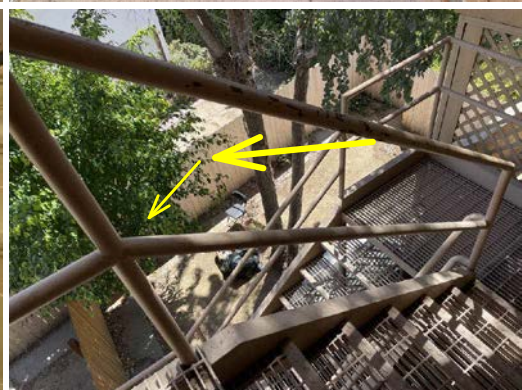
Stairs/Handrails: 1. Safety hazard with sharp top, 2. Short for protection, 3. Openings / Spacing at Balusters / Frame bars: Too far apart. Child and pet safety. Recommend installing more obstruction for safety.

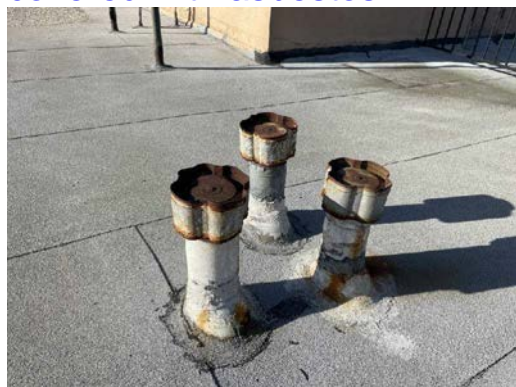
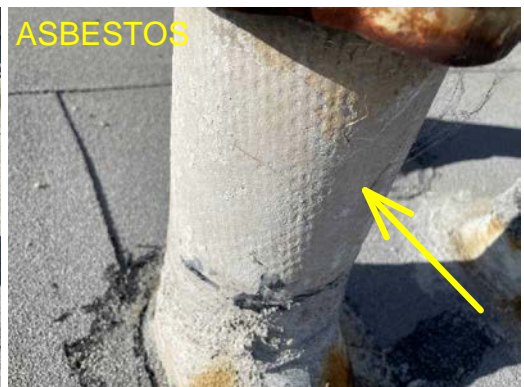
Plumbing Vents: **1. Many are due for replacement, 2. Some are covered with asbestos.**

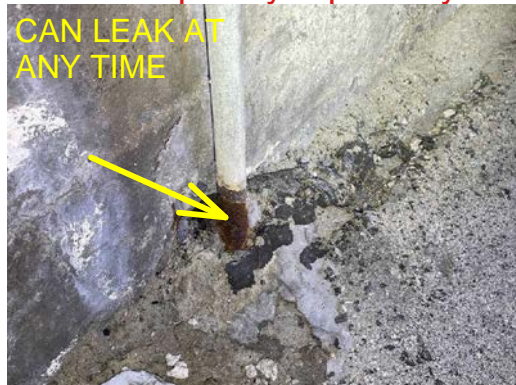
Water Lines: 1. At rear: Between pool rear retaining wall and front units rear parameter walls-, A. One or more copper-galvanized connections are of improper fitting material which may cause "Dielectric" or Galvanic / Electrolysis, leading to rupture. Consult a plumber for remedy and cost, B. Corrosion on galvanized pipe can cause rupture at any time 2. In Sub Garage: Swere and other drain lines show corrosion, and past leakage signs, which are susceptible to leakage at any time. Recommend repair / replacement by a professional plumber, to prevent damaged on vehicles parked underside the said pipes, as well as health and sanitation issues. Some temporary repairs by felt rapping noted.

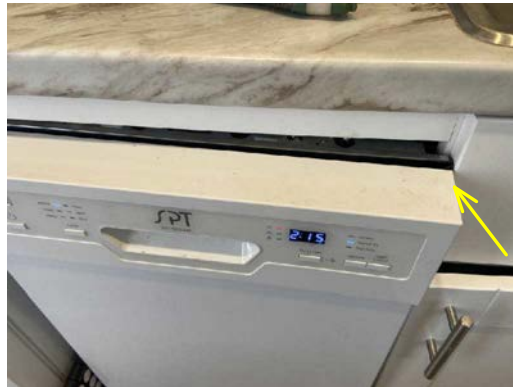
- 12. Acceptable Cooking Appliances: Hotpoint
- 13. Acceptable Ventilator: Window
- 14. Acceptable Disposal: Badger
- 15. Needs Attention Dishwasher: SPT - **Needs to fit in right.**

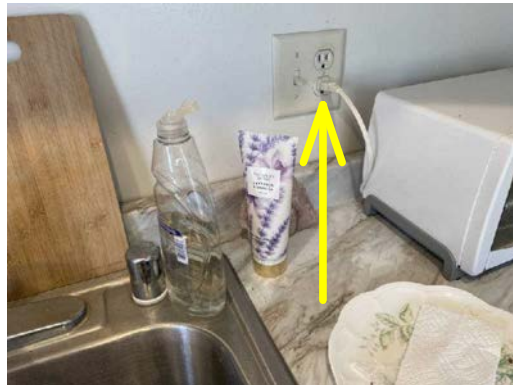
- 16. Air Gap Present? Yes
- 17. Not Inspected Trash Compactor:
- 18. Not Inspected Refrigerator:
- 19. Not Inspected Microwave:
- 20. Acceptable Sink: Stainless Steel
- 21. Serviceable Electrical: **Non GFCI outlet**

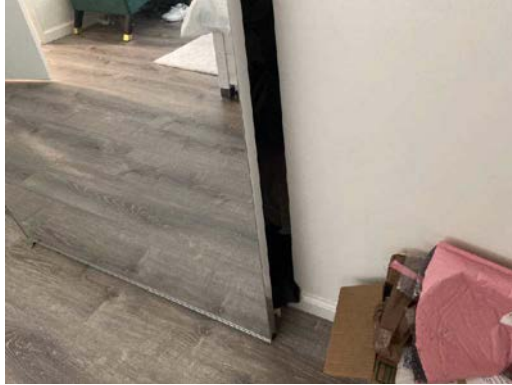
54. Needs Attention Closet: Large - Closet door needs repair. Tracks / Guides / Wheels are missing or not functional.

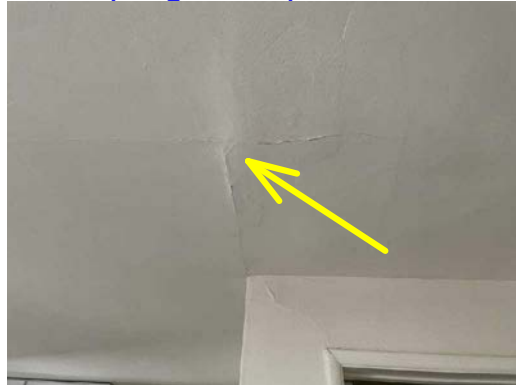
Ceiling: Paint and Paneling - Evidence of past or present water staining. Invasive inspection will reveal plumbing leakage or roof water pregnable points.

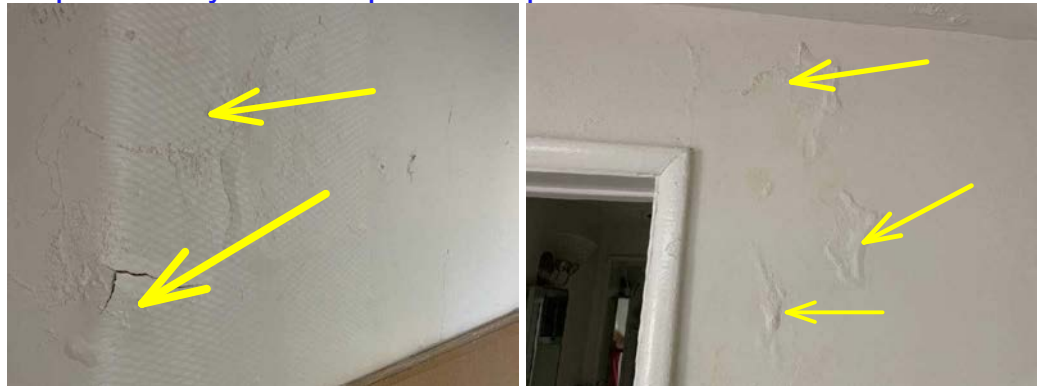
Walls: Paint and paneling - Evidence of past or present water damage noted. To determine the existence or activity of mold, inspection by mold expert is required.

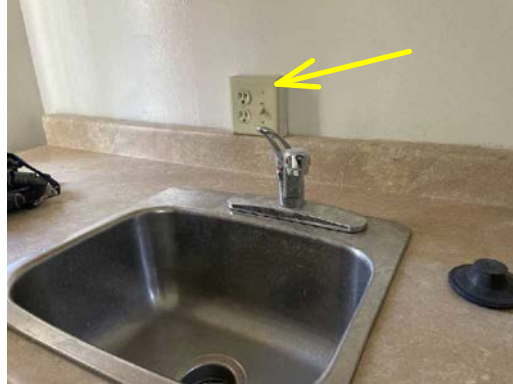
- 15. Not Inspected Dishwasher: Not applicable
- 16. Air Gap Present? No
- 17. Not Inspected Trash Compactor: Not applicable
- 18. Not Inspected Refrigerator: Not a part of this inspection
- 19. Not Inspected Microwave: Not applicable
- 20. Acceptable Sink: Stainless Steel
- 21. Serviceable Electrical: No GFCI or GFCI outlets. **Non-GFCI or GFCI labeled outlet. Consult a qualified Electrician.**

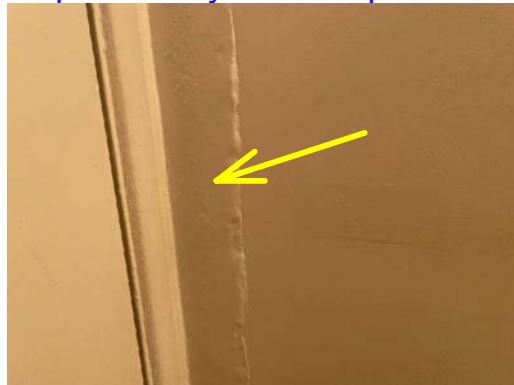
- 32. Not Inspected Closet: Not applicable
- 33. Acceptable Ceiling: Paint and Paneling
- 34. Serviceable Walls: Paint and paneling - Evidence of past or present water damage noted. To determine the existence or activity of mold, inspection by mold expert is required.

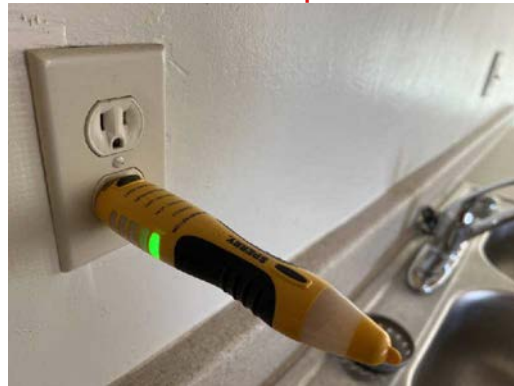
Electrical: No GFCI or GFCI outlets. **Non-GFCI or GFCI labeled outlet. Consult a qualified Electrician. One or more.**

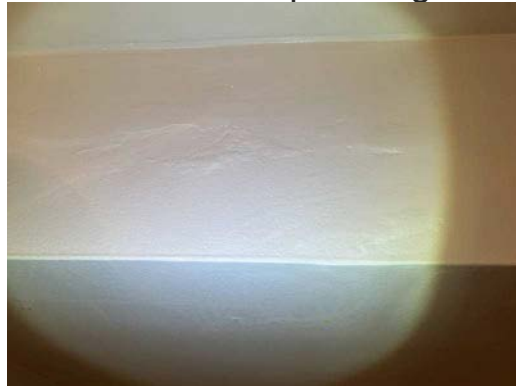
Walls: Paint and paneling - **Past repairs**

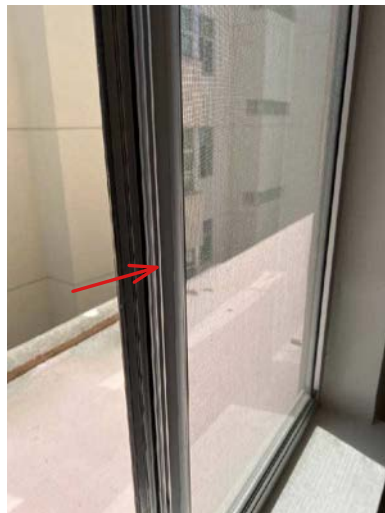
Closet: Double slider
Ceiling: Popcorn
Walls: Paint and paneling
Floor: laminate
Doors: Wood
Windows: Aluminum slider - [Handle missing.](#)

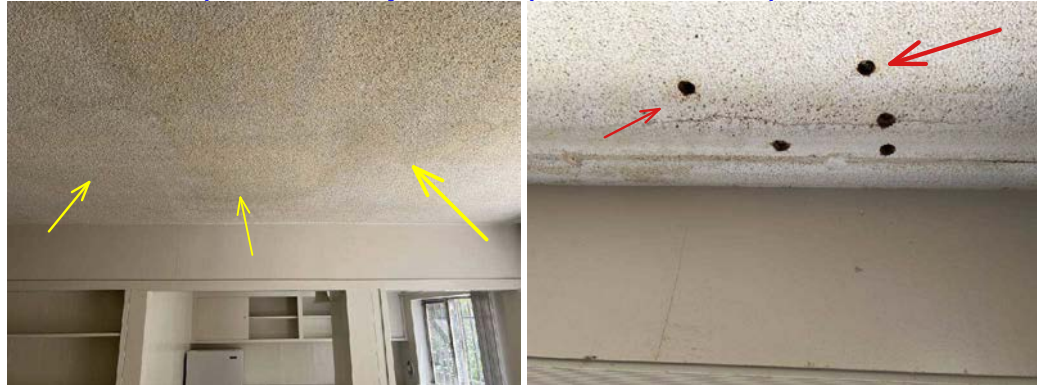
Ceiling: Popcorn - Water stains noted. Holes for water release noted. Invasive inspection may reveal possible mold presence.

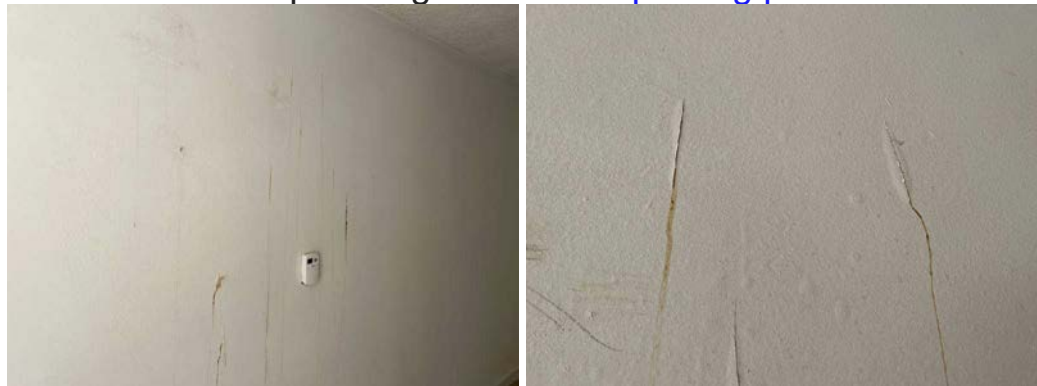
Walls: Paint and paneling - Loose or peeling paint.

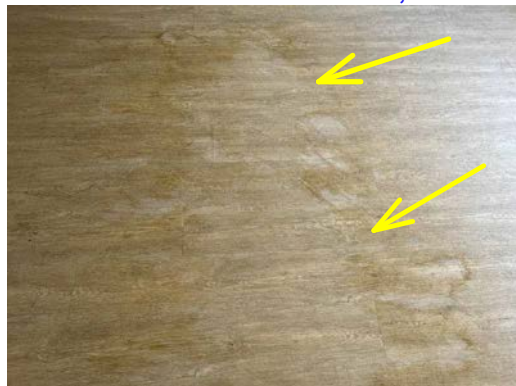
Floor: Laminate - Floor; stained.

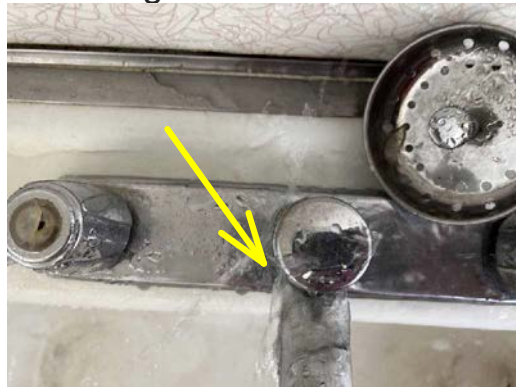
- 12. Acceptable Cooking Appliances: Premier
- 13. Acceptable Ventilator: Fan to Shaft
- 14. Acceptable Disposal: None
- 15. Acceptable Dishwasher: None
- 16. Air Gap Present? No
- 17. Acceptable Trash Compactor: None
- 18. Acceptable Refrigerator: Magic chef
- 19. Acceptable Microwave: Danby
- 20. Acceptable Sink: Porcelain Coated
- 21. Not Inspected Electrical: Not in service - **Power off**
- 22. Serviceable Plumbing/Fixtures: Chrome /Brass - **Water leakage.**

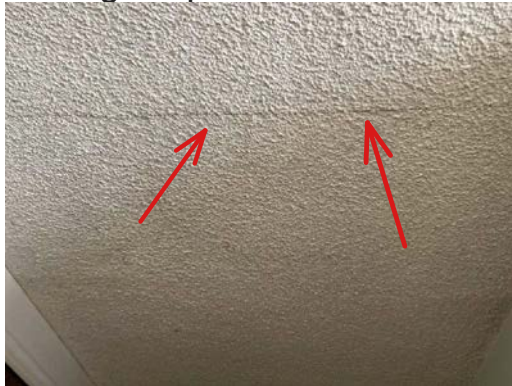
- 32. Serviceable
- Ceiling: Popcorn - [Stress cracks](#)

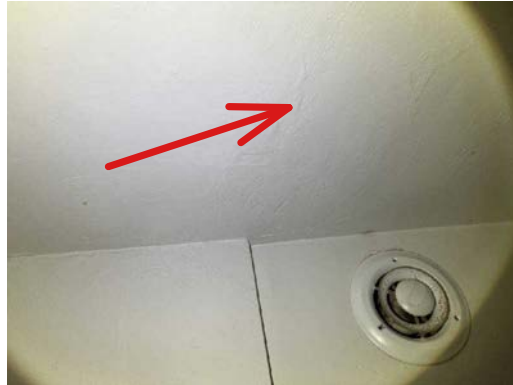
Ceiling: Paint and Paneling - Cracks present. Not Structural or Mechanical.

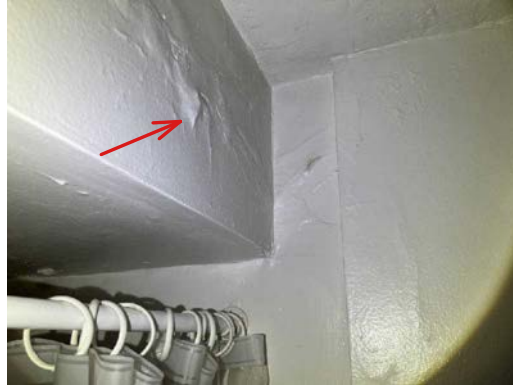
Walls: Paint and paneling - Evidence of past repair or damage

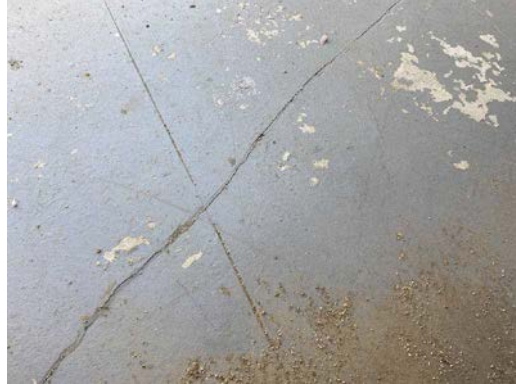
Balcony Floors: Laminate - **Worn out. Resurface and paint as necessary.**

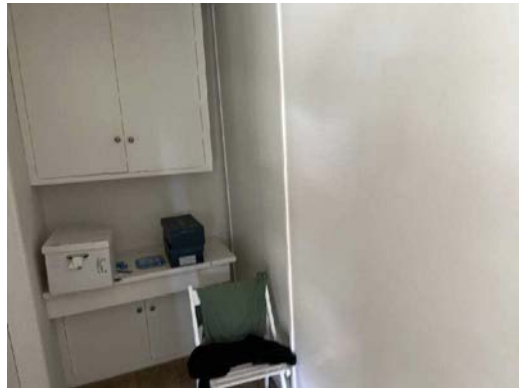
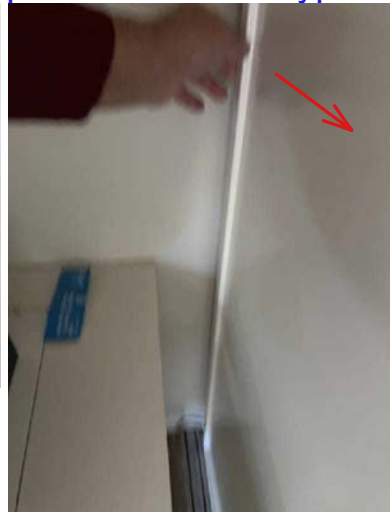
Ceiling: Popcorn
 Closet: double door slider - **Repairs needed at bypass closet doors**

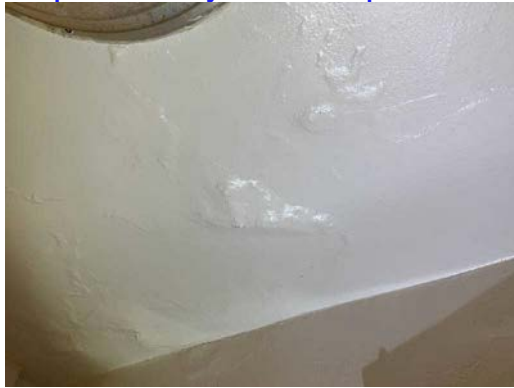
- 38. Acceptable Closet: None
- 39. Needs Attention Ceiling: Paint and Paneling - Evidence of past or present water damage noted. To determine the existence or activity of mold, inspection by mold expert is required.

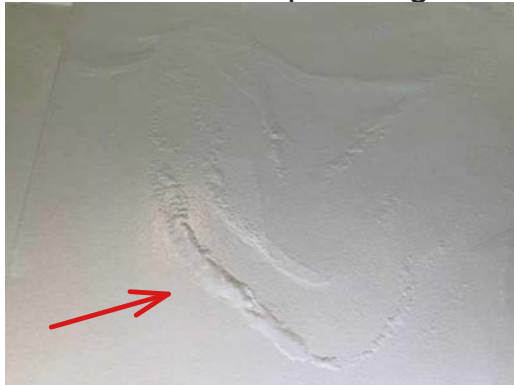
- 40. Acceptable Walls: Paint and paneling - Past repairs

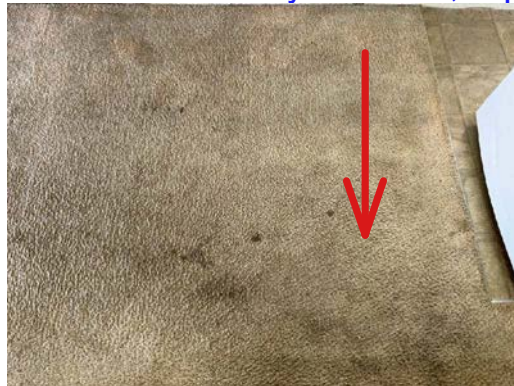
Floor: Linoleum, Carpet - Carpet Stained/soiled, here and in other units. For sanitary reasons, replace or clean.

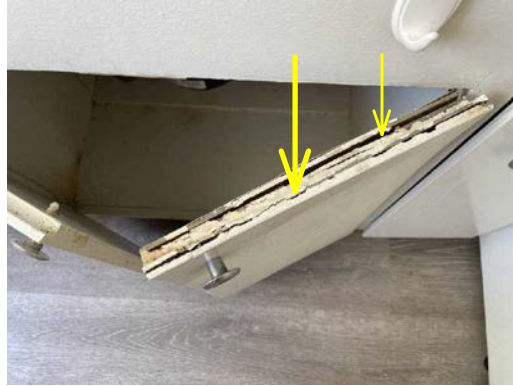
24. Needs Attention Cabinets: Wood - **Damaged**

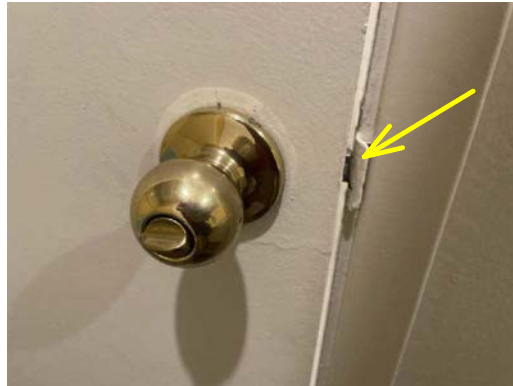
Doors: Wood - Loose or missing hardware

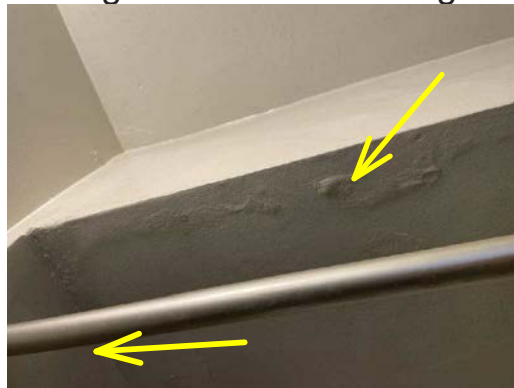
- 38. Not Inspected Closet: Not applicable
- 39. Serviceable Ceiling: Paint and Paneling - Evidence of past repair

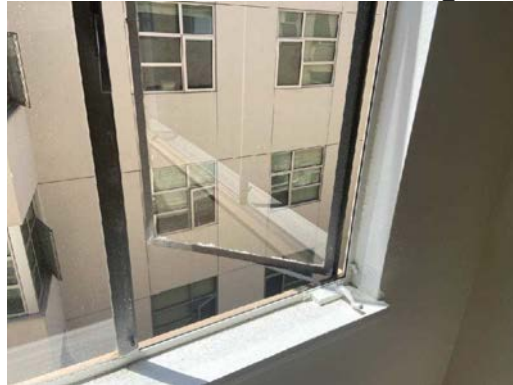
Doors: Wood
 Windows: Aluminum Swing - **Missing screen, here or in other units.**

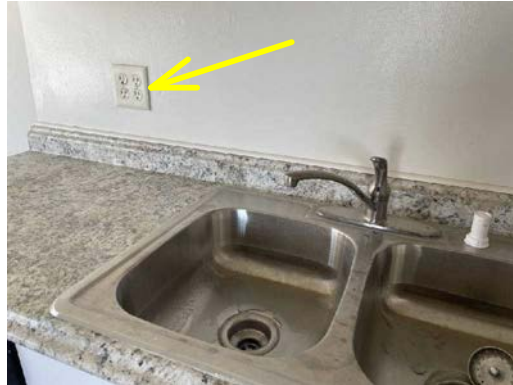
Electrical: **Non-GFCI or GFCI labeled outlet. Consult a qualified Electrician.**

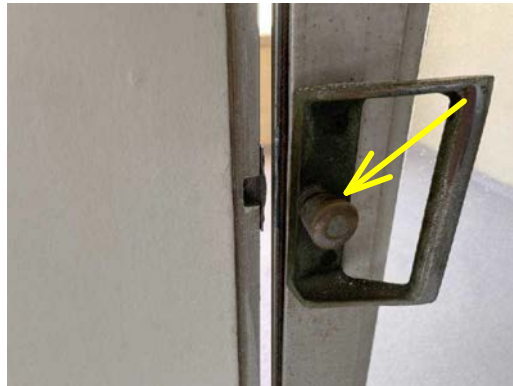
- 3. Not Inspected Closet: Not applicable
- 4. Acceptable Ceiling: Popcorn
- 5. Acceptable Walls: Paint and paneling
- 6. Acceptable Floor: Carpet
- 7. Serviceable Doors: Aluminum slider - **Loose or missing hardware**

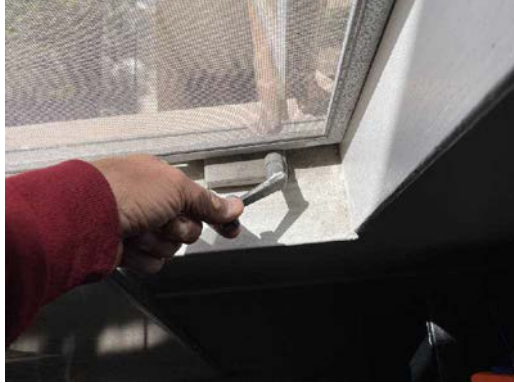
Windows: Alumimun - Hard operation. Lubricate, repair or replace as necessary.

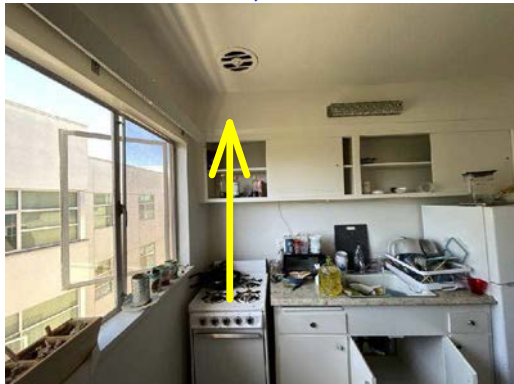
Ventilator: No ventilator hood and ducting installed. For sanitation and health reasons, recommend installation

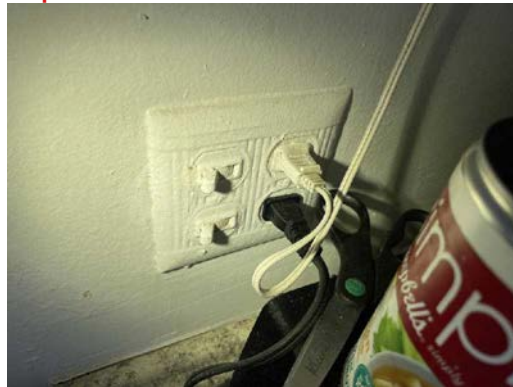
Disposal:
 Dishwasher: Not installed.
 Trash Compactor: Not Applicable
 Refrigerator: Not Applicable
 Microwave: Not Applicable
 Sink: Porcelain
 Electrical: **Two socket outlet without ground. Recommend replacement.**

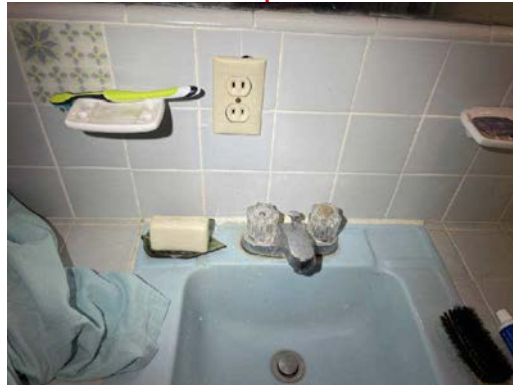
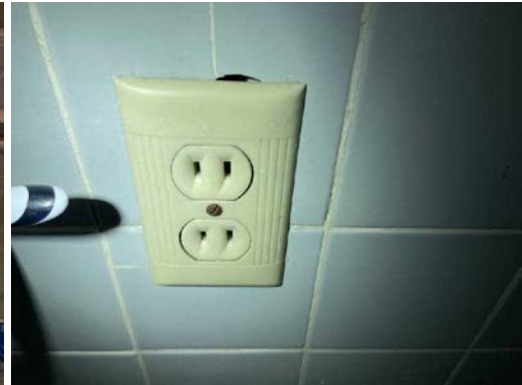
Ceiling: Paint and Paneling
 Walls: Paint and paneling
 Floor:
 Doors:
 Windows: Not Applicable
 Electrical: **1. Non GFCI outlet, 2. Two socket outlet without ground. Recommend replacement.**

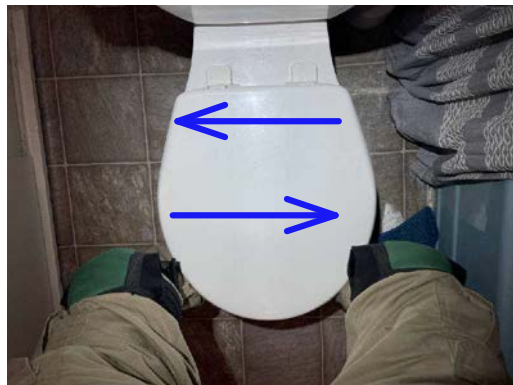
Sink/Basin:
 Faucets/Traps:
 Tub/Surround:
 Shower/Surround: Not Applicable
 Spa Tub/Surround: Not Applicable
 Toilets: **The toilet is loose**
