Property Inspection Report

Sample Report

[Residential-Condo or Townhouse.inspx](#)

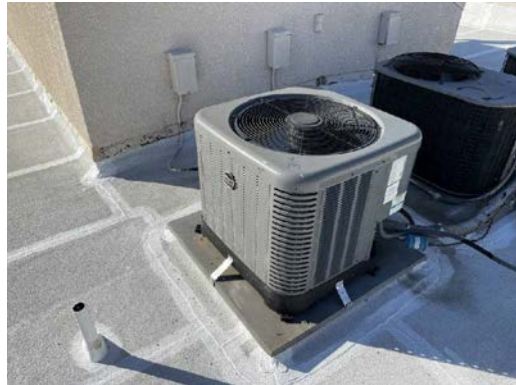
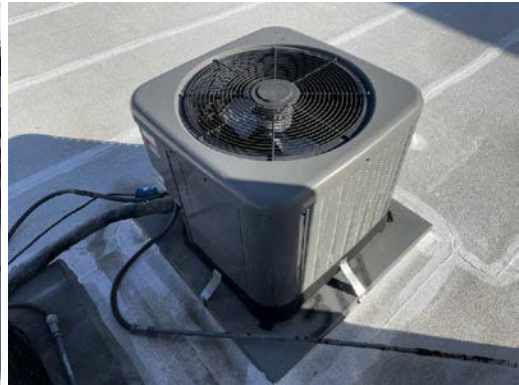
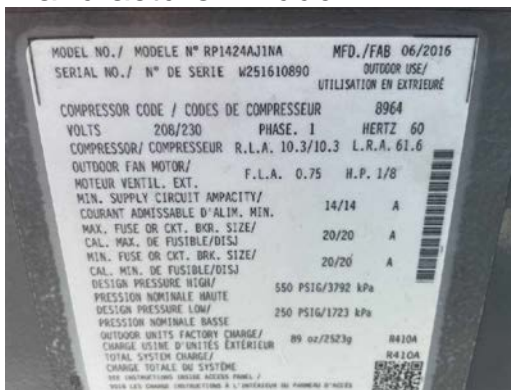
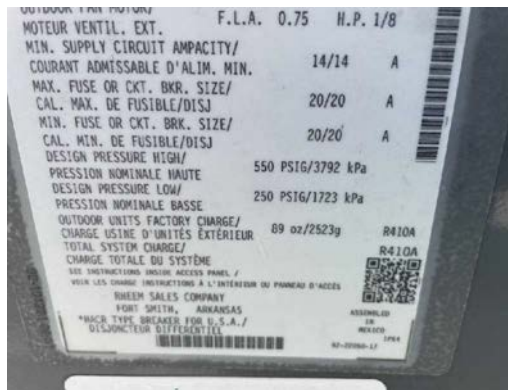
- 1. Acceptable A/C System Operation: Functional at the time of inspection
- 2. Acceptable Condensate Removal: PVC
- 3. Acceptable Exterior Unit: Roof

4. Manufacturer: Ruud

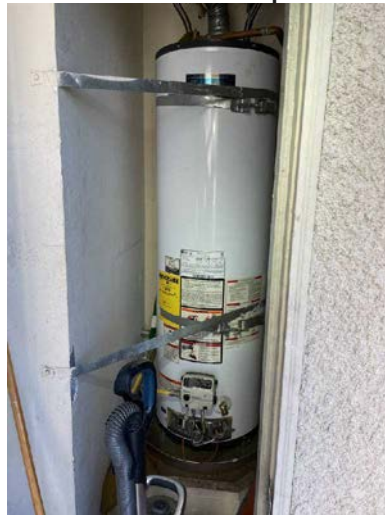
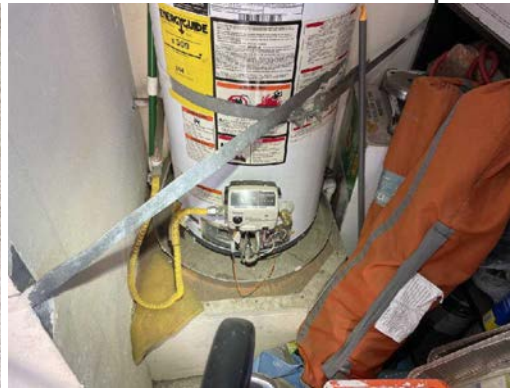
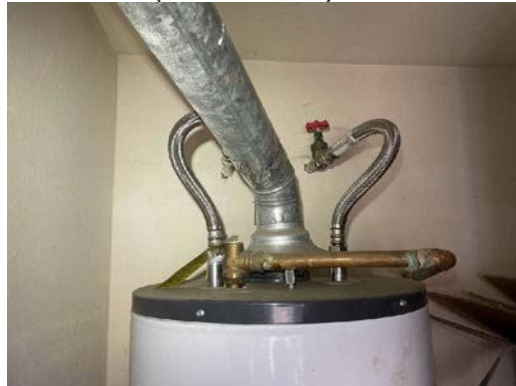
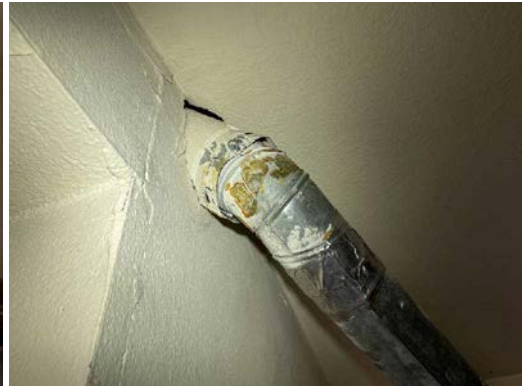
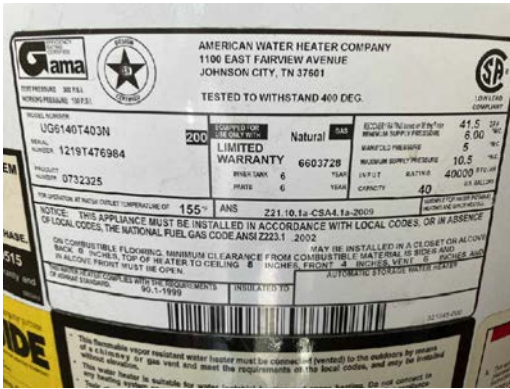
- 1. Not Inspected Service Line: No Access
- 2. Not Inspected Main Water Shutoff: No Access
- 3. Not Inspected Water Lines: Copper for what is visible
- 4. Not Inspected Drain Pipes: ABS or Cast Iron
- 5. Not Inspected Service Caps: Not accessible
- 6. Not Inspected Vent Pipes: ABS or Cast Iron
- 7. Not Inspected Gas Service Lines: Rigid Steel
- In closet add balcony Water Heater
- 8. Acceptable Water Heater Operation: Functional at time of inspection

9. Manufacturer: American

- 10. Type: Natural gas Capacity: 40 Gal.
- 11. Approximate Age: Area Served: Interior
- 12. Acceptable Flue Pipe: Metal
- 13. Acceptable TPRV and Drain Tube: Copper

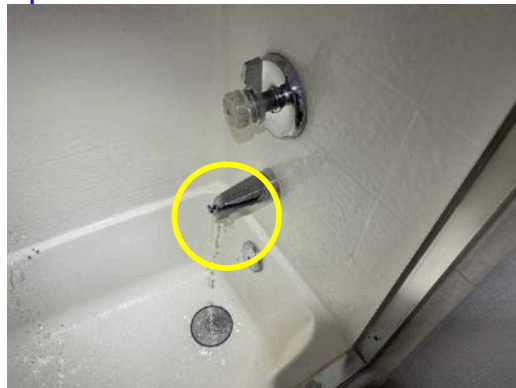
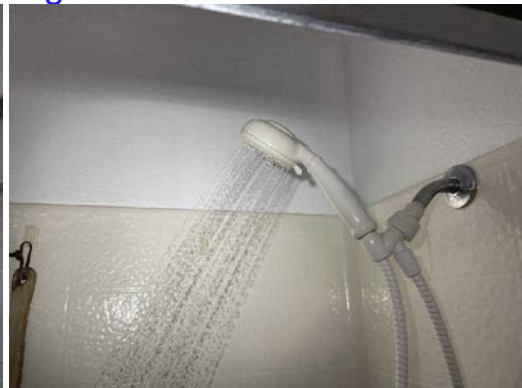
| 12. Needs Attention | Shower/Surround: Not Applicable - Diverter pullout knob is hard to operate or not effective in directing water |

2. # 1, Right Side Bathroom Shower/Surround: Not Applicable - Diverter pullout knob is hard to operate or not effective in directing water

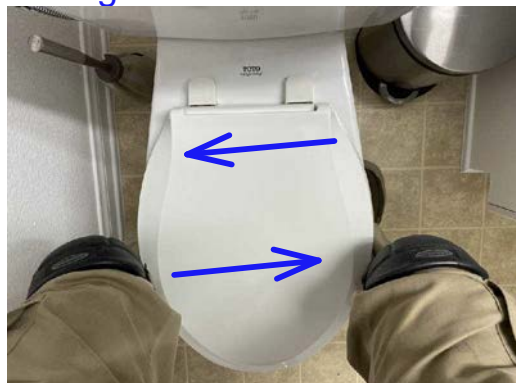
Spa Tub/Surround: Not Applicable
Toilets: **Toilet is loose. Secure as necessary, to prevent waste leakage.**

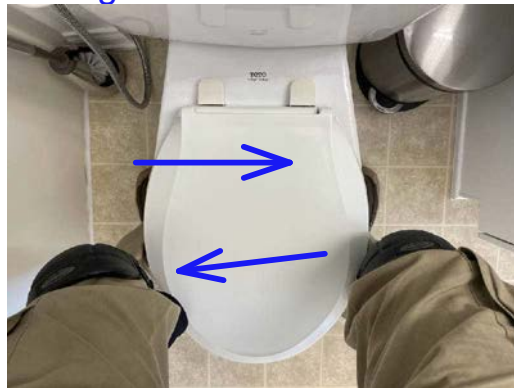
| 30. Serviceable | Toilets: Toilet is loose. Secure as necessary, to prevent waste leakage. |

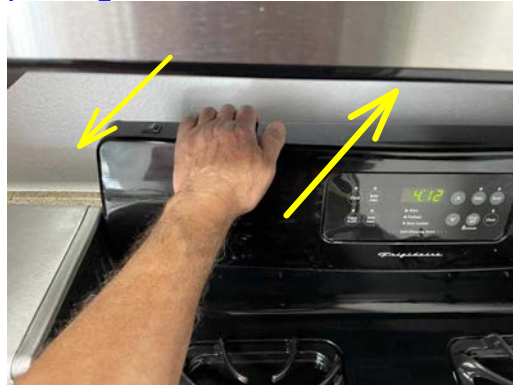
1. Needs Attention Cooking Appliances: Anti tip not installed or loose (Comes with the new units from manufacturer). Anti tip is an inexpensive bracket that holds the unit from tipping in case the front door is opened and weight is applied on it or a person (child) stands on the door. It secures the Oven Range to the wall or floor. This was tested simply by slightly pulling back on the unit. A safety notation

3. Left Side Kitchen Cooking Appliances: Anti tip not installed or loose (Comes with the new units from manufacturer). Anti tip is an inexpensive bracket that holds the unit from tipping in case the front door is opened and weight is applied on it or a person (child) stands on the door. It secures the Oven Range to the wall or floor. This was tested simply by slightly pulling back on the unit. A safety notation

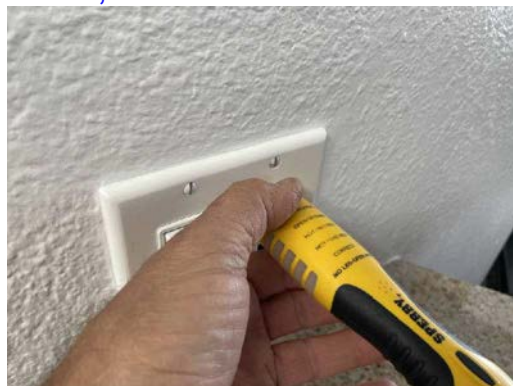
- 2. Acceptable Ventilator: Built In the Microwave
- 3. Acceptable Disposal:
- 4. Acceptable Dishwasher:
- 5. Air Gap Present? Yes
- 6. Not Inspected Trash Compactor: Not Applicable
- 7. Not Inspected Refrigerator: Not a part of this inspection
- 8. Not Inspected Microwave: Not Applicable
- 9. Acceptable Sink: Stainless Steel
- 10. Serviceable Electrical: 110 VAC GFCI or GFCI connected - Faulty outlet with loose, unconnected or crossed wires: Top of Counter

5. Left Side Kitchen Electrical: 110 VAC GFCI or GFCI connected - Faulty outlet with loose, unconnected or crossed wires: Top of Counter

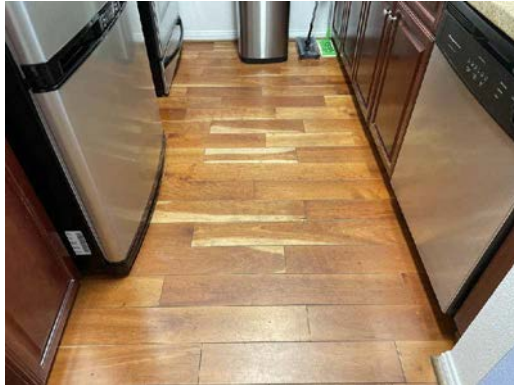
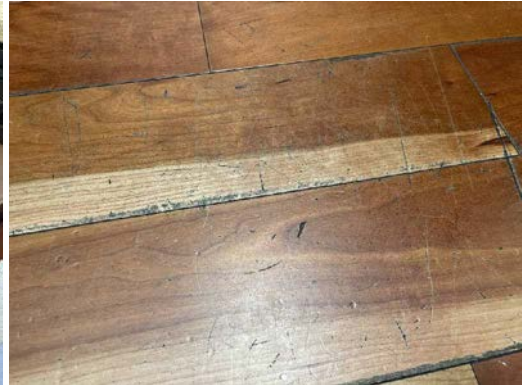
| 17. Needs Attention | Floor: Hardwood - Surface scratches, abrasion or wear out noted |

4. Left Side Kitchen Floor: Hardwood - Surface scratches, abrasion or wear out noted

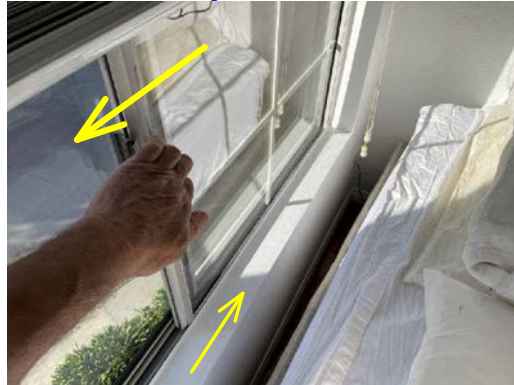
6. Needs Attention Windows: Aluminum Slider - Semi hard operation. Repair / Lubricate as necessary.

5. # 1, Right Side Bedroom Windows: Aluminum Slider - Semi hard operation. Repair / Lubricate as necessary.
