CITY PROPERTY SERVICES
Commercial & Residential Inspections

Property Inspection Report

Commercial Small

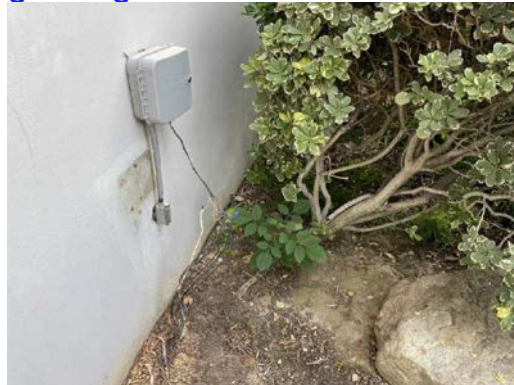
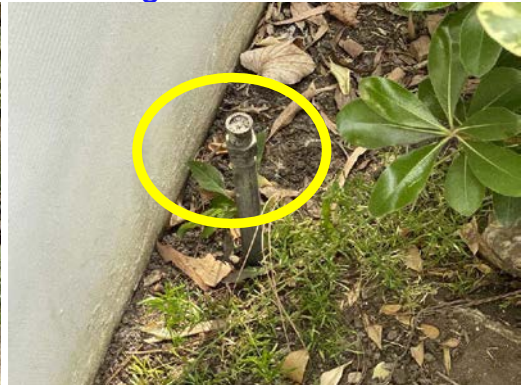
Grading: **Long term maintenance notation:** Some areas around the parameter walls, on the exterior show negative slopes(low at walls and high away from walls). These will cause increase of moisture content and seepage into the foundation walls and, over time, affect the foundation walls, as well as footing stucco of paint, causing erosion on the exterior surfaces(near flower beds) and creating a poor appearance in need of paint coating. Recommend correction of grading and controlled moisture and irrigation at these areas.

1. Grading: Long term maintenance notation: Some areas around the parameter walls, on the exterior show negative slopes(low at walls and high away from walls). These will cause increase of moisture content and seepage into the foundation walls and, over time, affect the foundation walls, as well as footing stucco of paint, causing erosion on the exterior surfaces(near flower beds) and creating a poor appearance in need of paint coating. Recommend correction of grading and controlled moisture and irrigation at these areas.

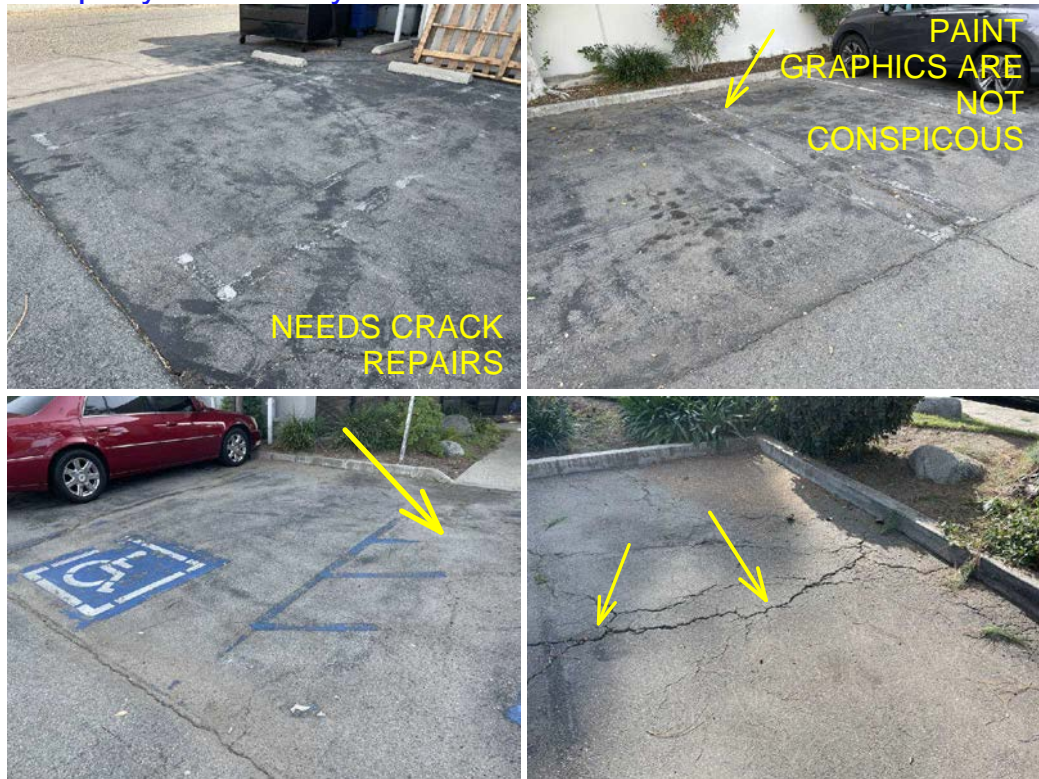
Parking Lot: 1. Some of the parking lot surfaces require fill and sealing, to prevent further decay, 2. Parking space lining paint graphics, including handicap signs, are worn out and should be revitalized to comply with handicap provision standards and to prevent dispute and liability by vehicle users. Consult a paving company for remedy and cost.

1. Parking Lot: 1. Some of the parking lot surfaces require fill and sealing, to prevent further decay, 2. Parking space lining paint graphics, including handicap signs, are worn out and should be revitalized to comply with handicap provision standards and to prevent dispute and liability by vehicle users. Consult a paving company for remedy and cost.

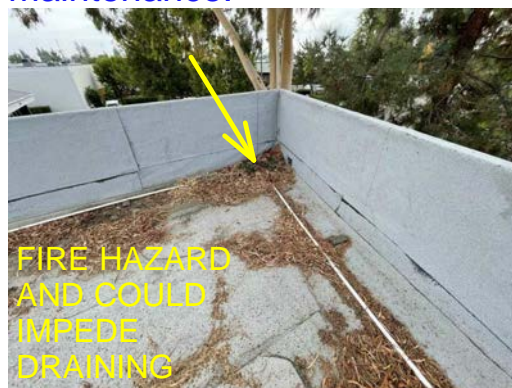
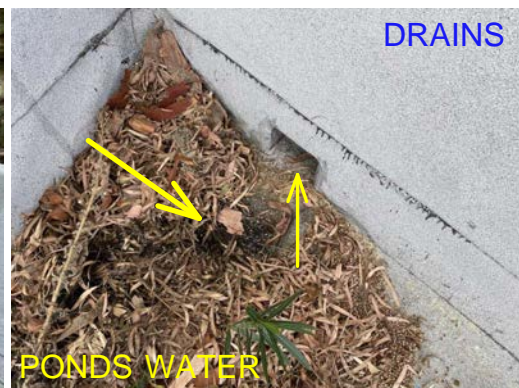
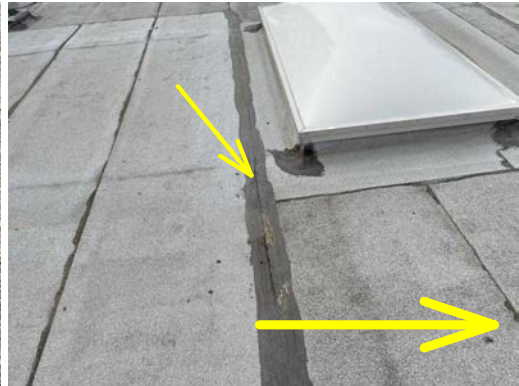
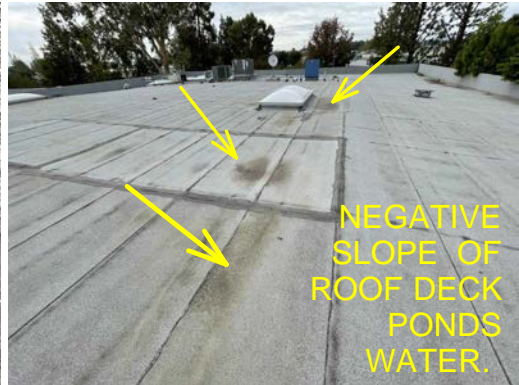
Material: Rolled roof material, build up - 1. In generally acceptable condition at present: Patch and repair needed at material junctions and flashings. Monitor roof for routine maintenance on yearly basis, before rain season, 2. Dry vegetation is fire hazard and could stuff and clog drain system (scuppers and down spouts), 3. Routine Maintenance Notation: Some or all previously applied roof cement / mastic are brittle, show cracks and are due for replacement as they are water pregnable, 4. Some spots show negative slope staining which pond water and will reduce the life span of the roof material at those areas. Monitor and maintain on yearly basis for preventive maintenance.

2. Main Structure Roof Surface Material: Rolled roof material, build up - 1. In generally acceptable condition at present: Patch and repair needed at material junctions and flashings. Monitor roof for routine maintenance on yearly basis, before rain season, 2. Dry vegetation is fire hazard and could stuff and clog drain system (scuppers and down spouts), 3. Routine Maintenance Notation: Some or all previously applied roof cement / mastic are brittle, show cracks and are due for replacement as they are water pregnable, 4. Some spots show negative slope staining which pond water and will reduce the life span of the roof material at those areas. Monitor and maintain on yearly basis for preventive maintenance.

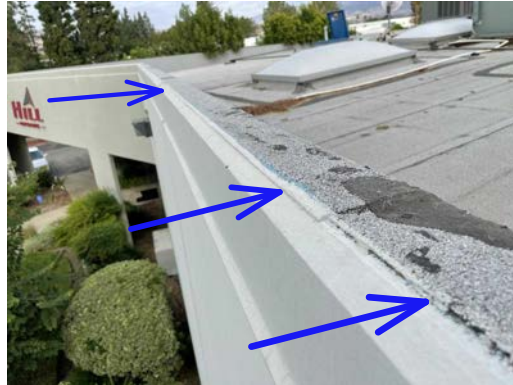
Flashing: Parapet wall edges without roof material overlap or installed cap flashing need close attention on yearly basis, to prevent water intrusion through sealed edges. In acceptable condition at inspection time. Monitor and maintain.

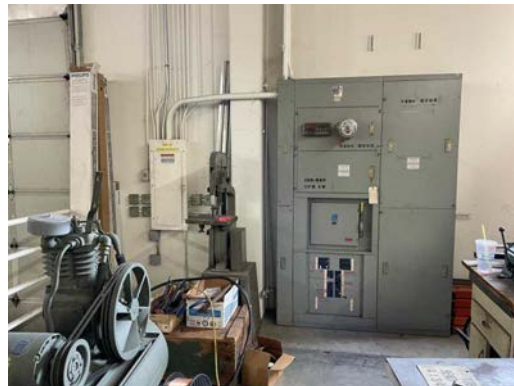
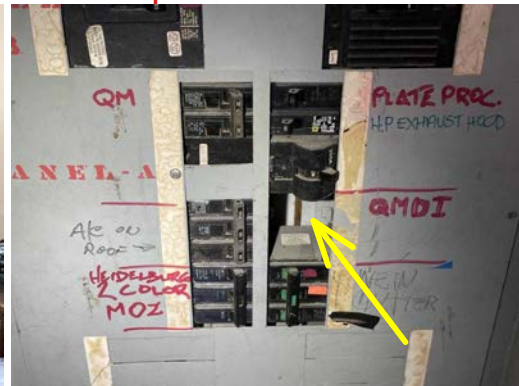
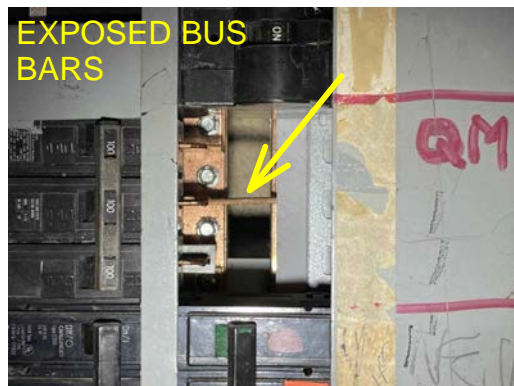
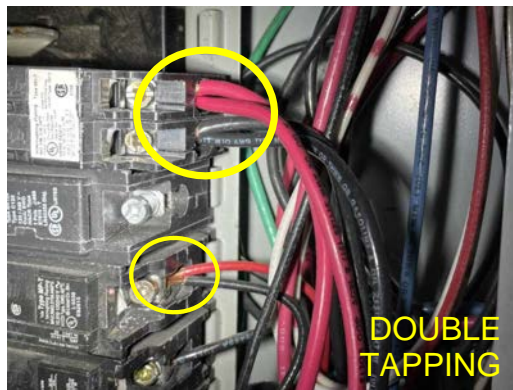
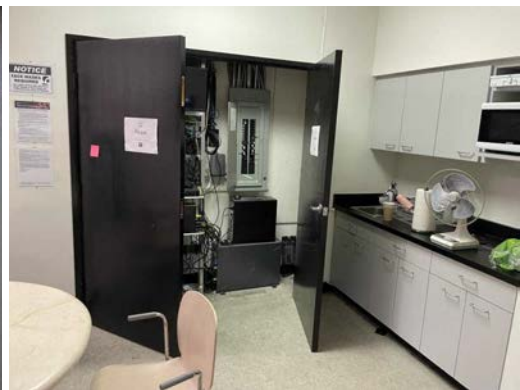
Breakers: Copper - 1. Double tap wiring-two or more wires on one or more breakers noted. This may cause overheating and start a fire, 2. Exposed bus bars, 3. Protective covers are missing, 4. Wrong gauge (size) wiring for some of the breakers noted. Consult a qualified electrician for further evaluations and repairs.

3. Rear and Employee lounge Electric Panel Breakers: Copper - 1. Double tap wiring-two or more wires on one or more breakers noted. This may cause overheating and start a fire, 2. Exposed bus bars, 3. Protective covers are missing, 4. Wrong gauge (size) wiring for some of the breakers noted. Consult a qualified electrician for further evaluations and repairs.

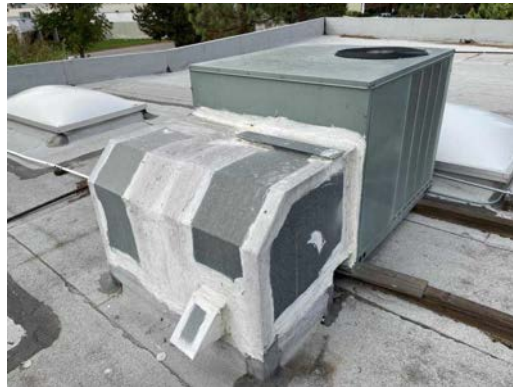
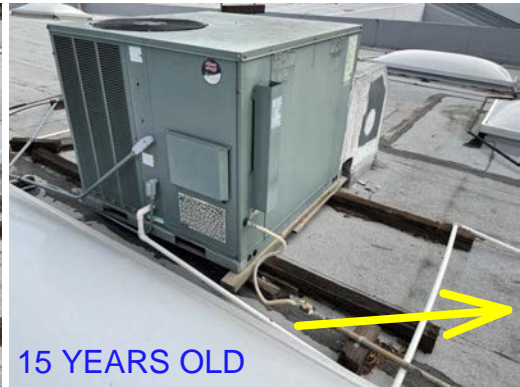
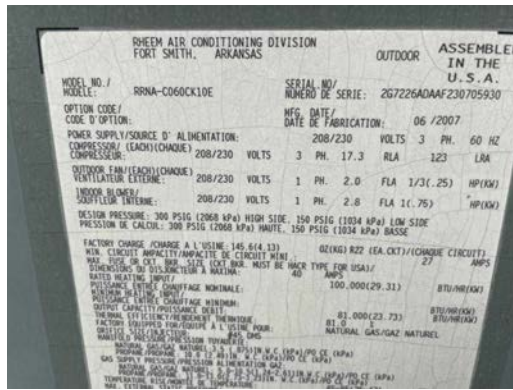
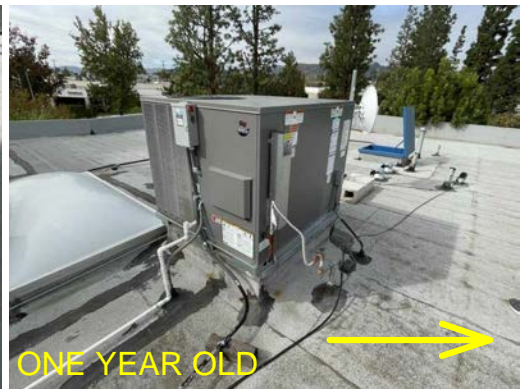
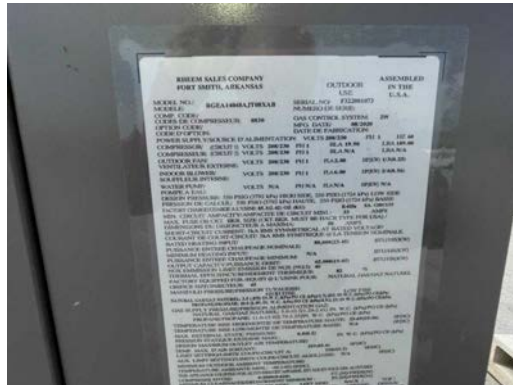
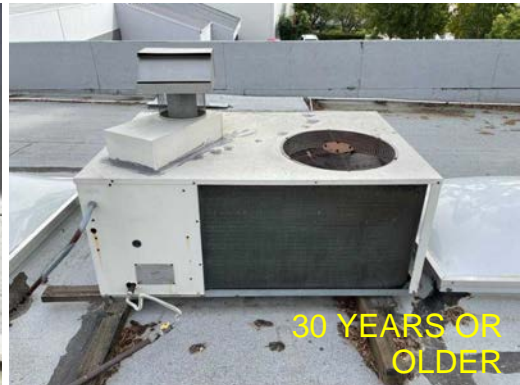
1. Needs Attention A/C System Operation: 1. One unit's functionality could not be inspected, as the designated thermostat was not functional or needed new batteries, 2. One of the units is over 30 years old and is beyond designed life. Consult an HVAC expert for timely replacement.

2. Roof Package System(heat and cold in one closet) AC System A/C System Operation:
1. One unit's functionality could not be inspected, as the designated thermostat was not functional or needed new batteries, 2. One of the units is over 30 years old and is beyond designed life. Consult an HVAC expert for timely replacement.
3. Roof Package System(heat and cold in one closet) AC System Electrical Disconnect: Pull type breaker at the unit - Tubes and boxes require sanding and painting for longevity.

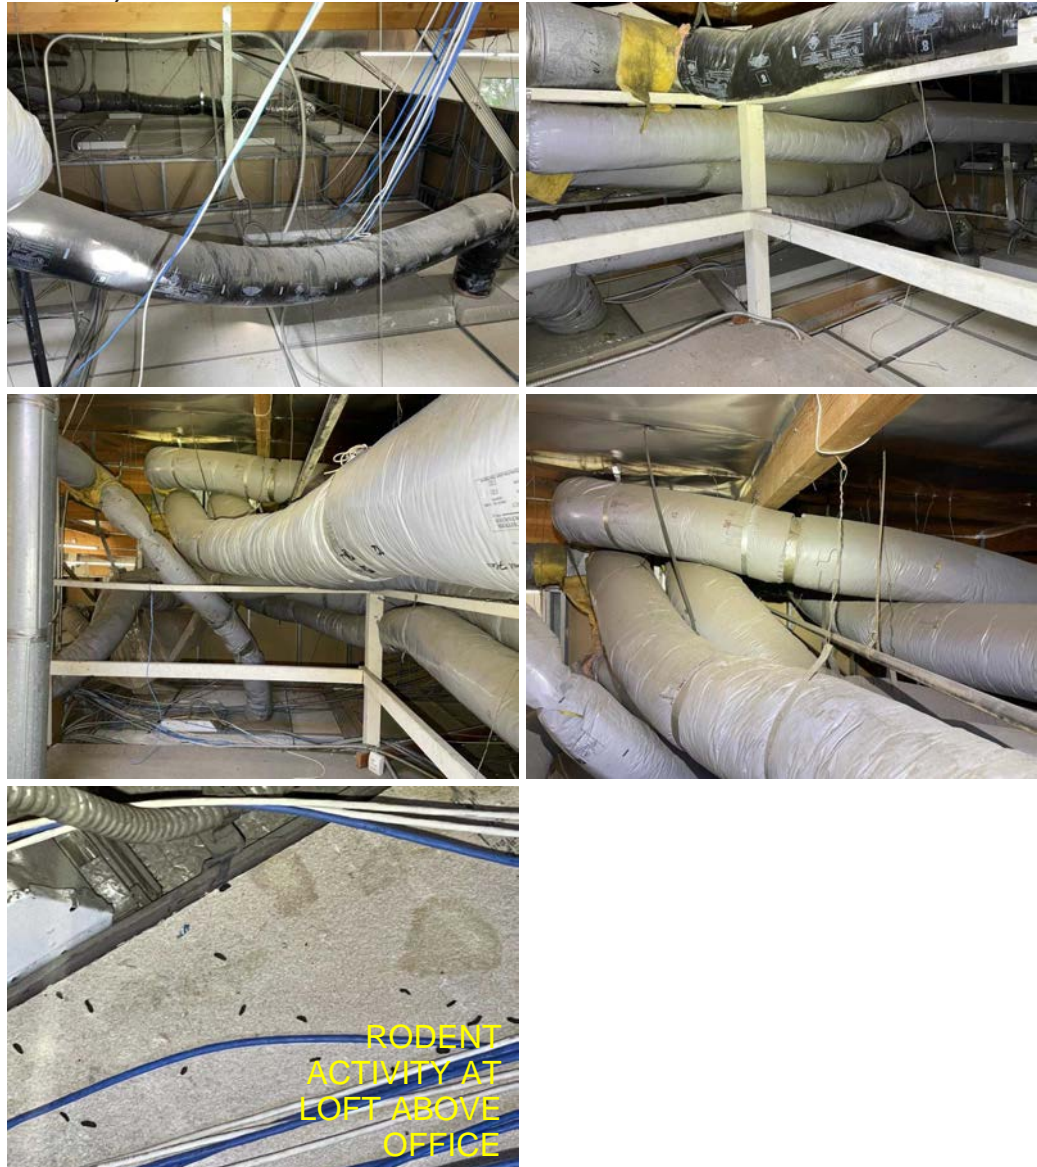
- 1. Acceptable Heating System Operation: Functional at Inspection time - **One could not be turned on due to thermostat issue.**
- 2. Manufacturer: Rheem
- 3. Type: Forced air Capacity: 65000 BTUHR , 91,000 BTU
- 4. Area Served: Interior Approximate Age:
- 5. Fuel Type: Natural gas
- 6. Not Inspected Heat Exchanger: No access
- 7. Unable to Inspect: 75%
- 8. Acceptable Blower Fan/Filter: Direct drive with filter
- 9. Needs Attention Distribution: Insuflex - **Evidence of rodent activity above office structure noted.**

4. Roof package System, Heat and cold in one closet Heating System Distribution: Insuflex - Evidence of rodent activity above office structure noted.

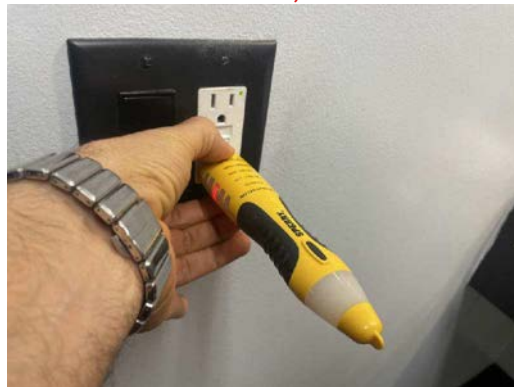
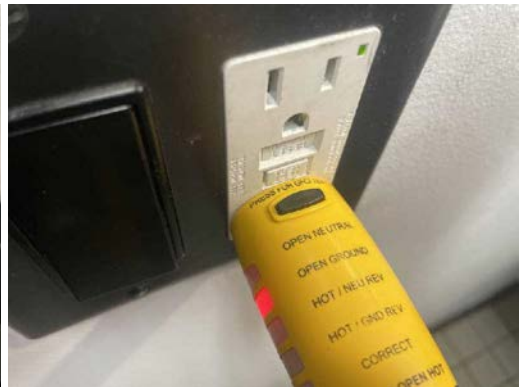
- 1. Acceptable Ceiling: Paint and Paneling
- 2. Acceptable Walls: Paint and paneling
- 3. Acceptable Floor: Tile
- 4. Acceptable Doors: Wood
- 5. Not Inspected Windows: Not Applicable
- 6. Serviceable Electrical: 110 VAC GFCI - 1. Faulty outlet with loose, disconnected or crossed wires., 2. Does not function as GFCI

4. #1, Mens, Right Side Hallway Rest Room Electrical: 110 VAC GFCI - 1. Faulty outlet with loose, disconnected or crossed wires., 2. Does not function as GFCI
5. #1, Mens, Right Side Hallway Rest Room Toilets: ProFlo , 1 1/2 Gallon Tank - The toilet is loose at the floor and may require replacement of the wax seal after securing.
6. #2, Women's, Right Side Rest Room Grab Bars: Metal - Not compliant with ADA. Side Grab Bar is missing.

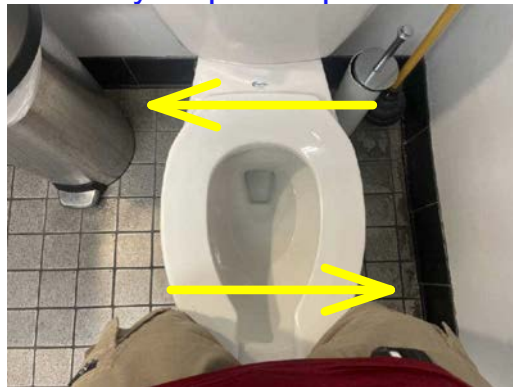
Faucets/Traps: Metal / PVC
Shower/Surround: Not Applicable
Urinals: Not Applicable
Toilets: ProFlo , 1 1/2 Gallon Tank - **The toilet is loose at the floor and may require replacement of the wax seal after securing.**

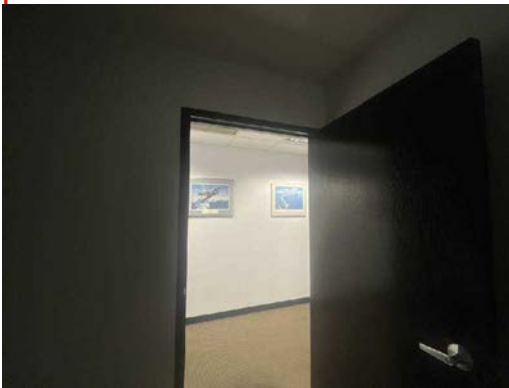
18. Emergency lighting present? No **Safety issue: Insufficient or no emergency lighting present. Recommend installation.**

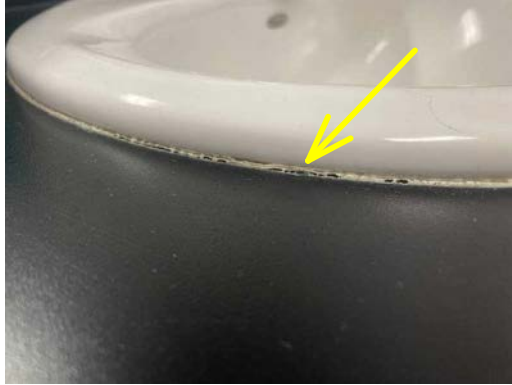
25. Needs Attention Counter/Cabinet: Laminate and wood - **Edge caulking needed to prevent water migration into the underside.**

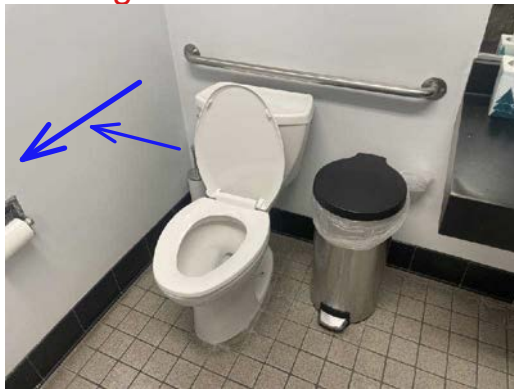
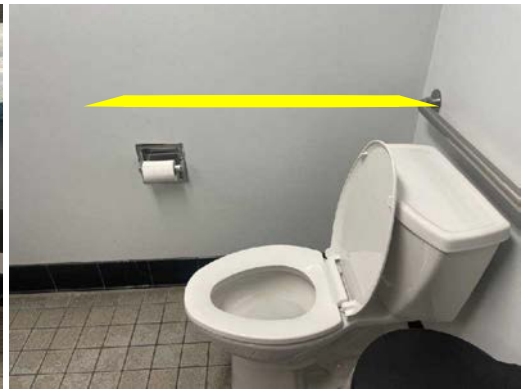
Sink/Basin: Porcelain Coated
 Faucets/Traps: Metal / PVC
 Shower/Surround: Not Applicable
 Urinals: Not Applicable
 Toilets: American Standard, 1 1/2 Gallon Tank
 Grab Bars: Metal - **Not compliant with ADA. Side Grab Bar is missing.**

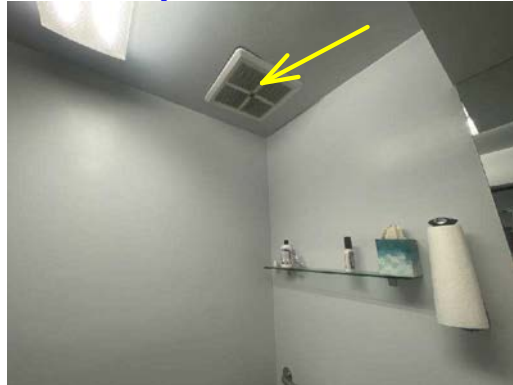
34. Serviceable Ventilation: Electric ventilation fan - Fan is noisy. Repair/Replace as necessary

7. #2, Women's, Right Side Rest Room Ventilation: Electric ventilation fan - Fan is noisy. Repair/Replace as necessary
8. #3, Warehouse Area, Multi Gender Rest Room Electrical: 110 VAC - Non-GFCI or GFCI labeled outlet. Consult a qualified Electrician.
9. #3, Warehouse Area, Multi Gender Rest Room Faucets/Traps: Metal / PVC - Missing or faulty drain stopper.
10. #3, Warehouse Area, Multi Gender Rest Room Toilets: ProFlo, 1 1/2 Gallon Tank - The toilet seat is loose. Repair/Replace as necessary

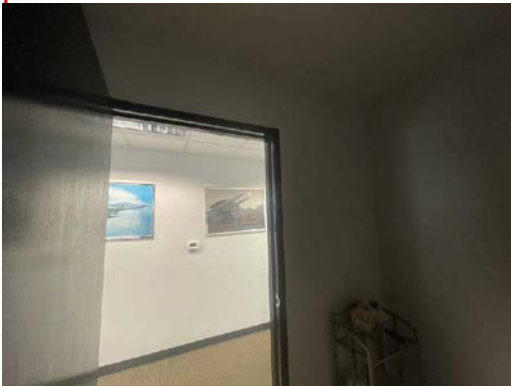
35. ADA Compliant No 1. Missing grab rails, 2. Inquire about ADA compliance, through a contractor.
36. Emergency lighting present? No Safety issue: Insufficient or no emergency lighting present. Recommend installation.

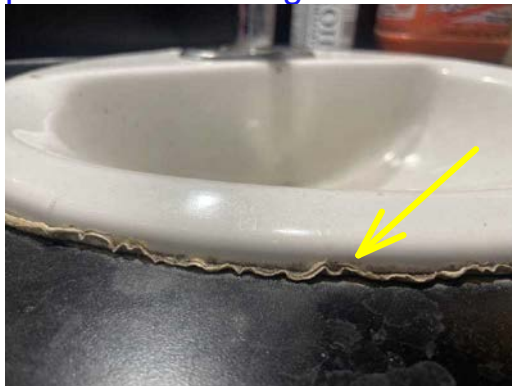
43. Needs Attention Counter/Cabinet: Laminate and wood - **Edge caulking needed to prevent water migration into the underside.**

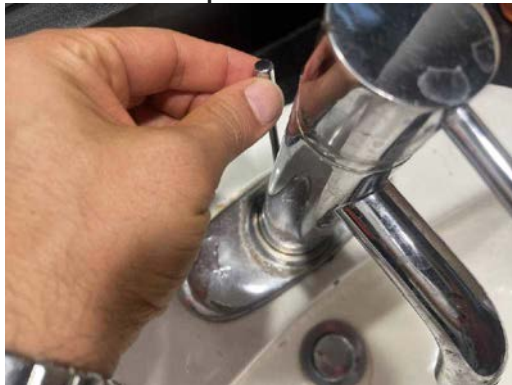
Sink/Basin: Porcelain Coated
Faucets/Traps: Metal / PVC - **Missing or faulty drain stopper.**

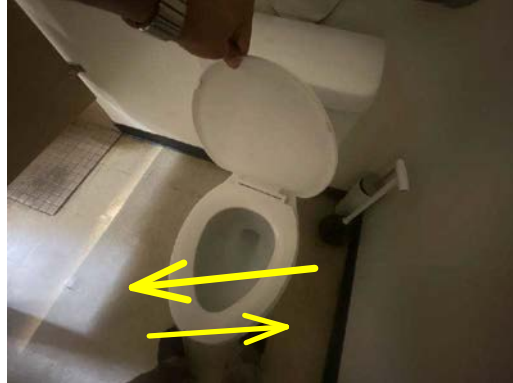
Toilets: ProFlo, 1 1/2 Gallon Tank - The toilet seat is loose.
[Repair/Replace as necessary](#)

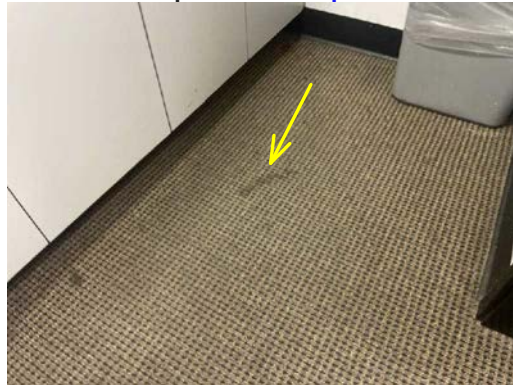
- 3. Not Inspected Disposal: Not Applicable
- 4. Not Inspected Dishwasher: Not Applicable
- 5. Air Gap Present? Not Applicable
- 6. Not Inspected Refrigerator: Not Applicable
- 7. Not Inspected Microwave: Not Applicable
- 8. Not Inspected Sink: Not Applicable
- 9. Acceptable Electrical: 110 VAC
- 10. Not Inspected Plumbing/Fixtures: Not Applicable
- 11. Acceptable Counter Tops: Laminate and composite materials
- 12. Acceptable Cabinets: Laminate and wood
- 13. Acceptable Ceiling: Suspended ceiling
- 14. Acceptable Walls: Paint and paneling
- 15. Needs Attention Floor: Carpet - **Carpet Stained/soiled**

8. #1, Coffee/Break Room, Center, Right Side Employee Lounge Floor: Carpet - Carpet Stained/soiled

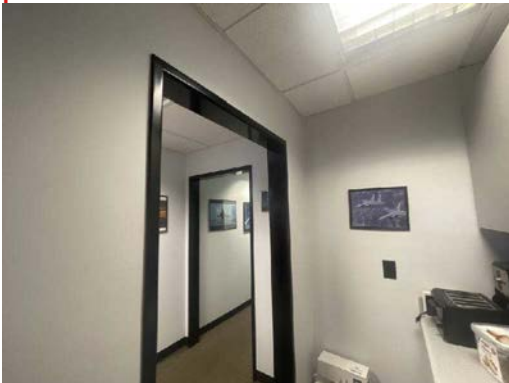
- 16. Not Inspected Doors: Not Applicable
- 17. Not Inspected Windows: Not Applicable
- 18. Not Inspected HVAC Source: Not Applicable
- 19. Emergency lighting present? No **Safety issue: Insufficient or no emergency lighting present. Recommend installation.**

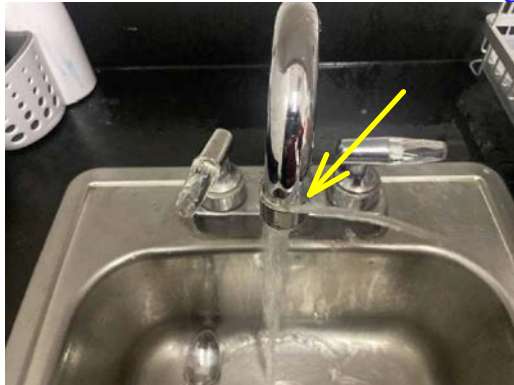
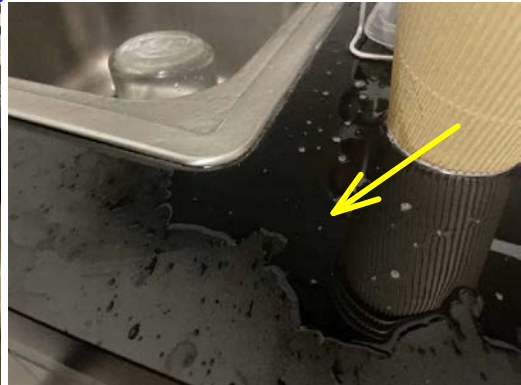
- #2, Warehouse Area, Center, Front Employee Lounge
- 20. Not Inspected Cooking Appliances: Not Applicable
- 21. Not Inspected Ventilator: Not Applicable
- 22. Not Inspected Disposal: Not Applicable
- 23. Not Inspected Dishwasher: Not Applicable
- 24. Air Gap Present? **Not Applicable**
- 25. Not Inspected Refrigerator: Not a part of this inspection
- 26. Acceptable Microwave: Sanyo
- 27. Serviceable Sink: Stainless Steel - **Leaking**

11. #2, Warehouse Area, Center, Front Employee Lounge Sink: Stainless Steel - Leaking
12. #2, Warehouse Area, Center, Front Employee Lounge Electrical: No GFCI or GFCI outlets. Non-GFCI or GFCI labeled outlet. Consult a qualified Electrician.

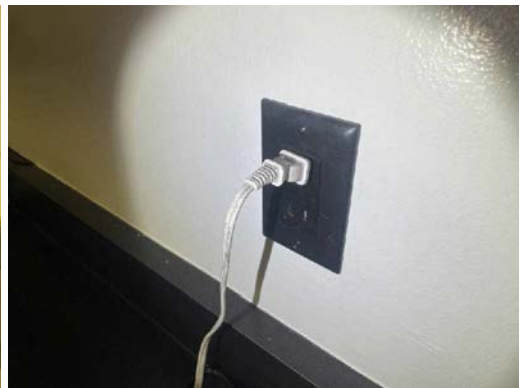
Electrical: No GFCI or GFCI outlets. **Non-GFCI or GFCI labeled outlet. Consult a qualified Electrician.**

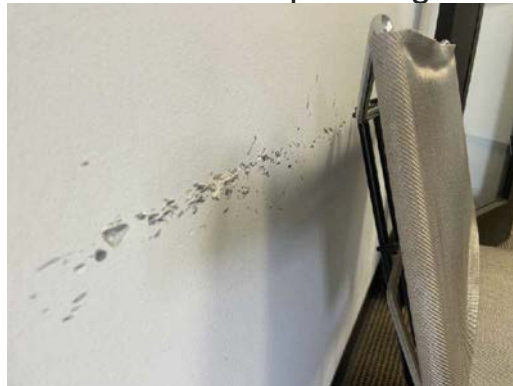
- 1. Not Inspected Closet: Not Applicable
- 2. Acceptable Ceiling: Suspended ceiling
- 3. Needs Attention Walls: Paint and paneling - **Loose or peeling paint**

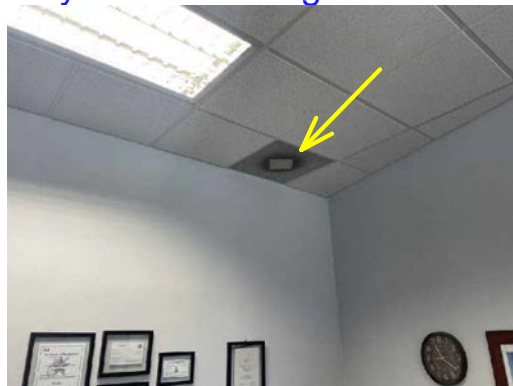
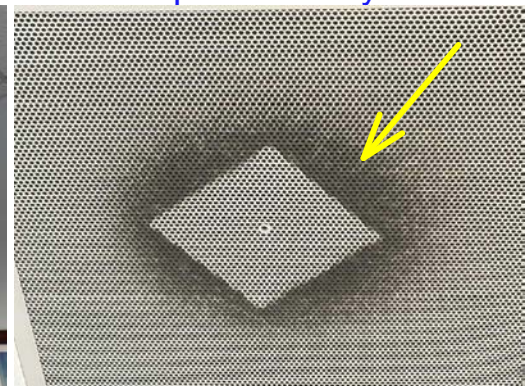
- 4. Acceptable Floor: Carpet
- 5. Acceptable Doors: Aluminum, Also entry
- 6. Acceptable Windows: Aluminum Fixed
- 7. Acceptable Electrical: 110 VAC
- 8. Needs Attention HVAC Source: Heating system register - **Soot build up noted. Ducts may need cleaning. Consult an HVAC expert to verify.**

9. #1, Front Office / Reception Office Space Walls: Paint and paneling - Loose or peeling paint
10. #1, Front Office / Reception Office Space HVAC Source: Heating system register - Soot build up noted. Ducts may need cleaning. Consult an HVAC expert to verify.

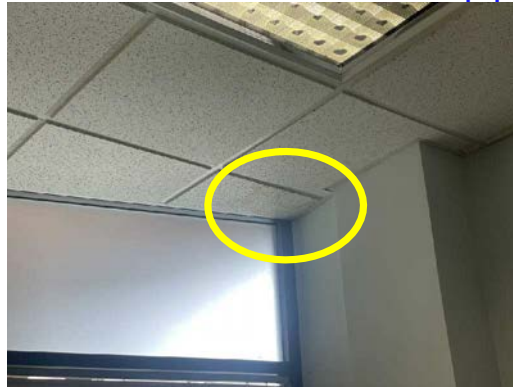
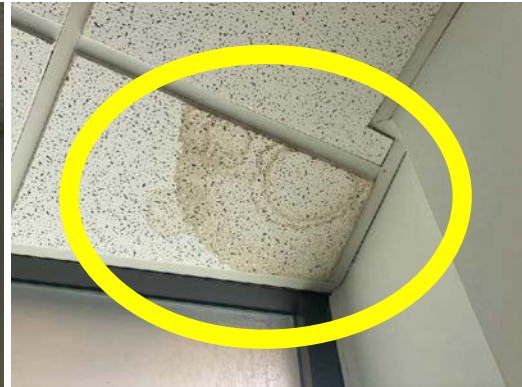
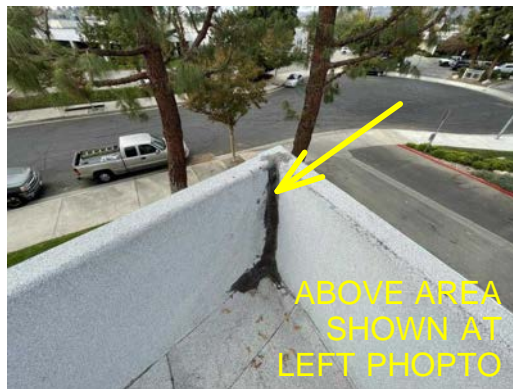
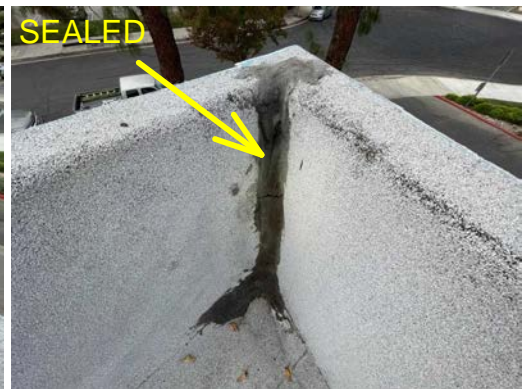
11. Needs Attention Ceiling: Suspended ceiling - 1. Evidence of past or present water staining noted. Invasive inspection will reveal plumbing leakage or roof water pregnable point. Roof area at this spot shows routine mastic patching, but no water pregnable concern noted. Inquire with owner and monitor and maintain for preventive maintenance, 2. The stains could relate to water pipe or HVAC duct condensation.

11. #2, Left Side, Front Office Space Ceiling: Suspended ceiling - 1. Evidence of past or present water staining noted. Invasive inspection will reveal plumbing leakage or roof water pregnable point. Roof area at this spot shows routine mastic patching, but no water pregnable concern noted. Inquire with owner and monitor and maintain for preventive maintenance, 2. The stains could relate to water pipe or HVAC duct condensation.

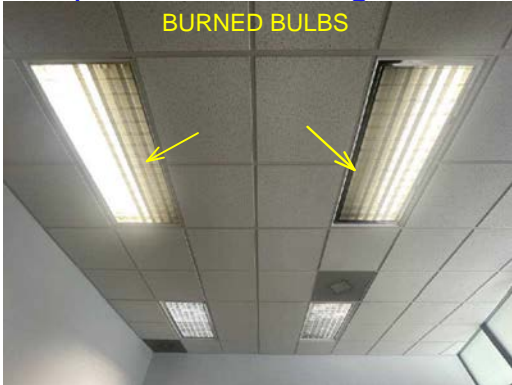
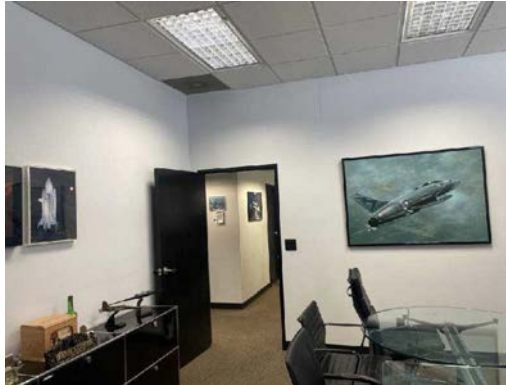
18. Emergency lighting present? No 1. Consult a contractor for emergency lighting compliance, 2. Ceiling bulbs burned out.

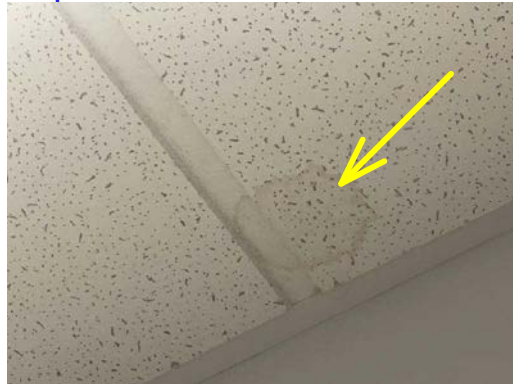
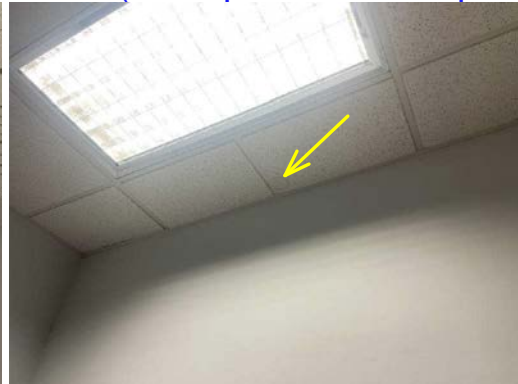
20. Needs Attention Ceiling: Suspended ceiling - Stains: Dry water stains noted. This may have been due to past roof leakage or minor condensation on water pipes, or HVAC ducts. Invasive soffit and ceiling observation is required to discover cause and effect (not a part of this inspection)

12. #3, Left Side, Front/Center Office Space Ceiling: Suspended ceiling - Stains: Dry water stains noted. This may have been due to past roof leakage or minor condensation on water pipes, or HVAC ducts. Invasive soffit and ceiling observation is required to discover cause and effect (not a part of this inspection)

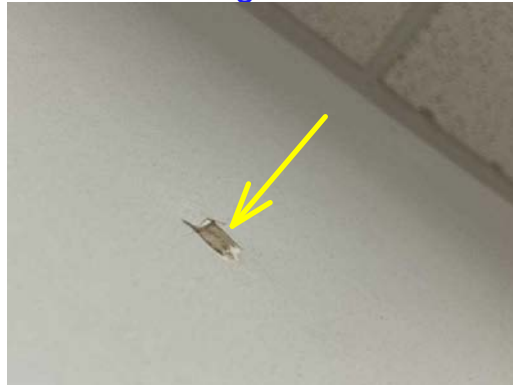
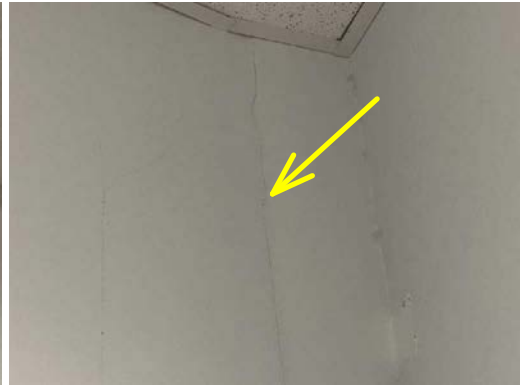
- 37. Not Inspected Closet: Not Applicable
- 38. Acceptable Ceiling: Suspended ceiling
- 39. Needs Attention Walls: Paint and paneling - **Stress / Cosmetic cracks and minor surface damage noted.**

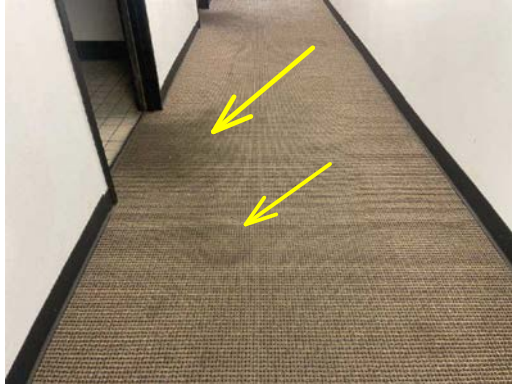
Floor: Carpet - Carpet Stained/soiled at different areas.

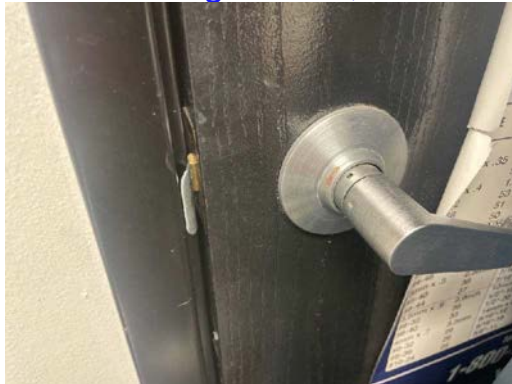
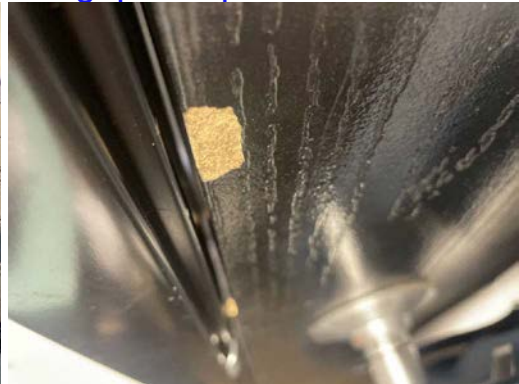
Doors: Wood - 1. Lockset(s) not latching-requires adjustment, 2. Minor damage noted, 3. Excessive gap at top noted.

13. #5, Right Side, Front Office Space Walls: Paint and paneling - Stress / Cosmetic cracks and minor surface damage noted.
14. #6, Right Side, Inside Warehouse Rear Office Space Doors: Wood - 1. Lockset(s) not latching-requires adjustment, 2. Minor damage noted, 3. Excessive gap at top noted.

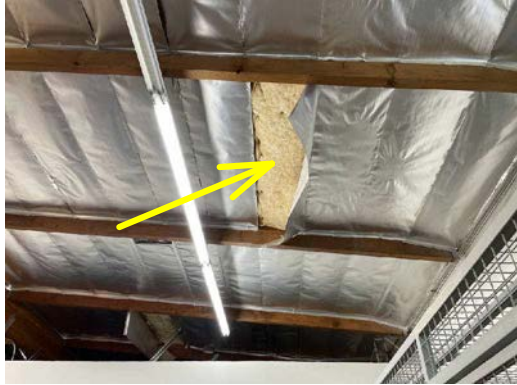
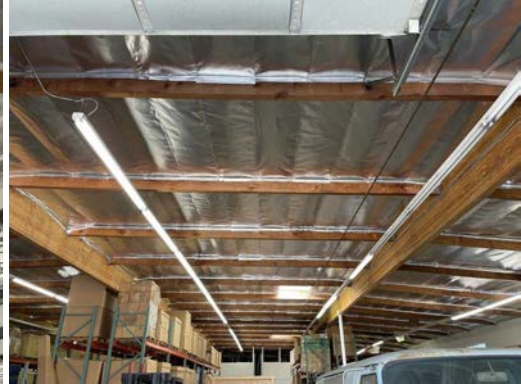
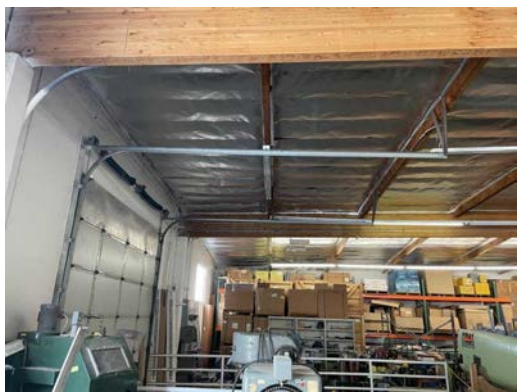
2. Needs Attention Ceiling: Exposed framing, Skylight - Aluminum covering are loose at one or more spots.

15. 1st Floor rear Work Area Ceiling: Exposed framing, Skylight - Aluminum covering are loose at one or more spots.

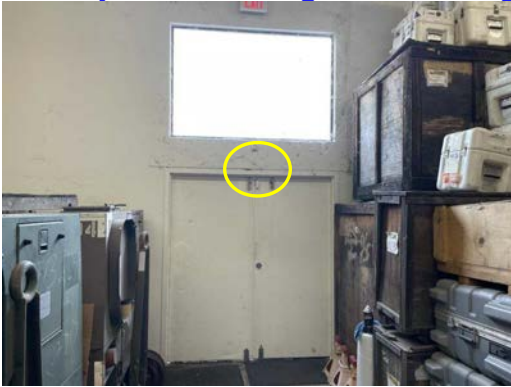
9. Emergency lighting present? No One or more emergency exit doors are missing, battery backed, Lighted exit signs.

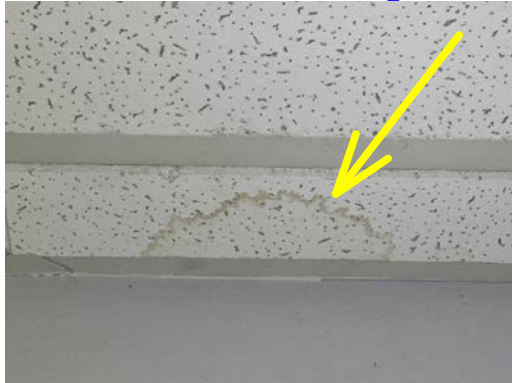
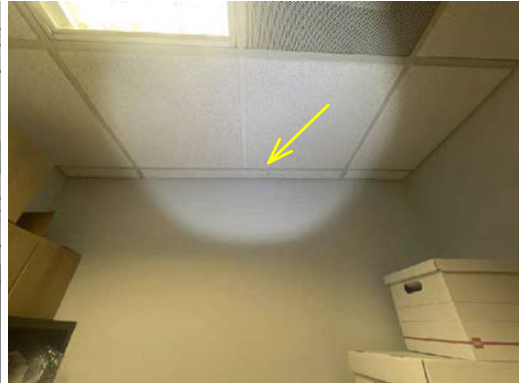
- 1. Needs Attention Ceiling: Suspended ceiling - [Water stains present. See similar photos and notations in this regard, in offices and other rooms.](#)

16. Right Side, Center Janitor's Room Ceiling: Suspended ceiling - Water stains present. See similar photos and notations in this regard, in offices and other rooms.
