CITY PROPERTY SERVICES

Property Inspection Report

Sample Report- Hill Side Property.inspx

Water On Yes
Temperature 75 F
Weather Partly cloudy Soil Conditions Dry
Space Below Grade Crawl Space
Building Type Duplex Garage Attached
Sewage Disposal City How Verified
Water Source City How Verified
Additions/Modifications Unknown
Permits Obtained Unknown

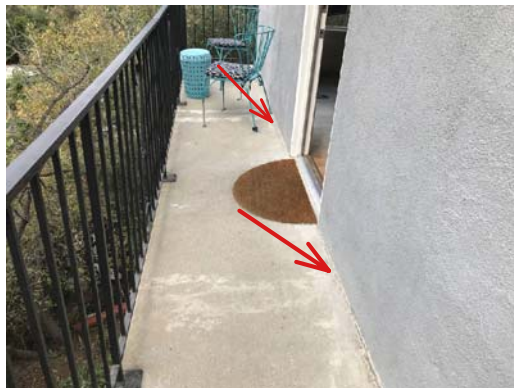
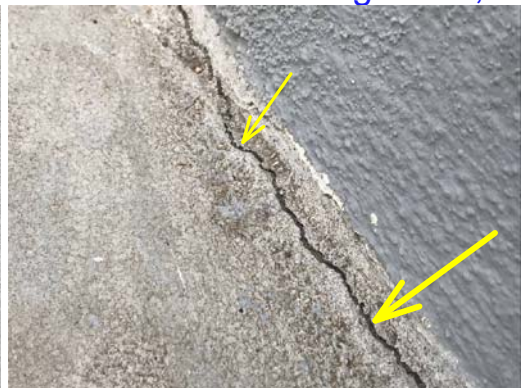
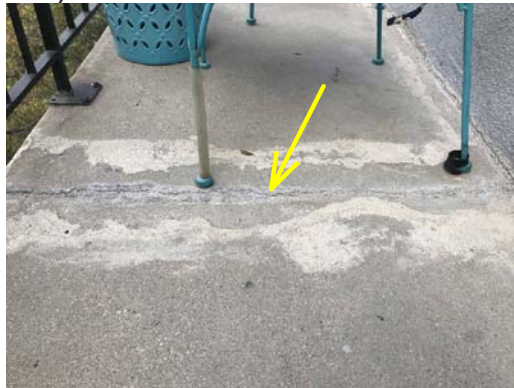
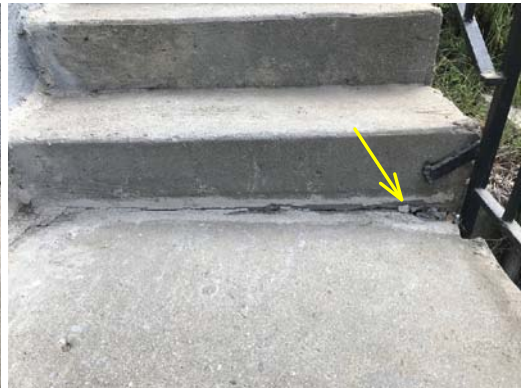
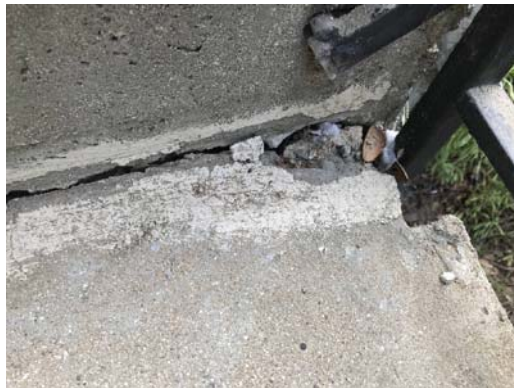
3. Acceptable Steps/Stoops: Brick / Paver, Concrete
4. Acceptable Porch: Wood
5. Acceptable Patio: Wood
6. Acceptable Deck: Wood, Concrete
7. Needs Attention Balcony: Wood, Concrete - Signs of slight movement / displacement are evident at left balcony of the unit 2 (under garage). Monitor to take corrective action. Also see notations in Retaining Walls, below.

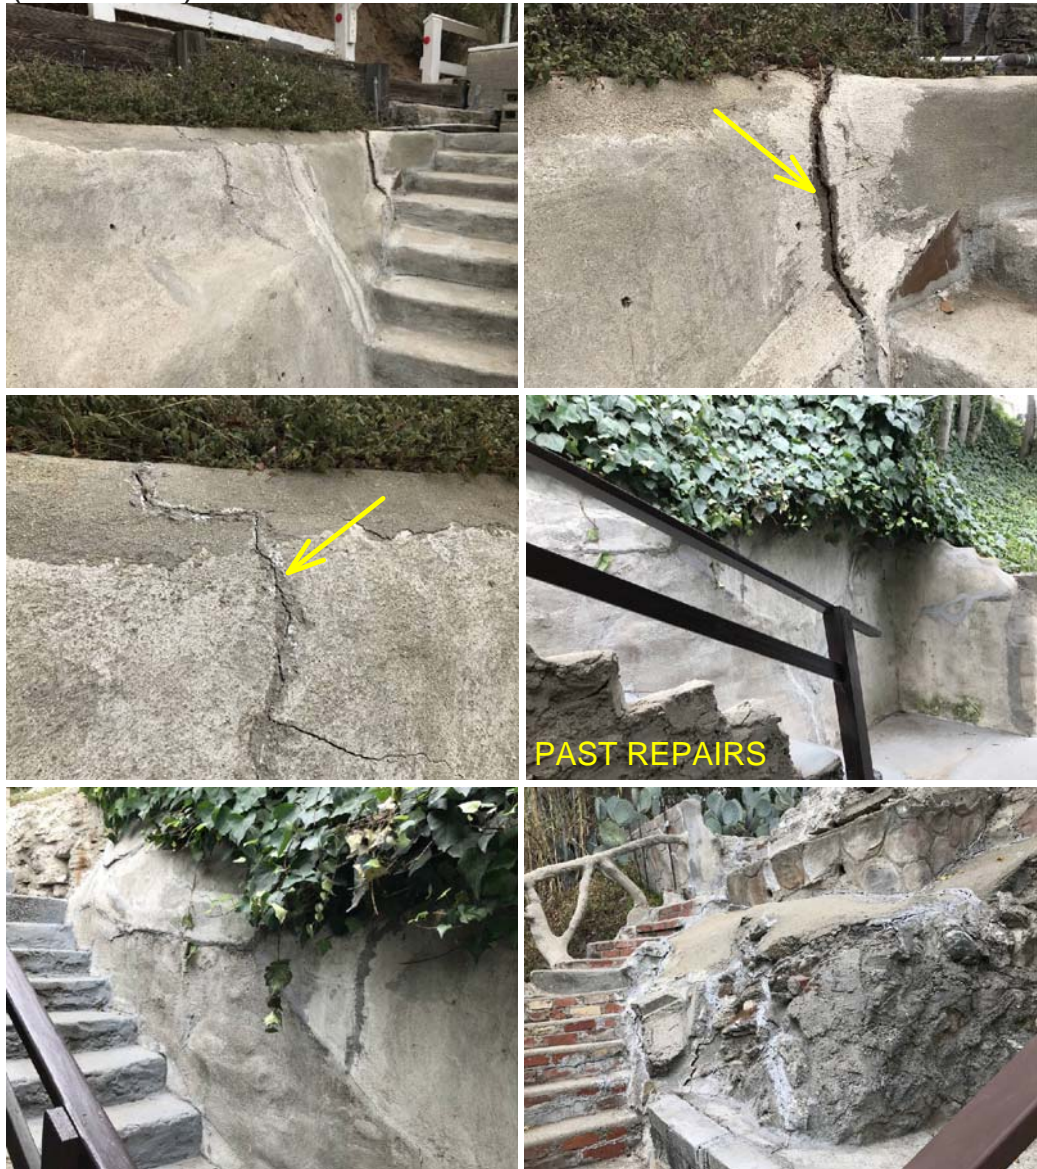
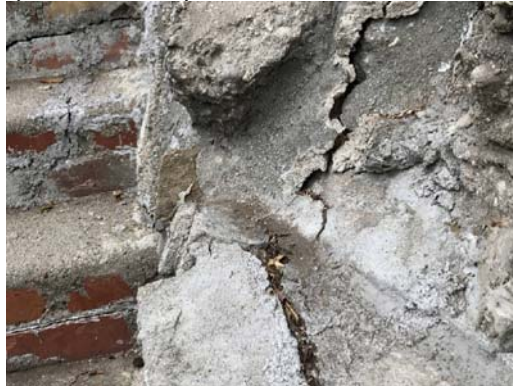
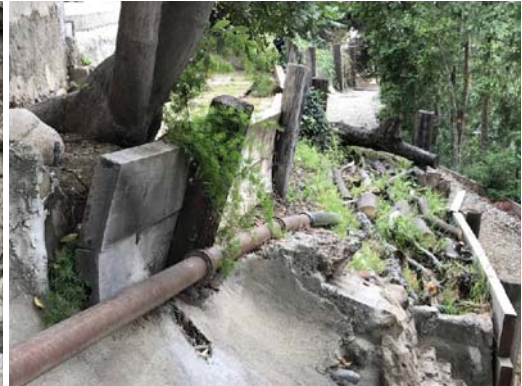
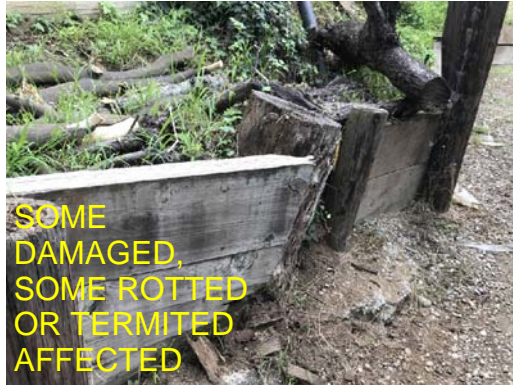
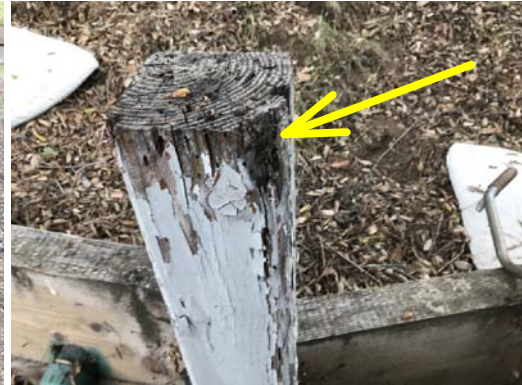
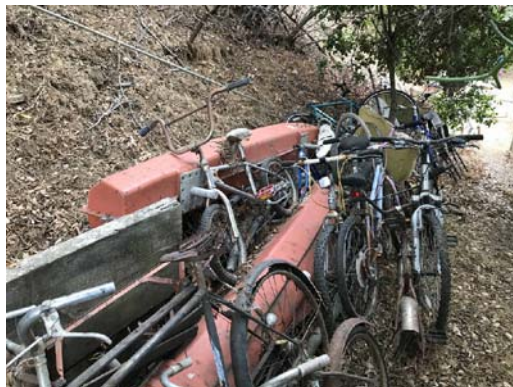
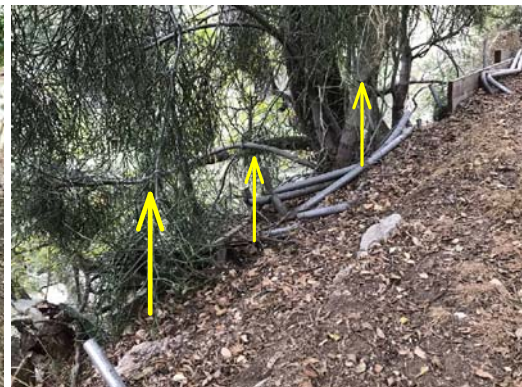
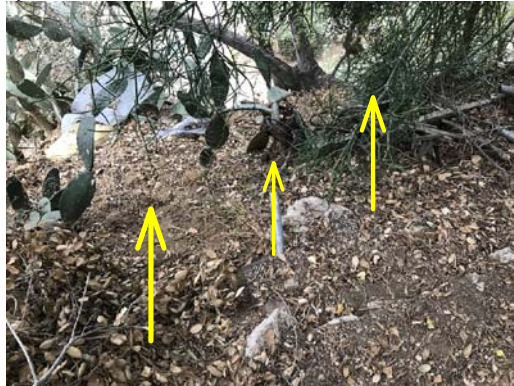
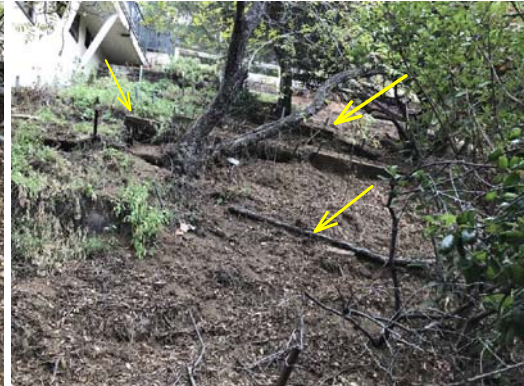
Retaining Walls: 1. Retaining walls need repair or reinforcement at different areas, including concrete stairs that are attached to them, which show deformation to some degree. Separation and minor displacement as well damage and rot on some of the wooden retainers are evident. Some of the cracks have occurred after sealing and grouting of some areas. Also see slabs and floors in Structure category. As this is a hill side structured property, a geologist or structural engineer could provide specialty opinion regarding the soil condition, etc and existing condition of this property, 2. If retaining walls adjacent to street have been installed by the local authority, then it is suggested that any defects and repair needs be conveyed to the local authority for maintenance or repairs if needed. Note: Some need repair and attention now. 3. The retaining walls / structure adjacent to

street pavement, at right side of property are covered with vegetation inspection of their condition was not possible. Recommend removal of the vines for two main reasons: A. Observation access for retainers condition, B. Prevention of moisture activity and rodent / insect traffic, 3. Recommend discontinuing with all sprinkler jetting heads to prevent moisture activity at all uncovered retained soil.

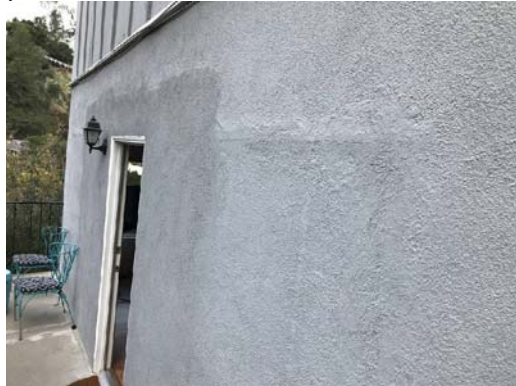
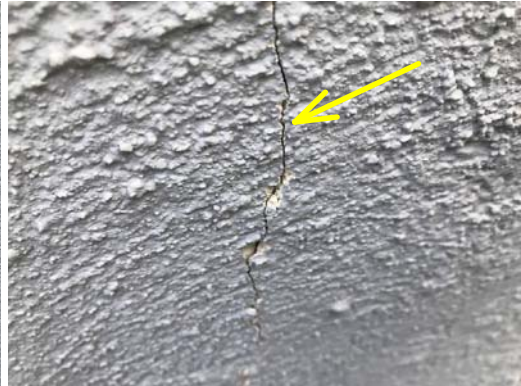
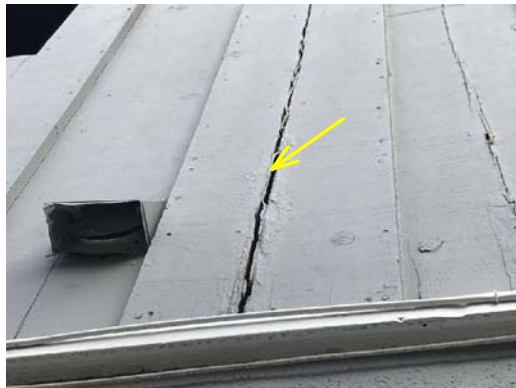
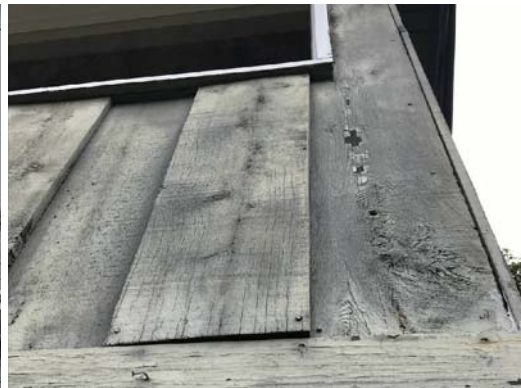
- 1. Needs Attention Type: Stucco, Siding - 1. Any opening, separation, or crack on the exterior walls should be sealed patched and painted if necessary, to prevent further decay and admittance of water or insect traffic,

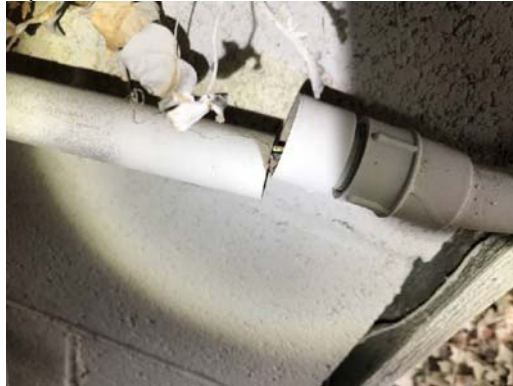
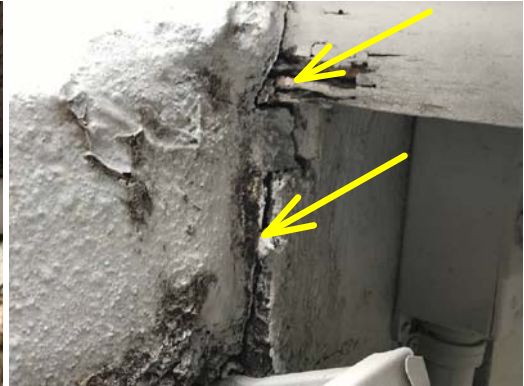
Soffits: Wood - **Obstructing / closing any corner spaces in the Soffit / Eaves structure will prevent rodent, bees, and insect activities. One or more noted. Recommend obstructing with metal screen.**

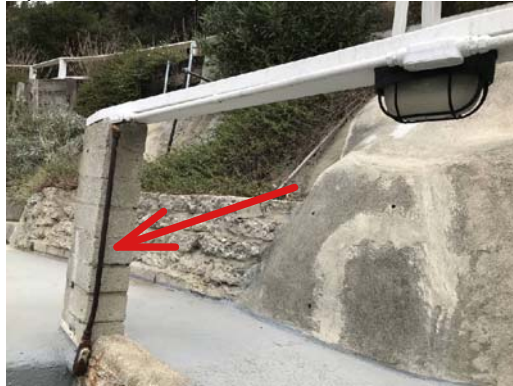
Exterior Lighting: **Electrical protective tube is corroded and is due for resurfacing and painting.**

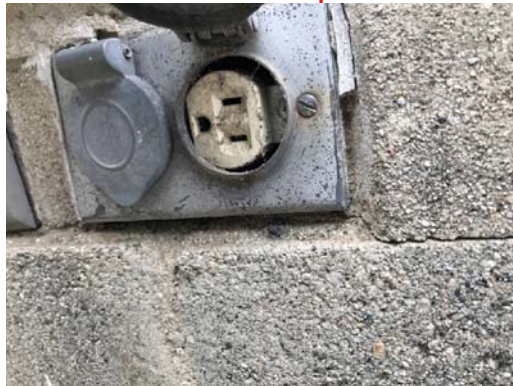
Exterior Electric Outlets: **One or more are not GFCI or GFCI labeled outlets. Consult a qualified electrician for remedy and cost.**

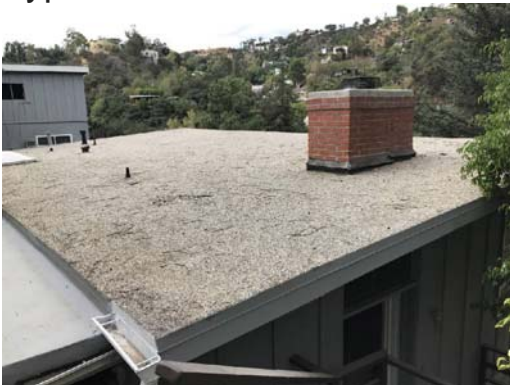
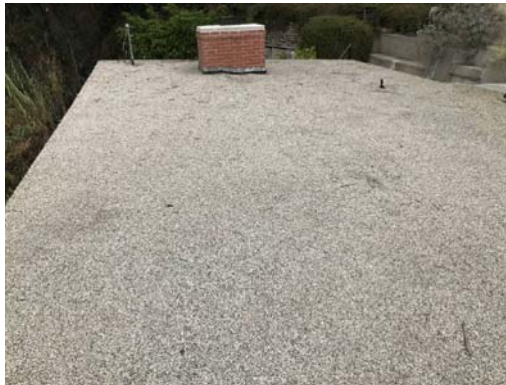
1. Method of Inspection: On roof
2. Not Inspected Unable to Inspect:
3. Needs Attention Material: Tar and gravel - **Minor gravel adding needed. In generally acceptable condition. Inspect roof on yearly basis for routine maintenance before rain season.**

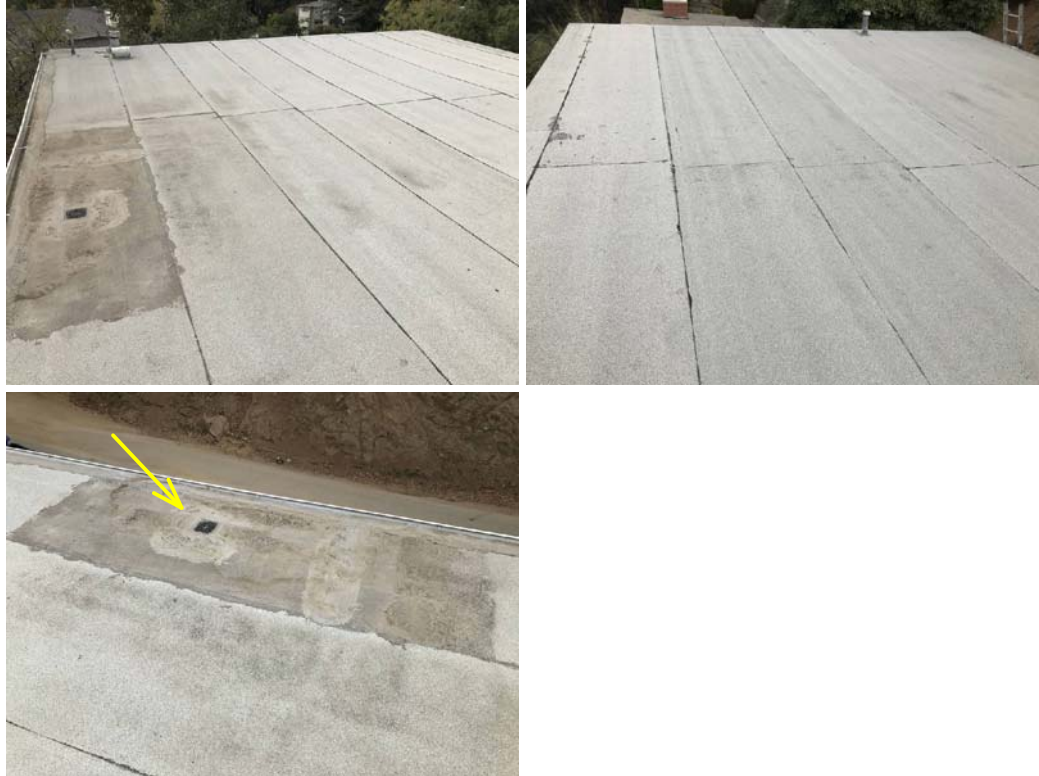
6. Needs Attention Roof: Rolled roof material, Build up - Always keep the scupper / drain intake free of debris to prevent water pooling on roof.

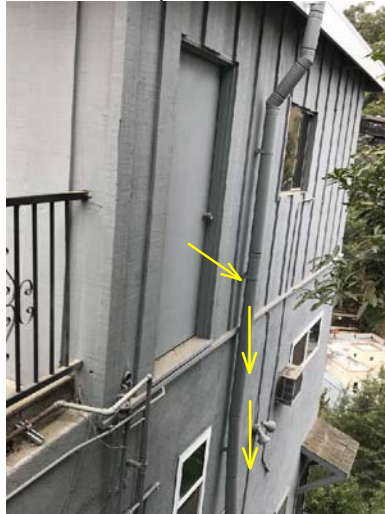
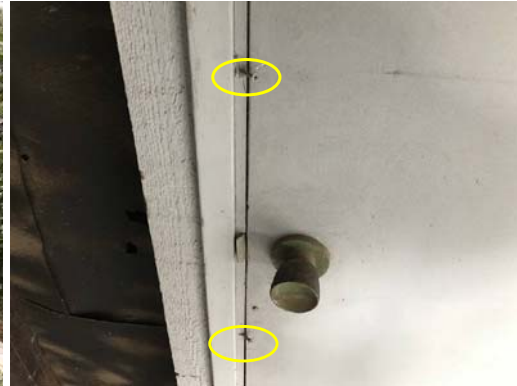
Service Doors: Wood - **Safety Notation: As this door opens to an open space with considerable height without any guard rails, recommend removing door and enclosing the opening for safety. If not desired, use locking devices with keys removed from the hardware.**

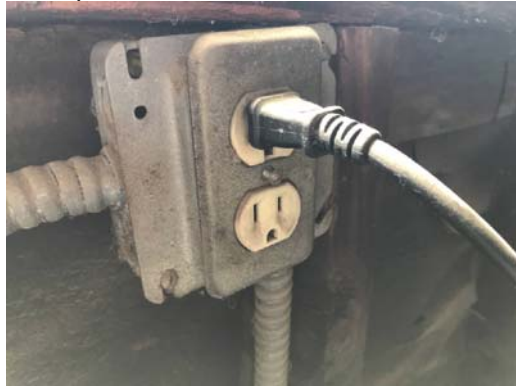
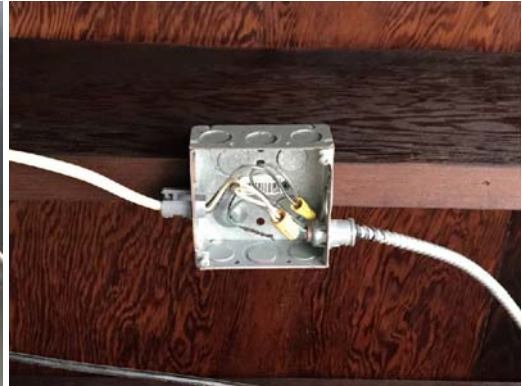
Electrical: **Non GFCI or GFCI labeled. Consult a qualified electrician. Exposed wiring, missing cover plates. Safety Notations.**

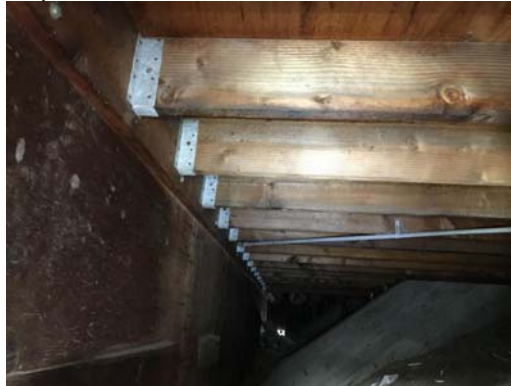
5. Needs Attention Bearing Walls: Frame - Past repairs close to foundation walls noted.

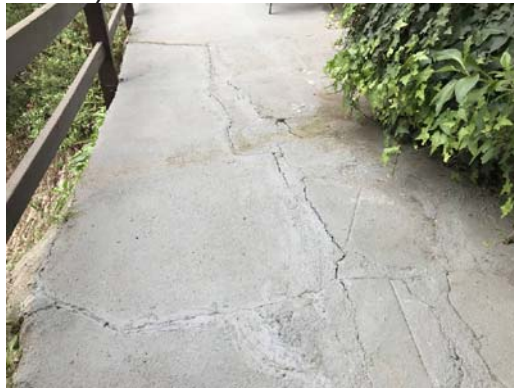
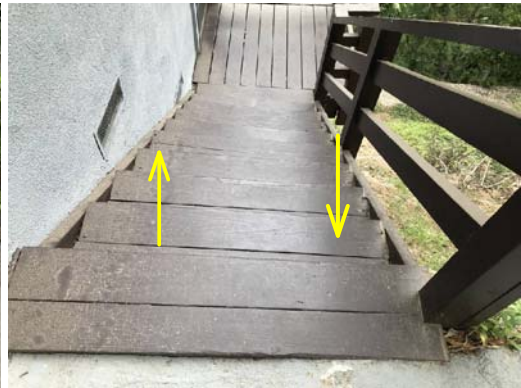
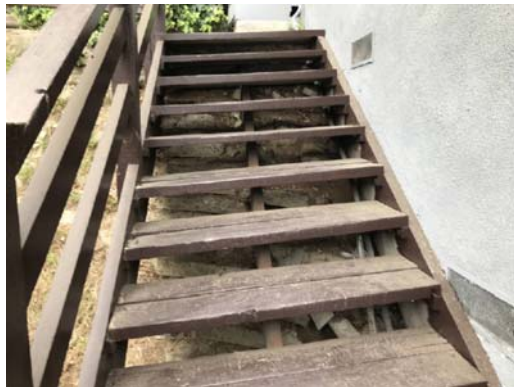
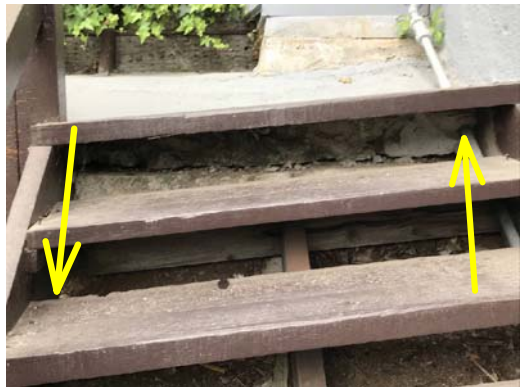
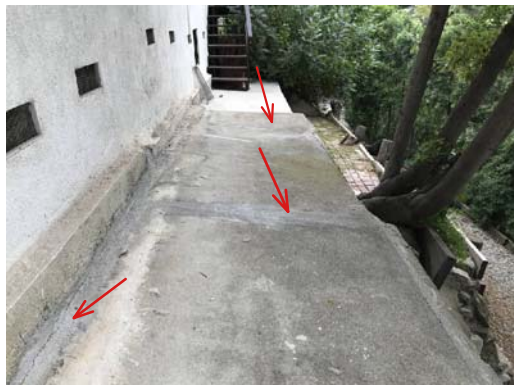
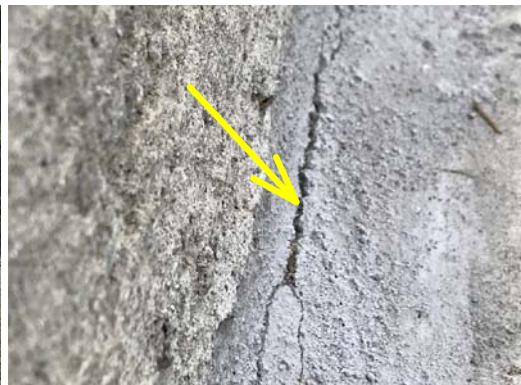
Floor/Slab: 1. Slabs at different areas show minor displacement and past repair, and after repair cracks. If these cracks have been here for longer than three years, then any soil movement progressions are very minute. A geologist can provide further evaluation and specialty opinion, 2. Some of the wooden or concrete stairs show displacement and deformation and some have been repaired. Some should be repaired at present as they may become trip and fall hazard.

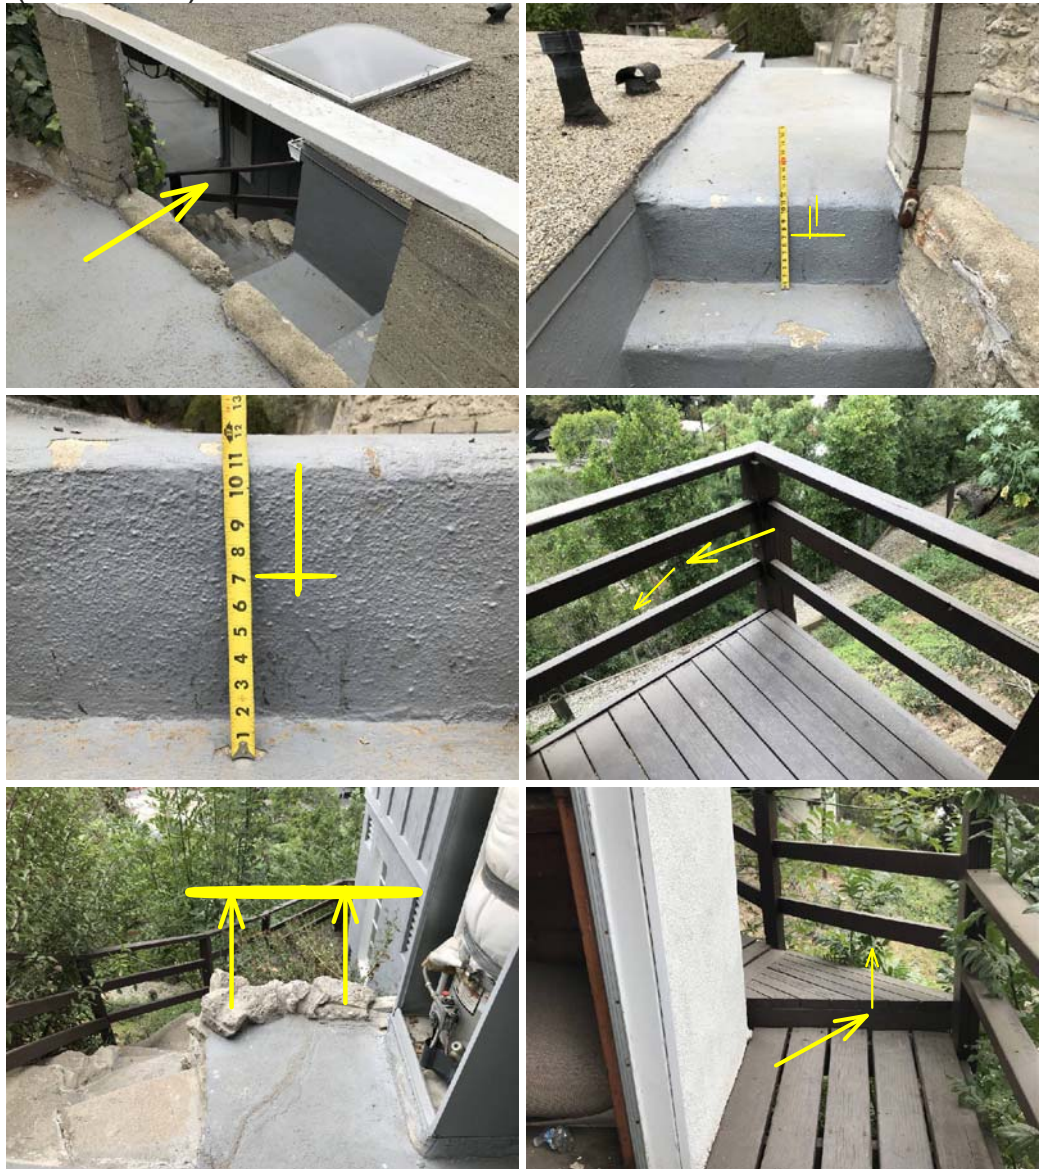
Stairs/Handrails: 1. Balusters / Frame bars are too far apart. At the time of original construction this may have not been a requirement. Child and pet safety. Consult a licensed contractor for remedy and cost, and inquire about your local code, 2. One or more posts show minor termite / rot and should be replaced, 3. Some spots should be equipped with guard rails (Left of water heater deck at main structure) for safety reasons, 4. Some are shorter or lower than standard and could become fall or trip hazard.

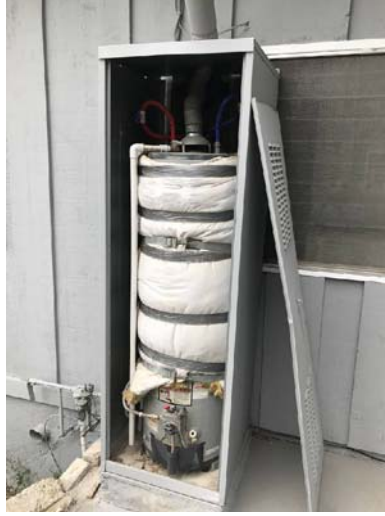
14. Serviceable

Water Heater Operation: **Not functional. No hot water production.**

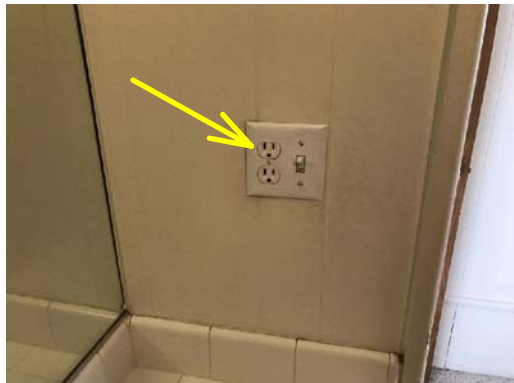
39. Serviceable

Electrical: 110 VAC - **Non GFCI or GFCI labeled. Consult a qualified electrician.**

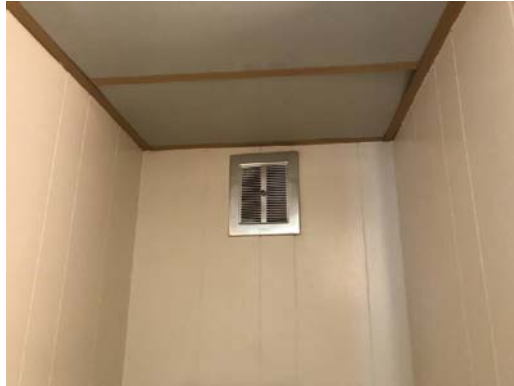
48. Serviceable

Ventilation: Electric ventilation fan - Fan inoperative

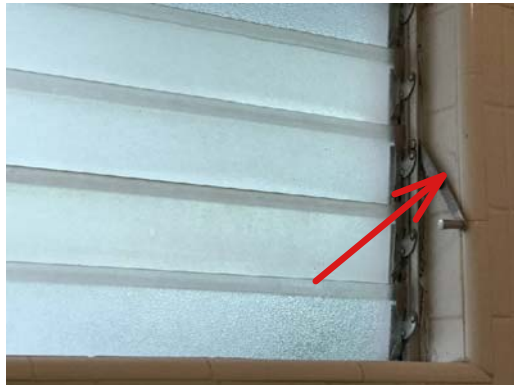
54. Serviceable

Windows: Jalousie - Window handle hard to operate or inoperative.

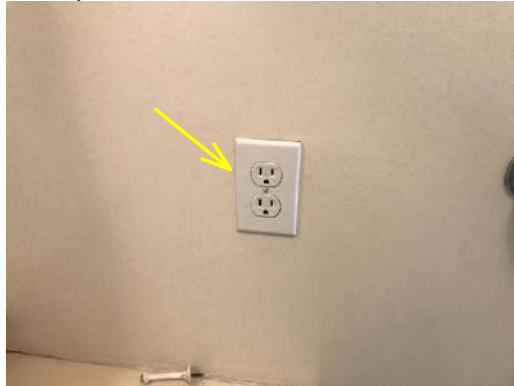
55. Serviceable

Electrical: 110 VAC - Non GFCI or GFCI labeled. Consult a qualified electrician.

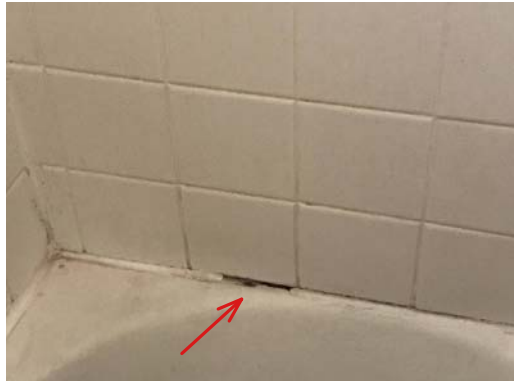
58. Acceptable
59. Acceptable
60. Acceptable

Faucets/Traps: Chrom and Metal
Tub/Surround: Porcelain tub and ceramic tile surround
Shower/Surround: **Caulking / Re Caulking will prevent water migration to the underside or into the wall cavity.**

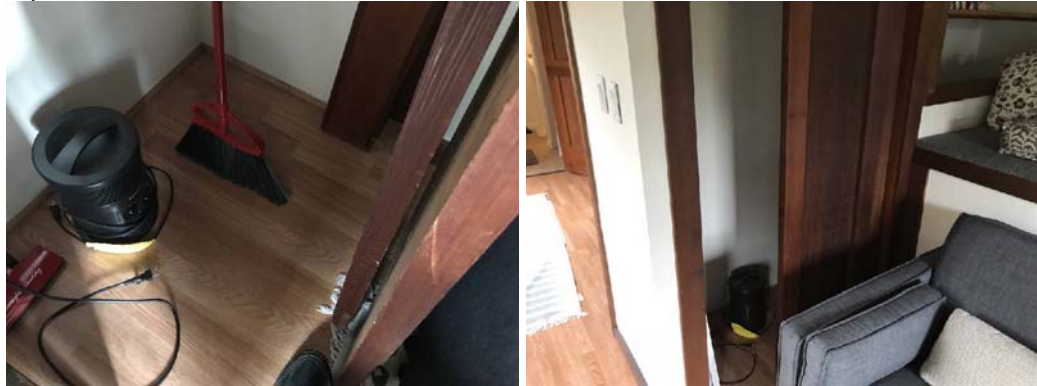
- 10. Needs Attention Closet: Small - **Missing or damaged guide rail causes wobbling / swinging**

13. 1st Floor , Unit two Bedroom Closet: Small - Missing or damaged guide rail causes wobbling / swinging

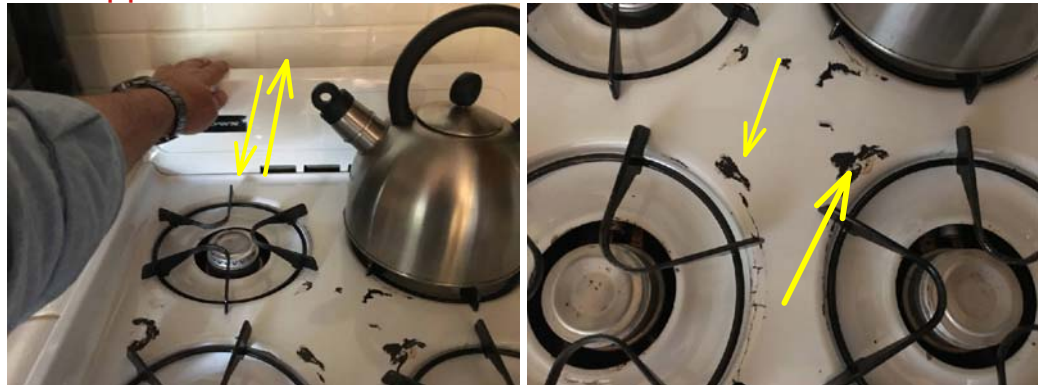
1. Serviceable

Cooking Appliances: Brown - 1-No anti tip is installed (Comes with the new units from manufacturer). Anti tip is an inexpensive bracket that holds the unit from tipping in case the front door is opened and weight is applied on it or a person (child) stands on the door. It secures the Oven Range to the wall or floor. This was tested simply by pulling back on the unit. A safety notation. 2-, Oven heating element inoperative
3- Chipped

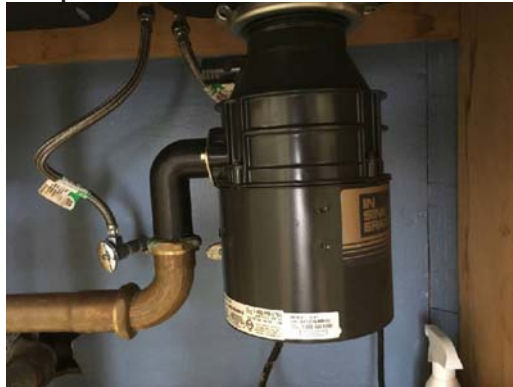
Disposal: In-Sinkerator - **Jammed**

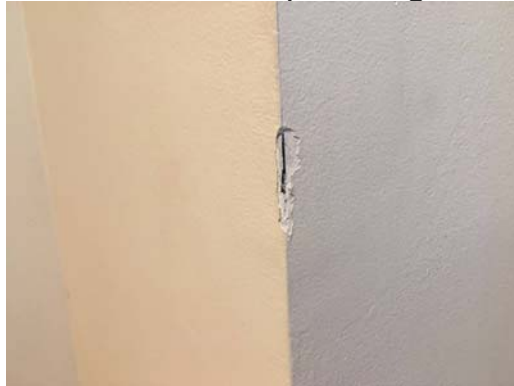
12. Acceptable

Walls: Paint and paneling - Peeling paint
