CITY PROPERTY SERVICES
Commercial & Residential Inspections

Property Inspection Report

Property Address

Prepared by: Shawn S. Azimi
Certified Master Inspector, or associates

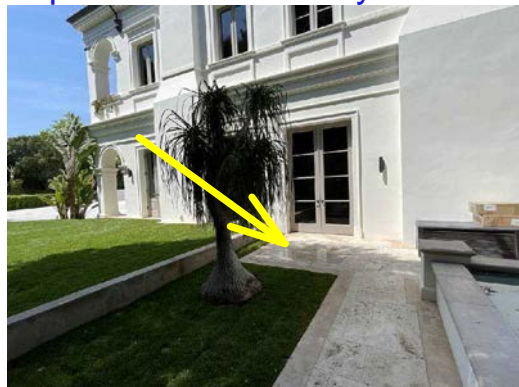
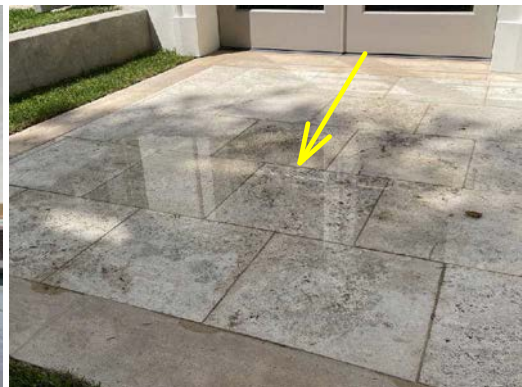
8. Needs Attention Grading: Right Side Front: Tiled deck shows minor sagging and water pooling, without effective drains. This is considered negative grading. Improve as necessary.

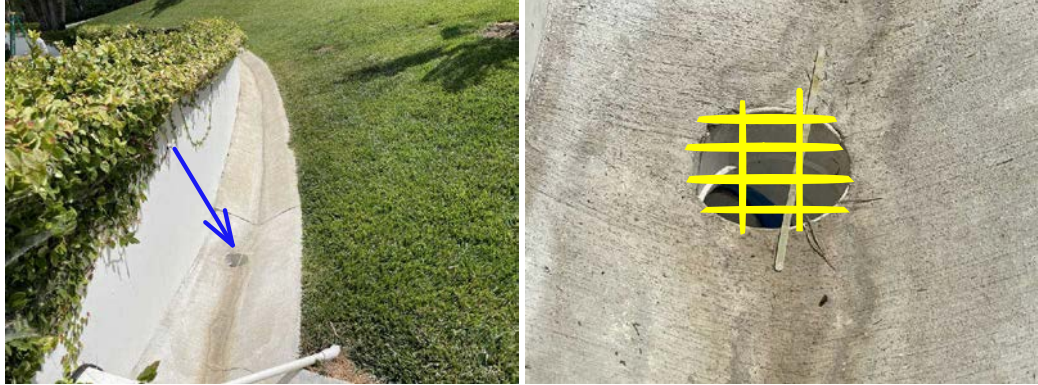
9. Needs Attention Swale: Concrete - Drain head not installed. Installation will prevent debris entry into the covered drain.

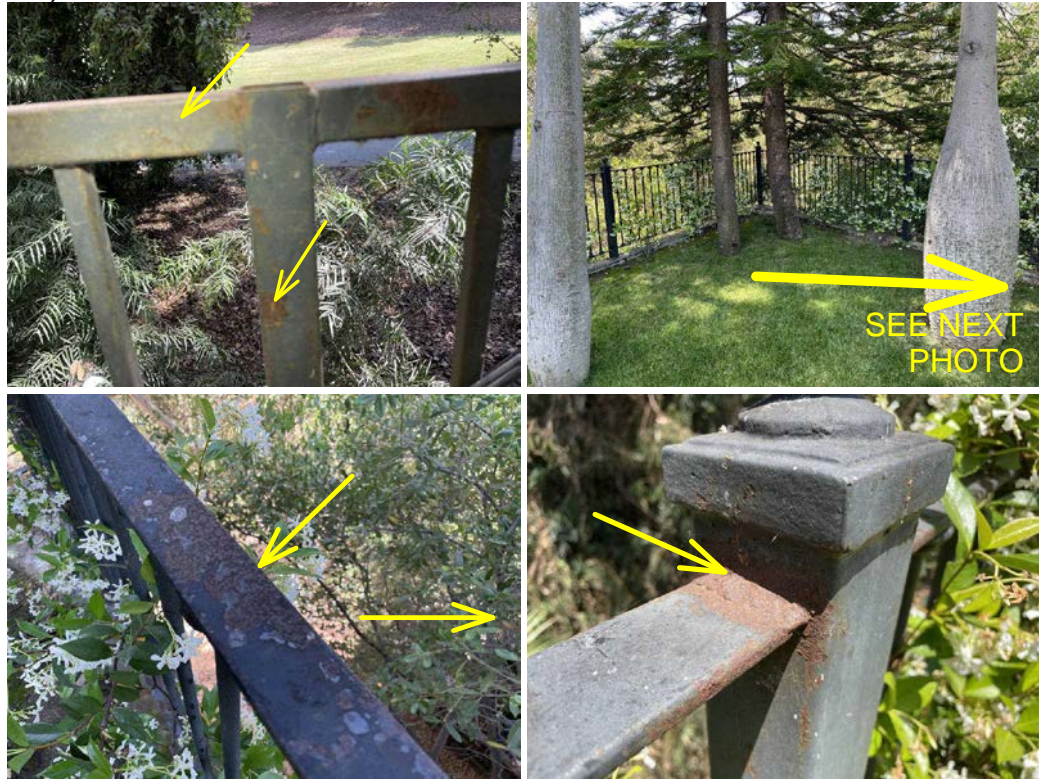
Fences: (continued)

16. Needs Attention Fences: Metal - 1. Metal Fence: Due for protective coating, 2. Concrete fence at right side: Soil under the fence structure is showing erosion with roots visible. Soil moisture at this area (the entire right side of lot with irrigation lines) needs attention and improvement, to prevent any cracks, displacement or damage to the concrete fence. This is a long term maintenance matter that must be addressed. Consult with a drain and foundation expert for further evaluation, remedy and cost.

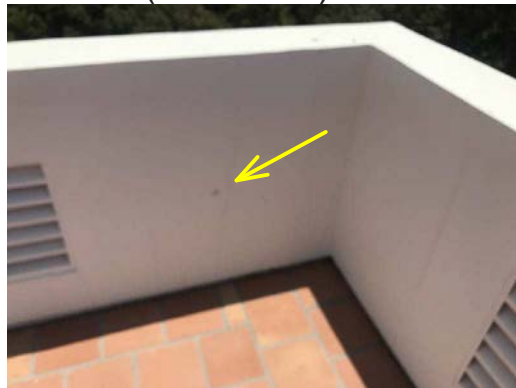
Exterior Electric Outlets: (continued)

13. Needs Attention Exterior Electric Outlets: 110 VAC GFCI - Exposed Wiring: Recommend proper protection

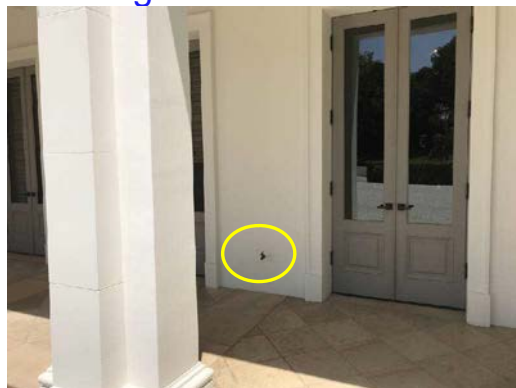
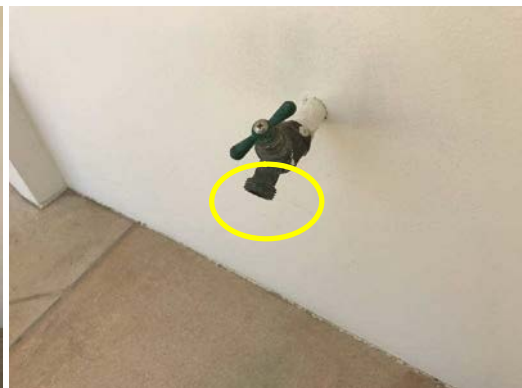
14. Needs Attention Hose Bibs: Gate - Anti Siphon diverter would prevent back flow of dirty and contaminated water into the house water lines. Consider installing.

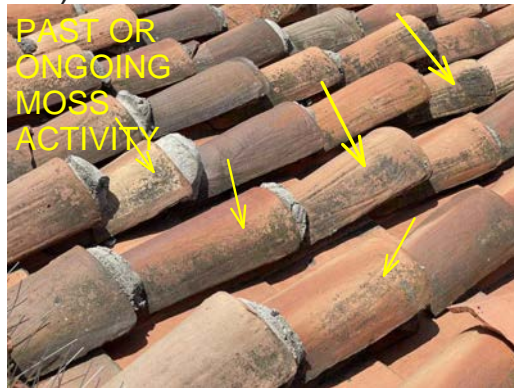
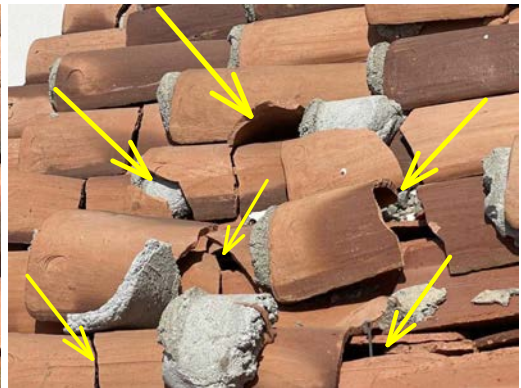
Material: (continued)

Material: Clay tile, Rolled roof torched material, build up - 1. Some need repair or replacement. Consult a roofer for remedy and cost, 2. Water ponding (or stains) evident on flat roof section. Monitor to take preventive action. Water ponding can cause less life for the roof material, at areas that hold water longer., 3. Moss build up on roof material surfaces noted. Moss build up at shady areas of the roof are not unusual. Periodic monitoring could verify if pressure washing and sealing is needed: Moss could damages tiles or shingles and make them leak prone, in the long run.

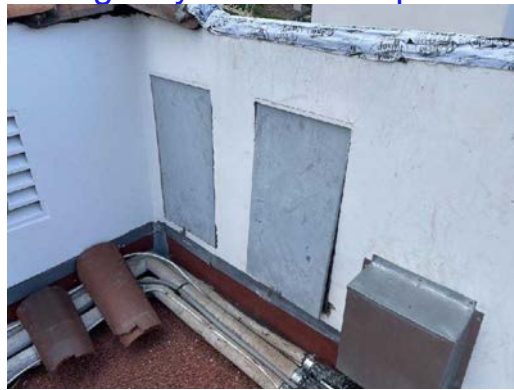
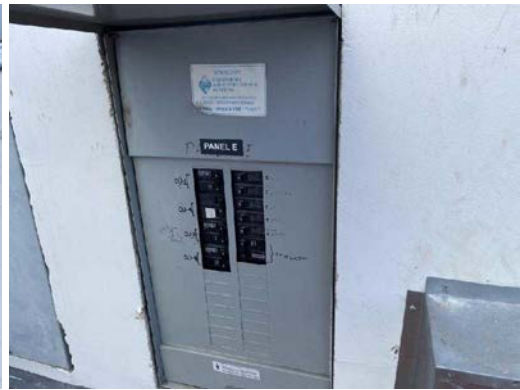
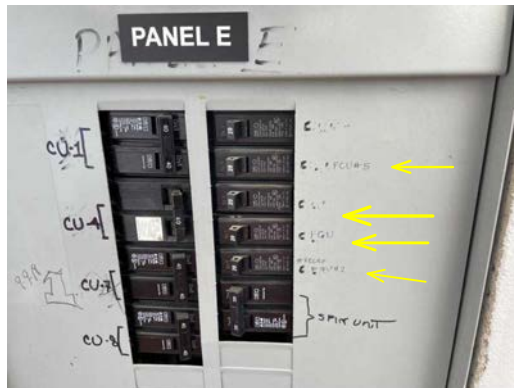
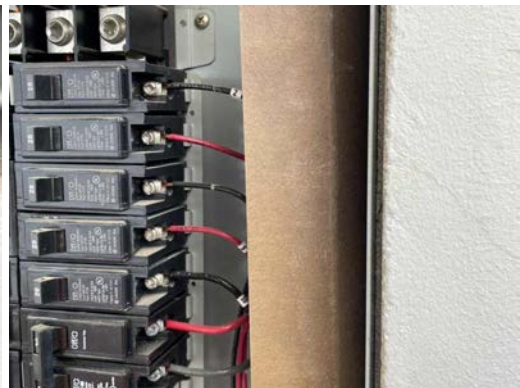
89. Serviceable Breakers: Copper - **Labeling not marked, inconspicuous, incomplete or not legible. Labeling is necessary as a matter of convenience and emergency. Consult a qualified electrician.**

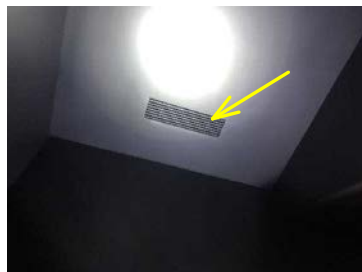
44. Serviceable

Ventilation: Electric ventilation fan and window - **Fan inoperative**

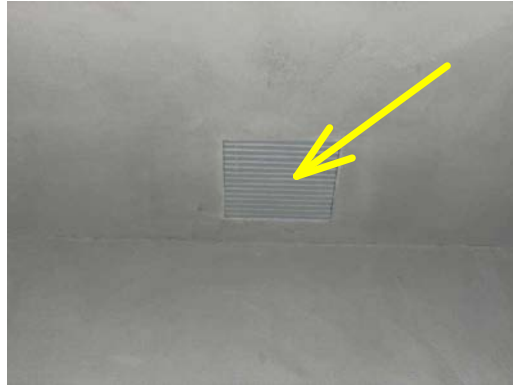
- 96. Not Inspected Spa Tub/Surround: Not Applicable
- 97. Acceptable Toilets:
- 98. Acceptable HVAC Source: Heat Registers
- 99. Serviceable Ventilation: Electric ventilation fan - **Fan inoperative**

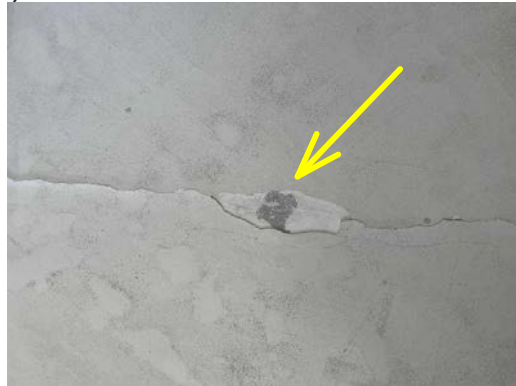
192. Acceptable Walls: Paint and paneling
193. Needs Attention Floor: Concrete overlay - [Surface cracks, abrasion or wear out noted. Repair as necessary.](#)

Floor: (continued)

12. # 7 Lower level , Hallway Bathroom Floor: Concrete - Surface cracks, abrasion or wear out noted. An appearance notation.
13. # 14, Left Side, Rear, 2nd Floor Bathroom Floor: Concrete overlay - Surface cracks, abrasion or wear out noted. Repair as necessary.

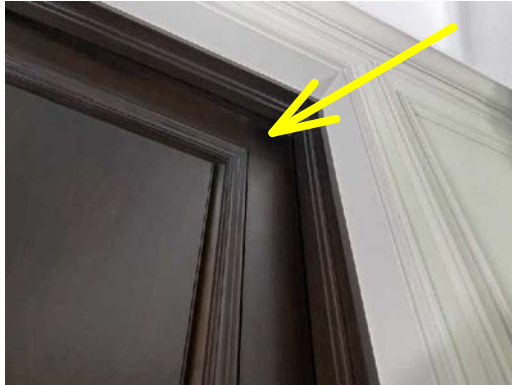
253. Acceptable Ventilation: Electric ventilation fan, Window
18, Right Side, Rear, 2nd Floor, Master Bathroom
-
254. Not Inspected Closet: Not Applicable
255. Acceptable Ceiling: Paint and Paneling
256. Acceptable Walls: Paint and paneling
257. Acceptable Floor: Tile
258. Serviceable Doors: Wood - Closet door Sticks. Improve for ease of operation

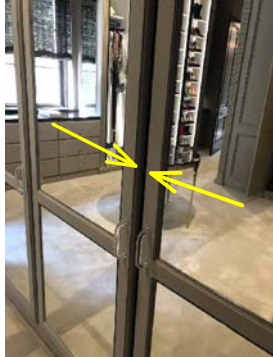
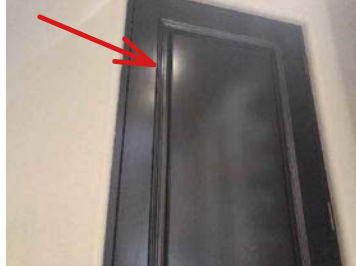
1, 2nd Floor, Left Side Bedroom

1. Serviceable Closet: Large, Walk in, Shelves - (1) Sliders don't shut completely(2), Door sticks. Improve for ease of shutting.

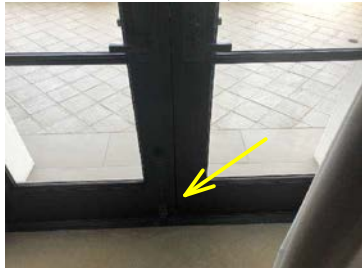
2. Acceptable Ceiling: Paint and Paneling
 3. Acceptable Walls: Paint and paneling
 4. Acceptable Floor: Carpet
 5. Serviceable Doors: Wood, Glass - Sticks. Improve for ease of operation

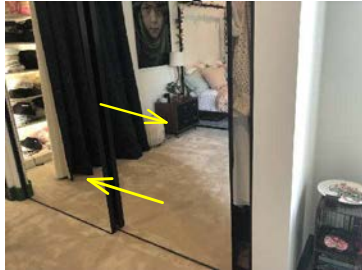
2, 2nd Floor, center Bedroom

- 10. Serviceable Closet: Large - **Door sticks. Improve for ease of shutting.**

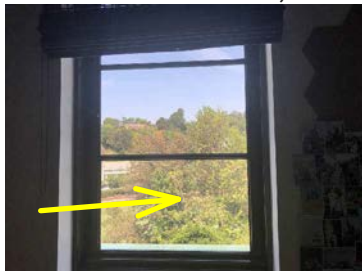
- 11. Acceptable Ceiling: Paint and Paneling
- 12. Acceptable Walls: Paint and paneling
- 13. Acceptable Floor: Carpet
- 14. Acceptable Doors: Pocket Slider
- 15. Serviceable Windows: Wood, Glass, Swing - **Screen: Not installed**

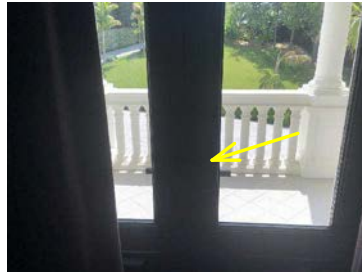
24. Serviceable

Windows: Door window - **Hart to operate or inoperable.**

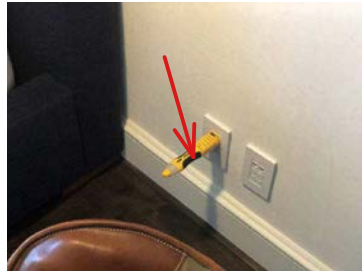
34. Serviceable

Electrical: 110 VAC - **Faulty outlet with loose, unconnected or crossed wires: One or more**

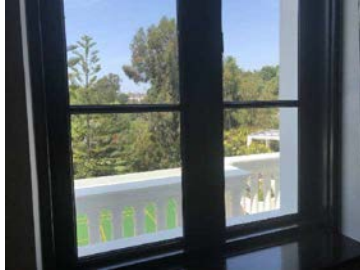
44. Acceptable HVAC Source: Heat Registers
45. Not Inspected Smoke Detector: Not a part of this inspection
6, Right Side, 2nd Floor Bedroom
-
46. Not Inspected Closet: Not Applicable
47. Acceptable Ceiling: Paint and Paneling
48. Acceptable Walls: Paint and paneling
49. Acceptable Floor: Hardwood
50. Acceptable Doors: Wood
51. Serviceable Windows: French, Wood - **Screen: Not installed**

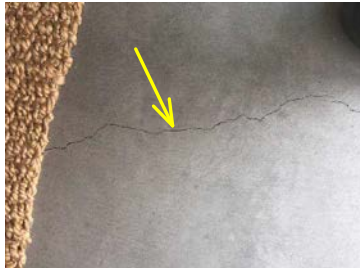
52. Acceptable Electrical: 110 VAC
53. Acceptable HVAC Source: Heat Registers
54. Not Inspected Smoke Detector: Not a part of this inspection
#7 Basement, Rear Bedroom
-
55. Not Inspected Closet: Not Applicable
56. Acceptable Ceiling: Paint and Paneling
57. Acceptable Walls: Paint and paneling
58. Needs Attention Floor: Concrete - **Surface cracks, abrasion or wear out noted**

14. #7 Basement, Rear Bedroom Floor: Concrete - Surface cracks, abrasion or wear out noted

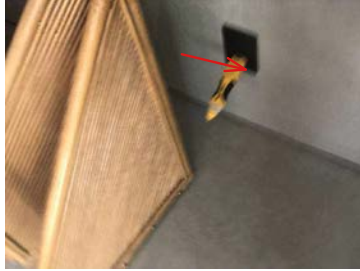
61. Serviceable Electrical: 110 VAC - Faulty outlet with loose, unconnected or crossed wires: One or more

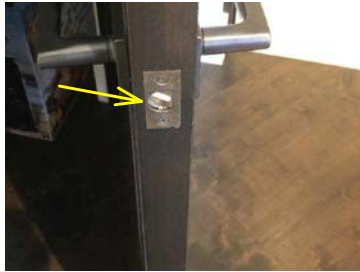
#8 , 1st Floor, Rear Bedroom

64. Serviceable Closet: Closet door - Hardware inoperable or hard to operate.

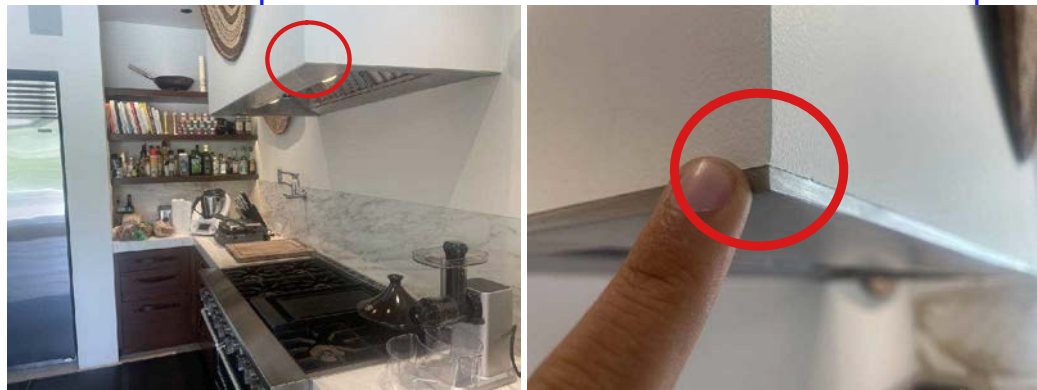
Left Side, Rear Kitchen

- 1. Acceptable Cooking Appliances:
- 2. Needs Attention Ventilator: **Tall persons should use caution near semi sharp edges.**

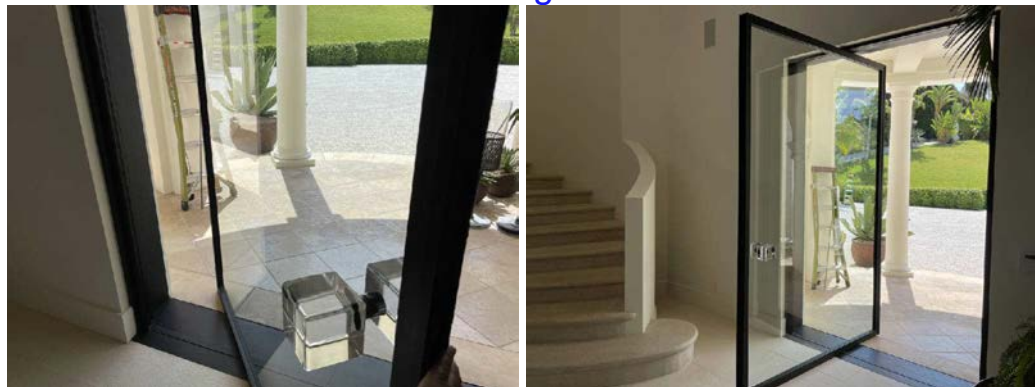
- 10. Not Inspected Closet: Not Applicable
- 11. Acceptable Ceiling: Paint and Paneling
- 12. Acceptable Walls: Paint and paneling
- 13. Acceptable Floor: Tile
- 14. Needs Attention Doors: Metal - [Pivotal door usage needs attention.](#)

16. Entry Hallway Living Space Doors: Metal - Pivotal door usage needs attention.
17. Family Room Living Space Ceiling: Paint and Paneling - Unfinished molding junction line. Resurface and paint as needed.
18. Lounge in the kitchen Living Space Doors: Metal - Pivot Type: Use caution operating this door when children or pets are present, as gap in open position could cause injury to a child or a pet. This notation applies to all similar doors in this property.
19. Lower level center hallway Living Space Floor: Concrete - Surface cracks, abrasion or wear out noted
20. Lower level center hallway Living Space Doors: Aluminum Swing glass - Pivot Type: Use caution operating this door when children or pets are present, as gap in open position could cause injury to a child or a pet. This notation applies to all similar

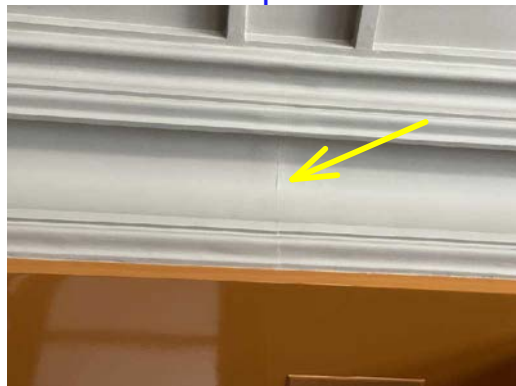
Family Room Living Space

- 37. Not Inspected Closet: Not Applicable
- 38. Needs Attention Ceiling: Paint and Paneling - **Unfinished molding junction line. Resurface and paint as needed.**

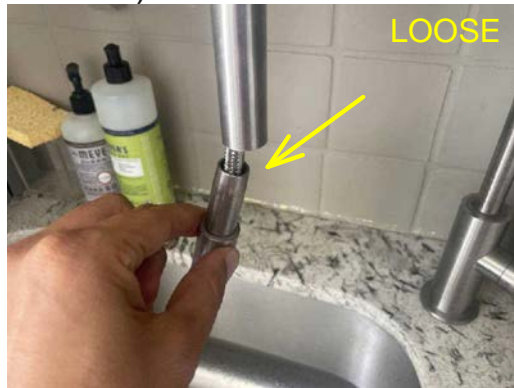
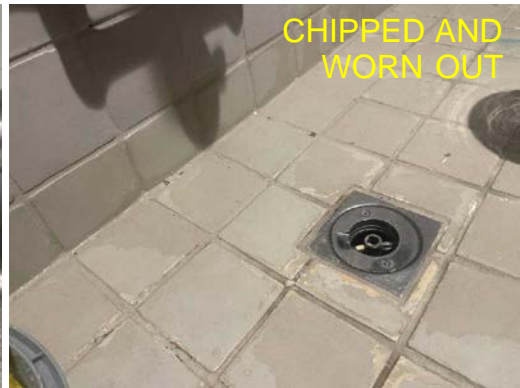
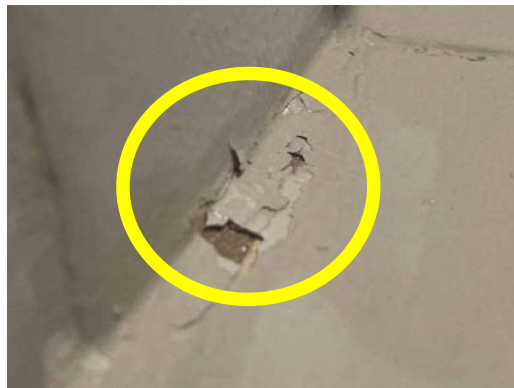
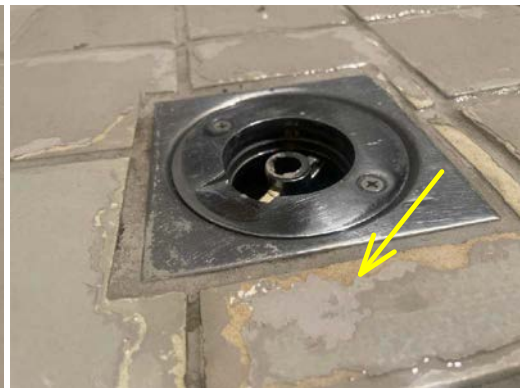
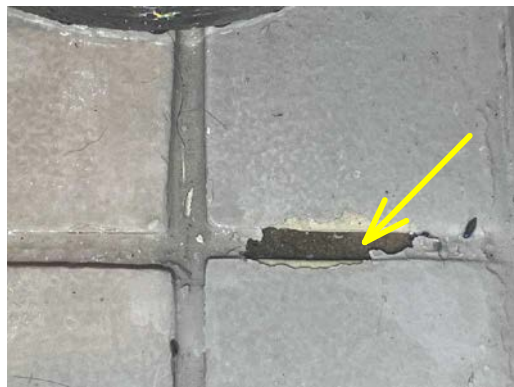
Laundry Tub: Tile, Stainless Steel - 1. Caulking or re caulking will prevent water migration to underside., 2. Loose fixture noted, 3. Chipped tiles noted.
