CITY PROPERTY SERVICES
Commercial & Residential Inspections

Property Inspection Report

Beach property

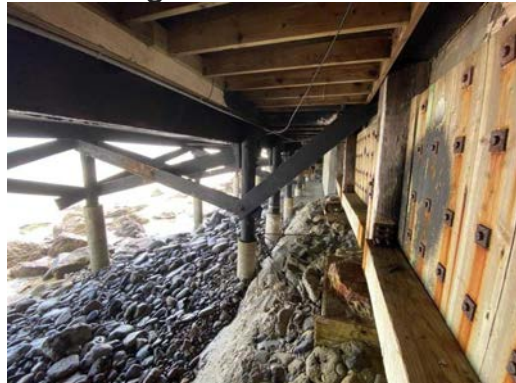
| 5. Needs Attention | Retaining Walls: Wood and Steel bolts |

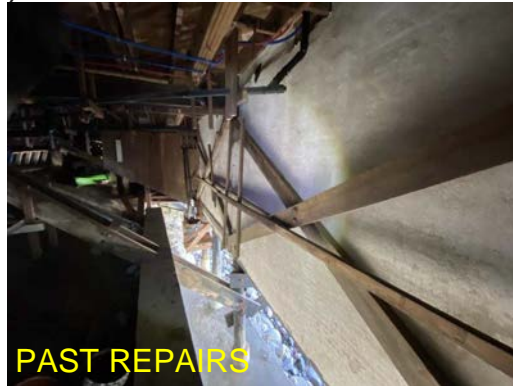
Joists/Trusses: 2x12 - Some of the floor joists show minor and sporadic dry rot. Consult a termite expert to verify if sistering (reinforcing) is needed.

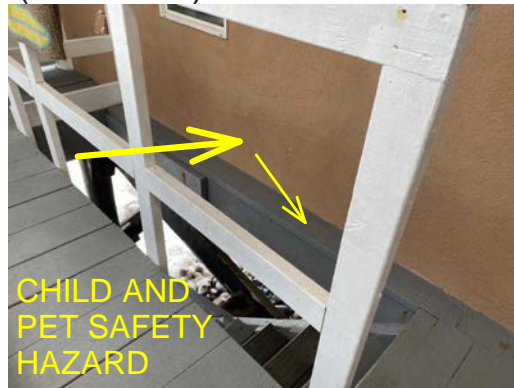
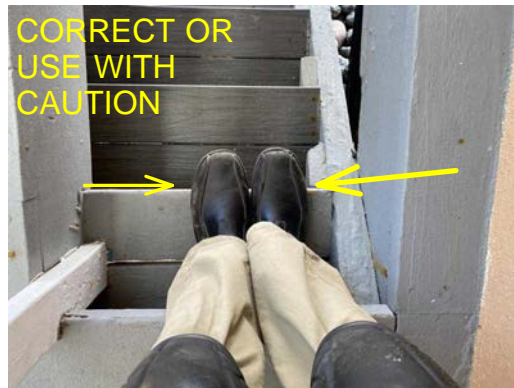
Stairs/Handrails: (continued)

Stairs/Handrails: 1. Balusters / Frame bars are too far apart. At the time of original construction this may have not been a requirement. Child and pet safety. Consult a licensed contractor for remedy and cost, and inquire about your local code, 2. No hand rails installed on stairs leading to beach, 3. Corrosion on balcony metal / wood framing, in different units, noted. Recommend further evaluation by a welder or contractor for any required revitalization, 4. Glass panels close to balcony floors should be tempered glass (safety glass) No print or etching is visible on the glass for verification. Consult a glass installer / expert to verify and take appropriate action if necessary, 5. One or more runs (steps) on stairs to the beach are short in depth and may cause injury hazard. Recommend correction. If correction is not possible, use with caution, install alarming tape /stripe and keep lighted during dark hours.

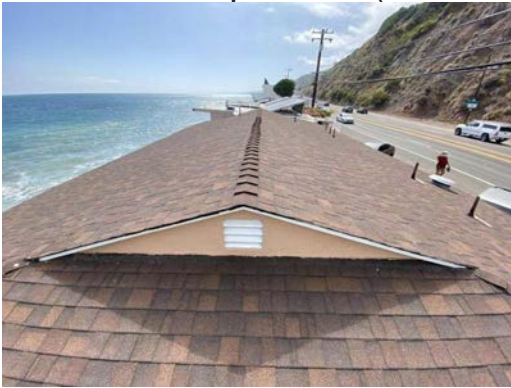
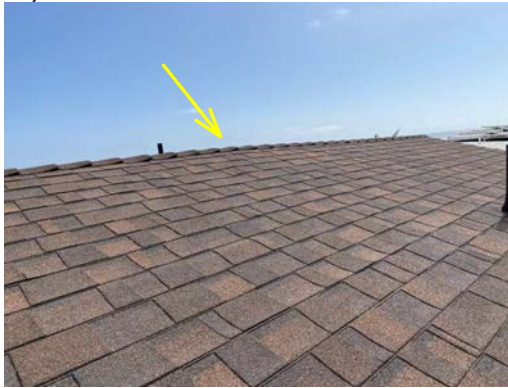
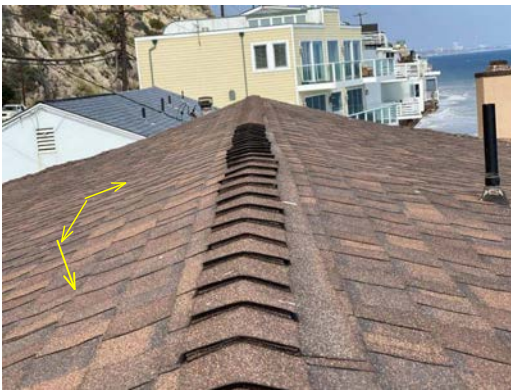
Material: Asphalt shingle - Repair at right side edge is needed to prevent water seepage into the interior.

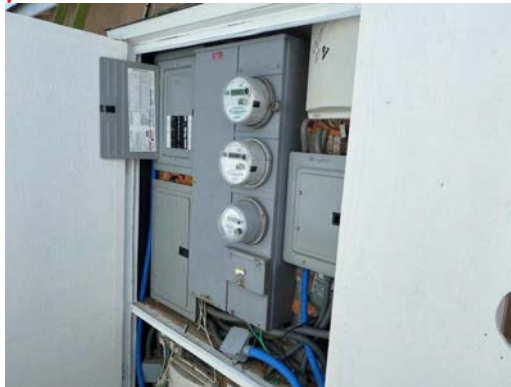
1. Needs Attention Note: All panels are at left side of the complex - 1. The electrical panel condition, though observed, it was erased by mistake. Therefore, re inspection is required to complete this section, which will contain photographs and notations, 2. Re inspection conducted on July 21, 2020 and photos and notations are added to the report which makes this report complete, 3. There are 4 units, but only three meters and breaker panels could be located and no other visible panel could be found.

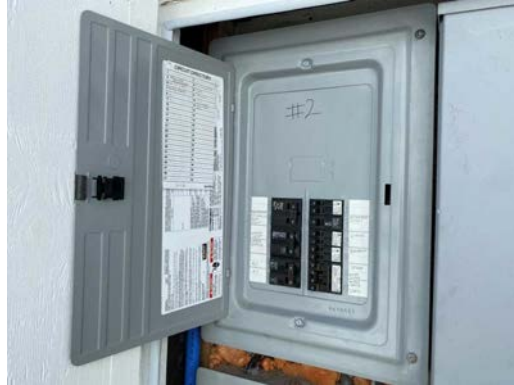
2 , Unit 2 Electric Panel

- 18. Maximum Capacity: 125 Amps
- 19. Acceptable Main Breaker Size: None
- 20. Serviceable Breakers: Copper - **Double taps are present at breakers. These circuits need to be moved to their own circuit breaker and cannot share a breaker. It is recommended that a qualified electrician inspect the new circuits and properly connect the new circuits to an individual breaker for each circuit**

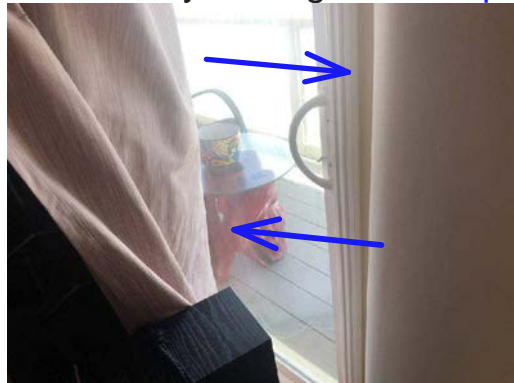
- 3. Not Inspected Closet: Not applicable
- 4. Acceptable Ceiling: Paint and Paneling
- 5. Acceptable Walls: Paint and paneling
- 6. Acceptable Floor: Hardwood
- 7. Serviceable Doors: Vinyl sliding - **Hard operation**

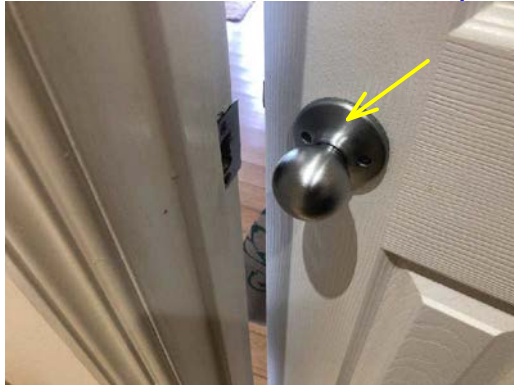
- 38. Not Inspected Closet: Not applicable
- 39. Acceptable Ceiling: Paint and Paneling
- 40. Acceptable Walls: Paint and paneling
- 41. Acceptable Floor: Hardwood
- 42. Acceptable Doors: Wood - **No lock for privacy**

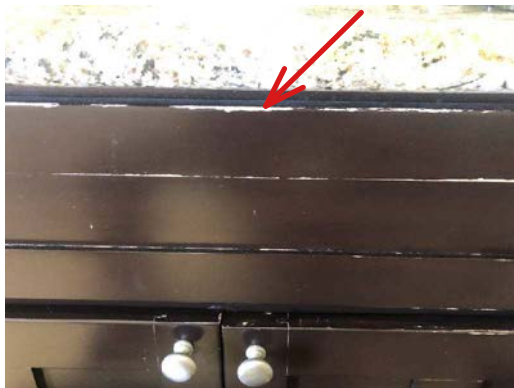
- 43. Not Inspected Windows: Not applicable
- 44. Acceptable Electrical: 110 VAC GFCI
- 45. Needs Attention Counter/Cabinet: Granite and Wood. **Resurfacing and finish needed.**

5. Open to Living Room Kitchen Cabinets: Wood - Open hole noted under the sink. Repair and patch as necessary.
6. Left side, Rear Bathroom Counter/Cabinet: Granite and Wood. Resurfacing and finish needed.
7. Balcony Walls: stucco - May need paint coating soon.

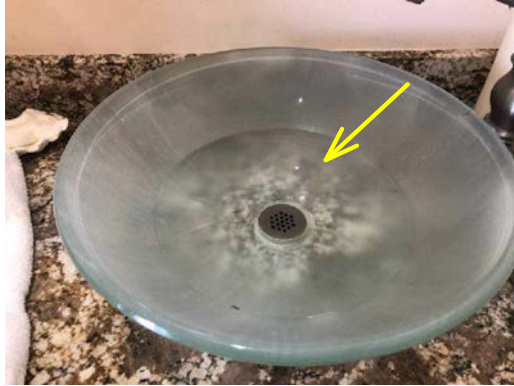
46. Serviceable

Sink/Basin: Molded single bowl - **Slow draining.**

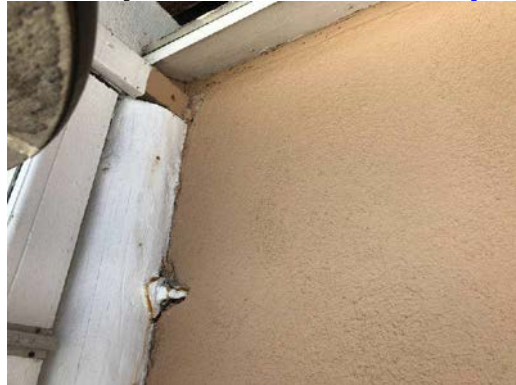
65. Needs Attention

Balcony Walls: stucco - **May need paint coating soon.**

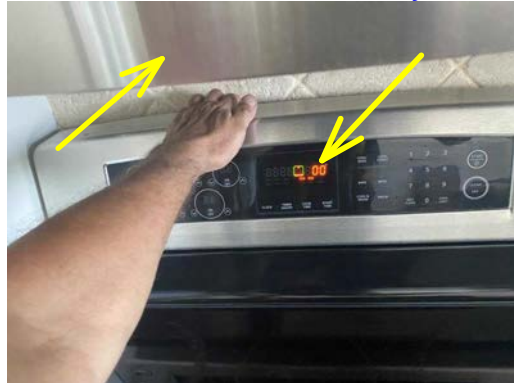
- 12. Serviceable Cooking Appliances: 1.No anti tip is installed (Comes with the new units from manufacturer). Anti tip is an inexpensive bracket that holds the unit from tipping in case the front door is opened and weight is applied on it or a person (child) stands on the door. It secures the Oven Range to the wall or floor. This was tested simply by pulling back on the unit. A safety notation, 2. One plate not functional.

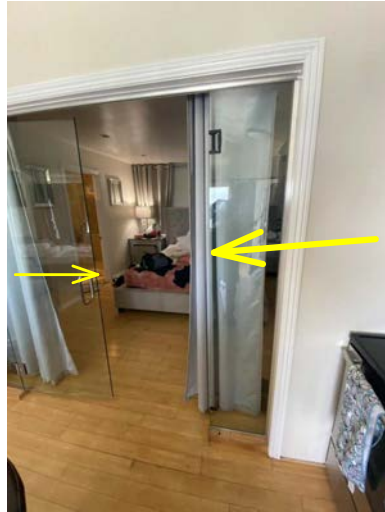
Ceiling: Paint and Paneling
Walls: Paint and Paneling
Floor: Hardwood
Doors: Wood - **Half installed.**

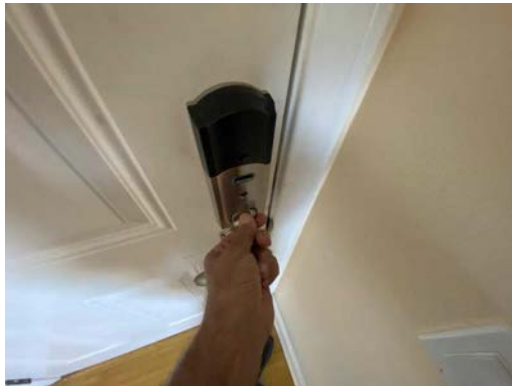
- 7. Needs Attention Doors: Wood And sliding vinyl - **Entry door require push to engage lock.**

11. Living Room Living Space Floor: Hardwood - Worn, surface damaged or abraded floor.
12. Living Room Living Space Doors: Wood And sliding vinyl - Entry door require push to engage lock.

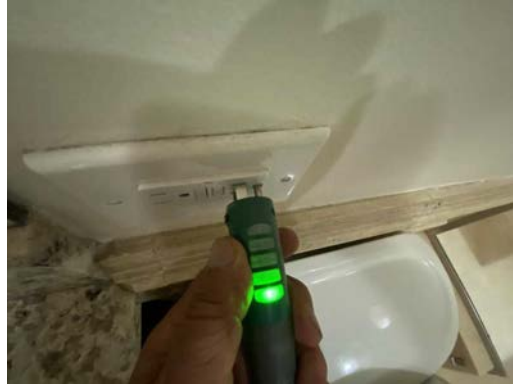
44. Serviceable

Electrical: 110 VAC GFCI - **Hard to plug in.**

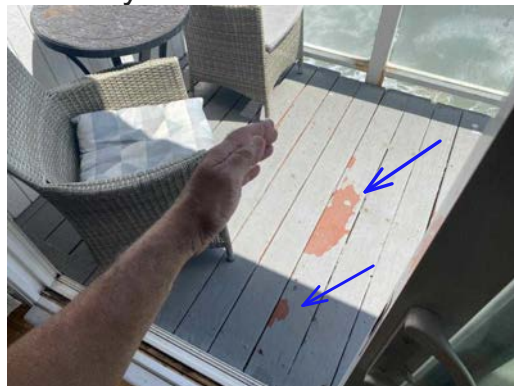
Balcony Floors: Wood or Resin

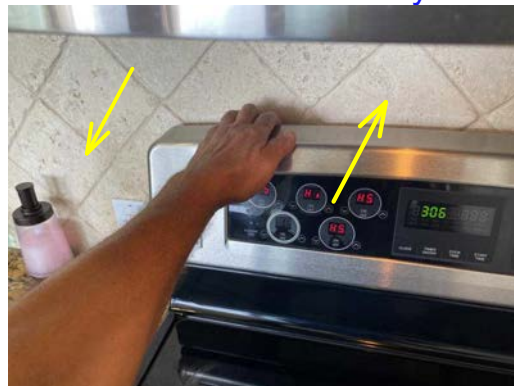
12. Needs Attention

Cooking Appliances: 1. No anti tip is installed (Comes with the new units from manufacturer). Anti tip is an inexpensive bracket that holds the unit from tipping in case the front door is opened and weight is applied on it or a person (child) stands on the door. It secures the Oven Range to the wall or floor. This was tested simply by pulling back on the unit. A safety notation, 2. Hot plate issue

13. Kitchen Cooking Appliances: 1.No anti tip is installed (Comes with the new units from manufacturer). Anti tip is an inexpensive bracket that holds the unit from tipping in case the front door is opened and weight is applied on it or a person (child) stands on the door. It secures the Oven Range to the wall or floor. This was tested simply by pulling back on the unit. A safety notation, 2. One hot plate not functional or with delay.
14. Kitchen Cabinets: Wood - Knob missing.
