**CITY PROPERTY SERVICES**  
Commercial & Residential Inspections

# Property Inspection Report

**Sample Report Address**

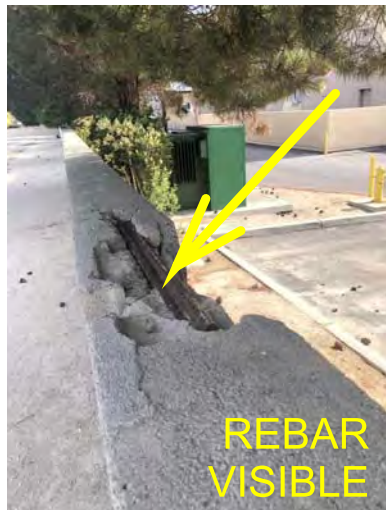
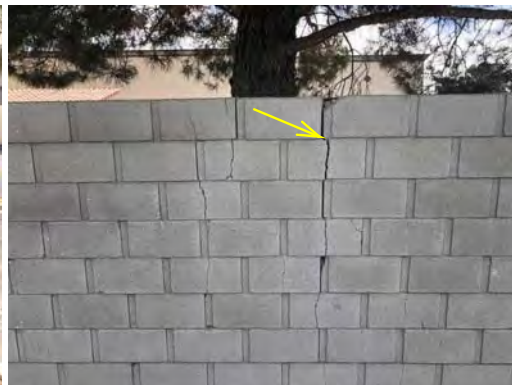
Fences: Chain link, Block - Fences need attention or repair due to: Cracks, sharp edges, corrosion, wobbling or erosion.

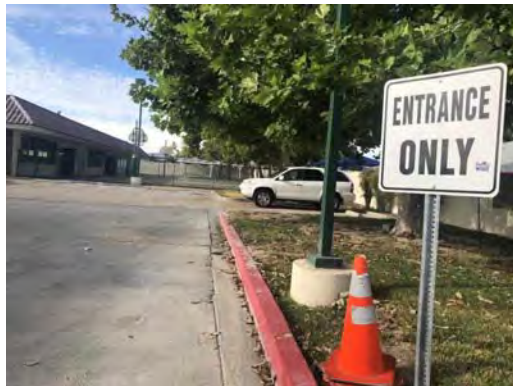
18. Needs Attention Parking Lot: Concrete, Asphalt - (1) Needs to be resurfaced, (2) Lines need to be re-striped (3) Trip hazards & Cracks noted.

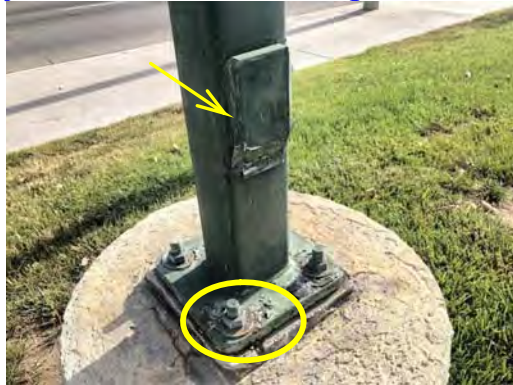
Parking Lot Lighting: Pole light - Exposed wiring, water pregnable junction boxes / fittings and corrosion noted.

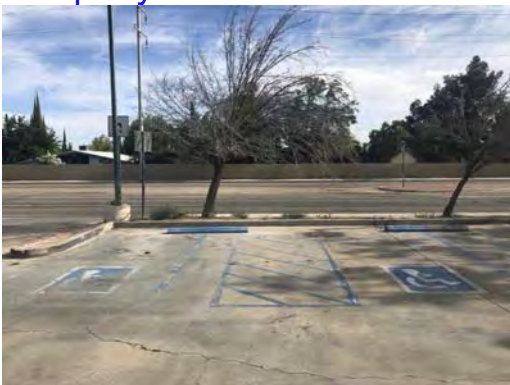
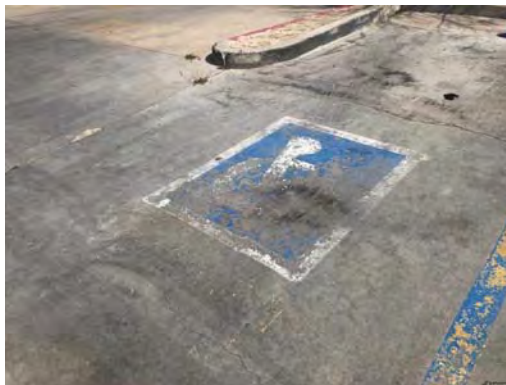
20. Access ADA Compliant: No ADA notations: (1) Faded, insufficient or improper signage noted. Parking lot ADA need to be revitalized. (2) Some of the doors, restrooms, and other standards may not be in compliance with ADA standards. Consult a paving company

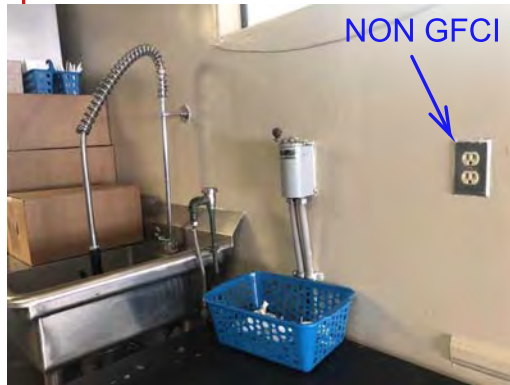
1. Access ADA Compliant: No [See notations in "Lots and Grounds" category in this report.](#)
2. Acceptable Entrance Door: Metal
3. Needs Attention Stairs/Handrails: Metal stairs with metal handrails - [See steps and stoops in Lots and Grounds.](#)
4. Emergency lighting present? Yes [Consult a contractor for compliance.](#)
5. Acceptable Ceilings: Suspended ceiling, Paint and Paneling
6. Acceptable Walls: Paint and paneling
7. Acceptable Floors: Carpet
8. Not Inspected Windows: Not Applicable
9. Acceptable Electrical: 110 VAC - **Non-GFCI or GFCI labeled outlet. Consult a qualified Electrician.**

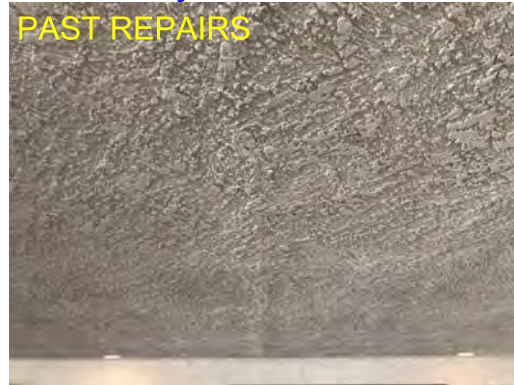
Type: Stucco - (1) Past repairs noted (2) Any cracks or opening should sealed and patched and painted to prevent further decay and water entry into the interior.

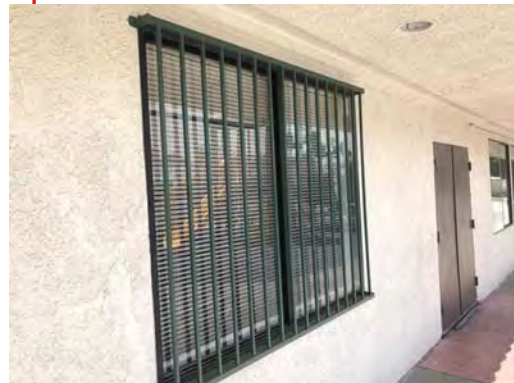
Windows: Alumimum, Slider - One function of a window is escape route for fire or earthquake. Security bars should swing open and be operable from inside in case of an emergency.

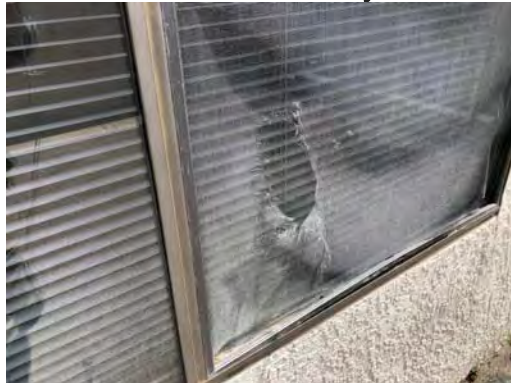
9. Needs Attention Window Screens: Vinyl mesh - One or more are damaged.

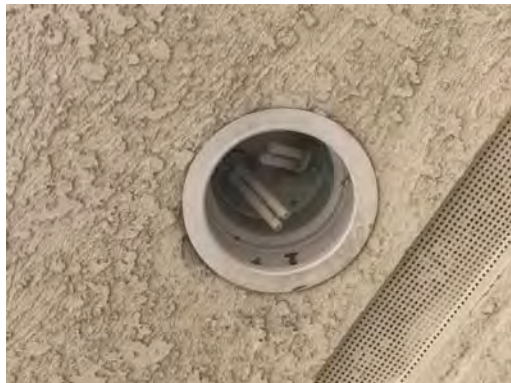
Exterior Lighting: Surface mount - Many are missing lens cover. Some are loose.

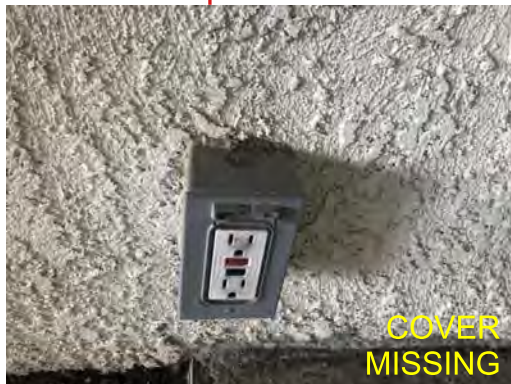
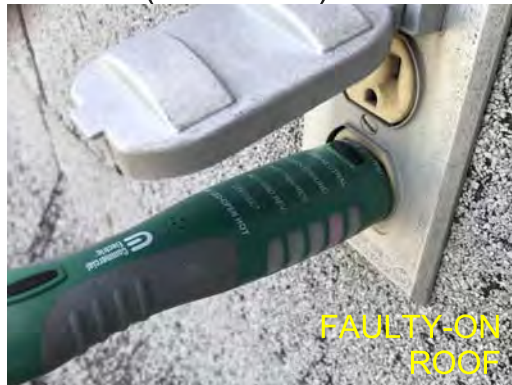
Exterior Electric Outlets: (1) One or more are not GFCI or GFCI labeled outlets. Consult a qualified electrician for remedy and cost. Faulty outlet with unconnected, loose or crossed wires (2) One or more are exposed and should have cover (3) One or more are faulty.

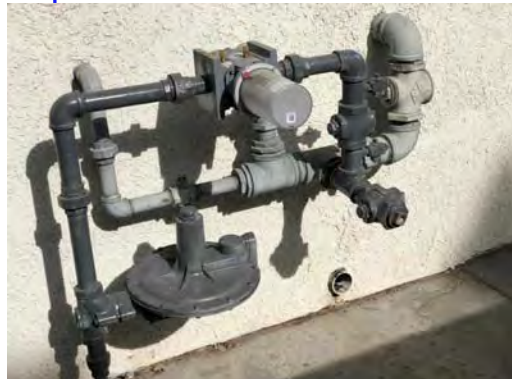
Gas Meter: Left Side - Equipped with Earth Quake shut of valve. Earth Quake Shut off Valves should be checked by a qualified plumber for functionality and defects check at least every two years. Inquire with owner for last testing done.

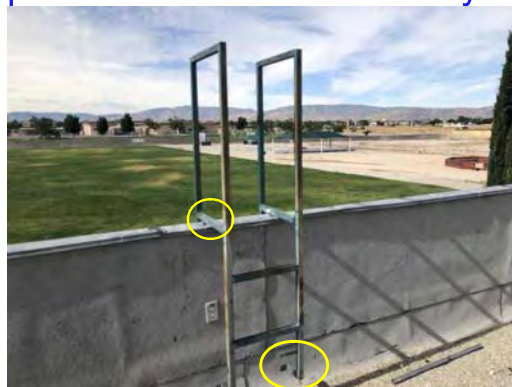
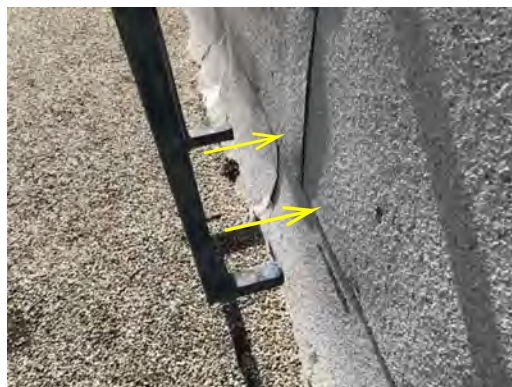
2. Serviceable Roof Access Ladder Safety and Liability Notation: Both of the attached metal roof ladders wobble slightly: The bolts are loose due to unattached lower bar extensions and applied force by weight of the user. Recommend installing filler of some sort, between the lower section and the roof parapet walls to prevent wobbling and looseness progression. Timely sanding and painting of these components prevent corrosion and decay.

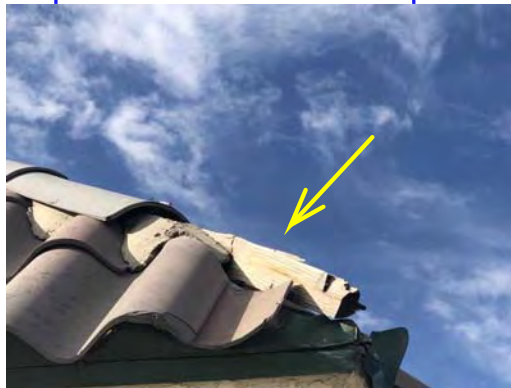
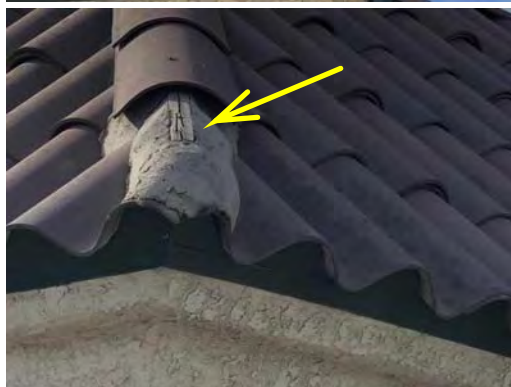
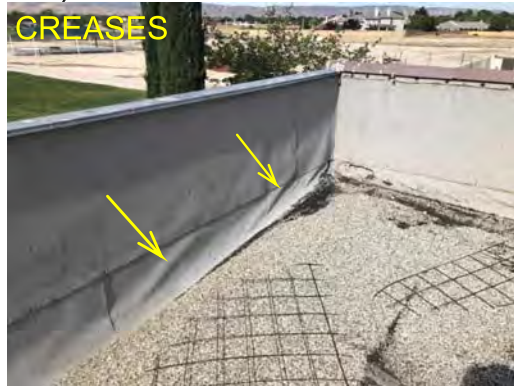
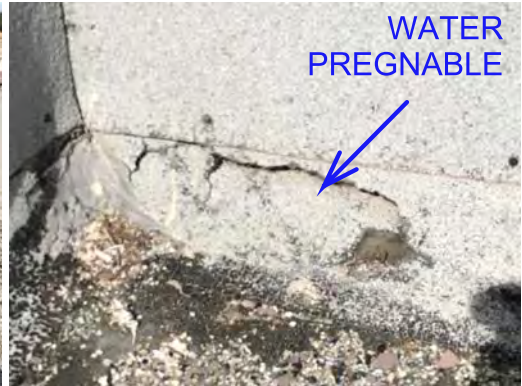
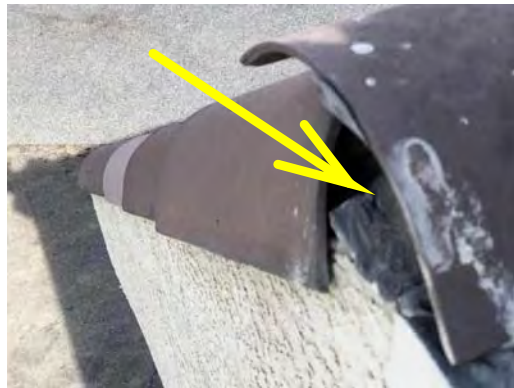
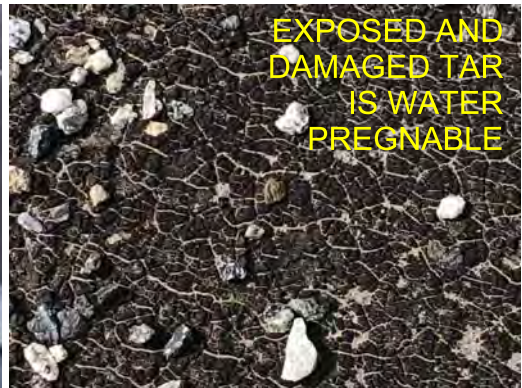
Material: Tar and gravel and Roll Asphalet sheathing - (1) Missing cap tiles noted. Install to prevent water migration to underside (2) Roof tiles show past moss build up stains. If excessive moss activity is noted in the future, pressure washing is recommended. Roof should be checked for routine maintenance and repairs on yearly basis, before rain season (3) Parapet wall asphalt sheathing show creases that could break and become water pregnable. Monitor to take corrective action as necessary (4) Damage and water pregnable spots on asphalt sheathing material noted. Repair and seal to prevent water intrusion into the interior (5) Exposed tar material on roof deck is evident at many areas. Recommend repair by a professional roofer (6) Recent improper repairs that pond water noted (7) Roof is spongy when walked on. Reinforcement of the roof framing or deck may be required. Consult with a professional roofer or a framing expert.

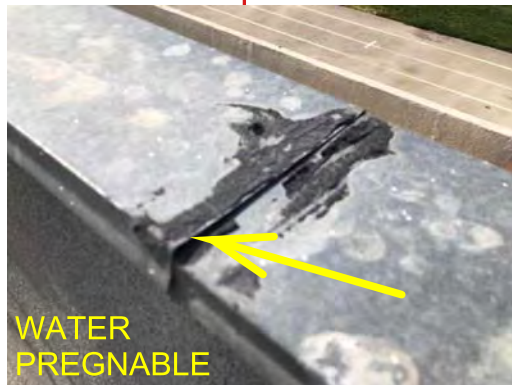
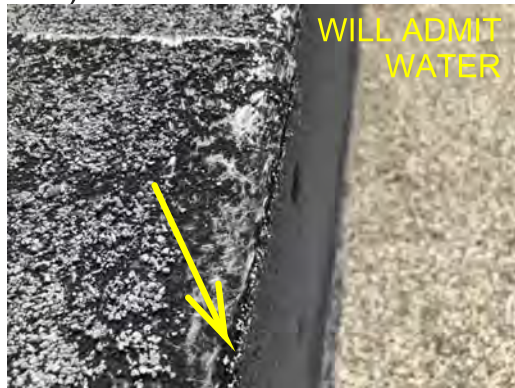
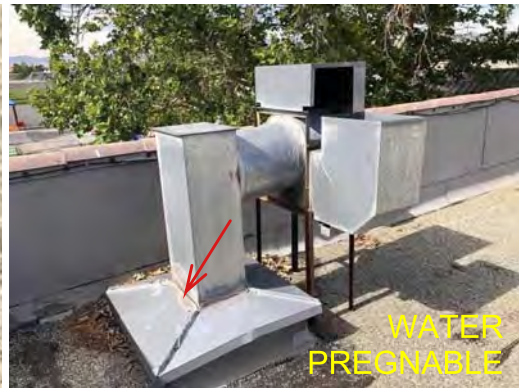
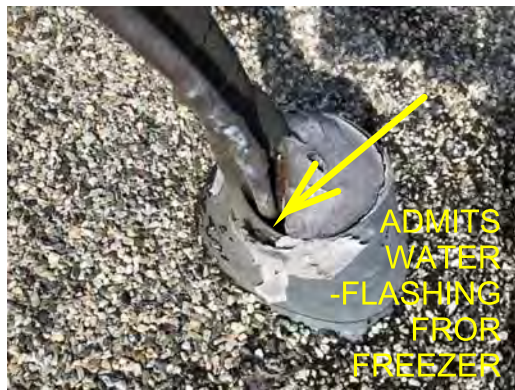
8. Serviceable Flashing: Aluminum - (1) Some need patching (2) Some are worn out and due for replacement

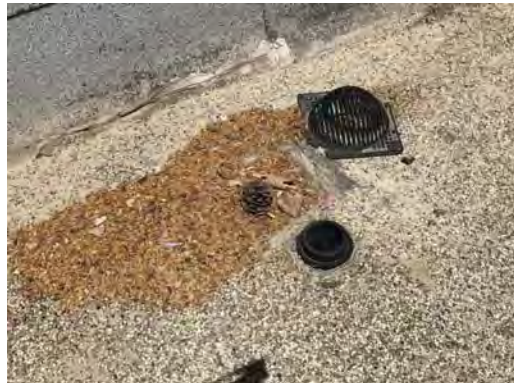
Roof Drains: Slope Drain, Scupper - Some of the roof drains are stuffed and some covers are displaced. Repair as necessary.

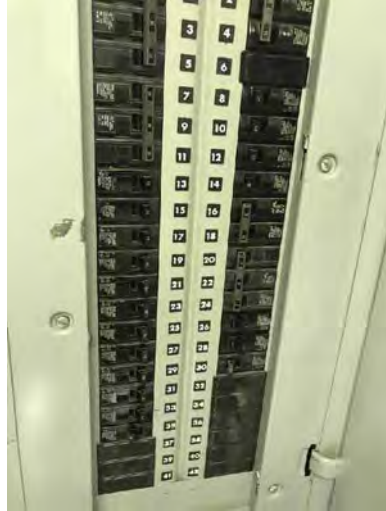
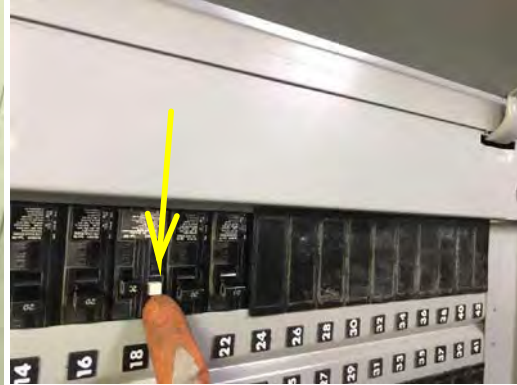
Main Breaker Size:  
Breakers: Copper - #18 has GFCI or AFCI but not functional

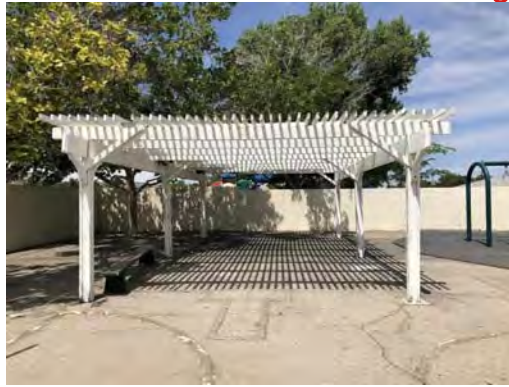
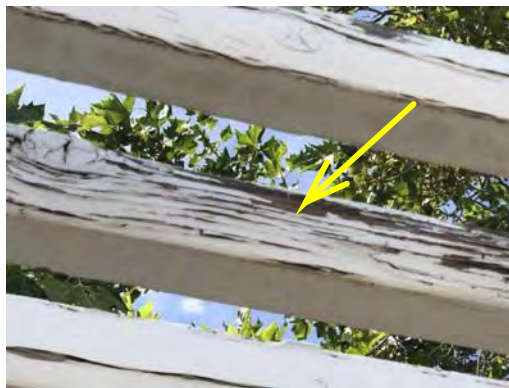
Beams: Solid wood - (1) **Safety and Liability Notation: The overhang structure at right side play ground is not plumb and wobbles slightly. Consult with a framer to verify if reinforcement is needed** (2) This structure is due for resurfacing and paint coating.

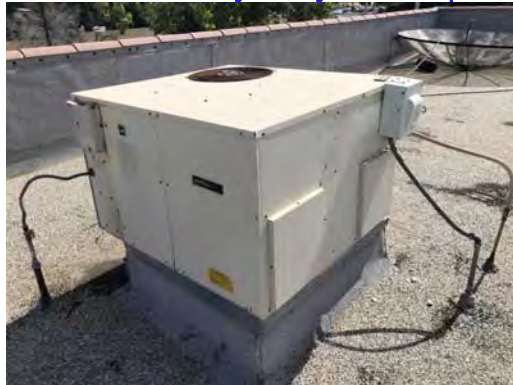
A/C System Operation: Functional at the time of inspection - HVAC package units (cold and heat in one closet) are aged and require attention and yearly tune up, as a long term maintenance plan.

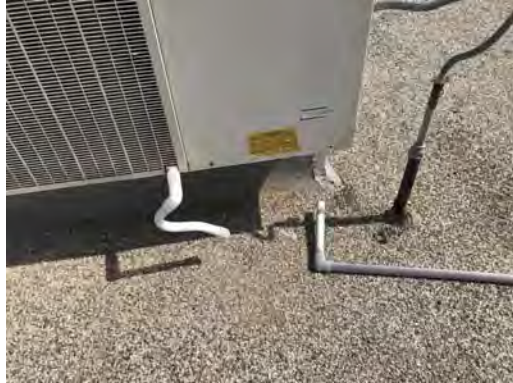
2. Needs Attention Condensate Removal: PVC - One or moer are broken.

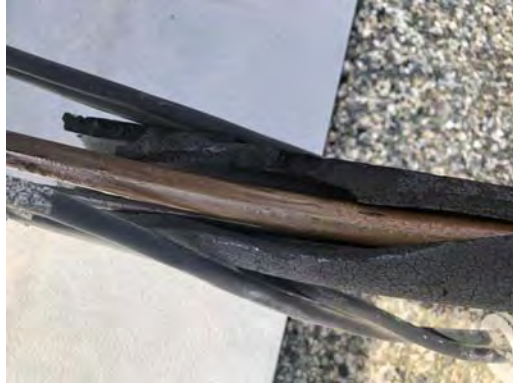
Refrigerant Lines: High pressure, Low pressure - For the split unit, insulation is due for replacement.

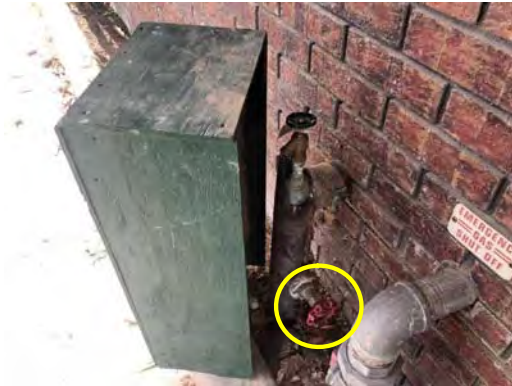
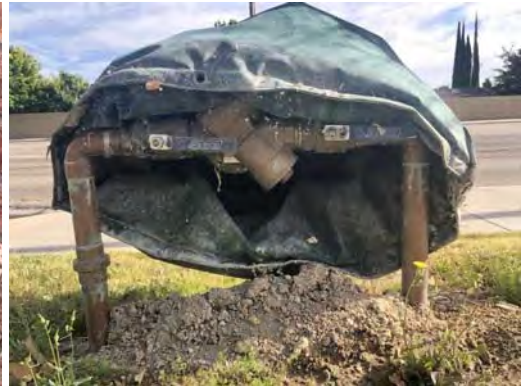
| 4. Serviceable | Drain Pipes: ABS and Cast Iron - <a href="#">Separation noted. Repair as necessary.</a> |

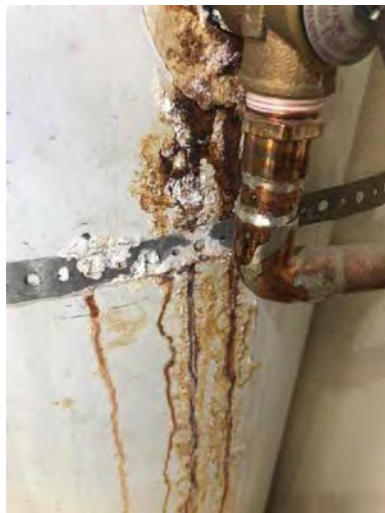
Water Heater Operation: Functional at time of inspection - (1) Evidence of past or present water leakage in drain tube from pressure relief valve. (2) Earthquake support straps missing or not properly installed (3) Water heater is due for replacement as it is aged and shows signs of malfunction and leakage.

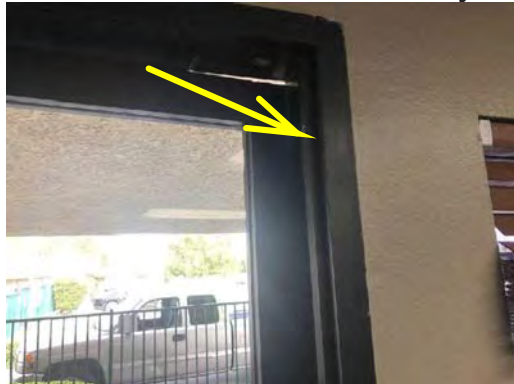
14. Serviceable Doors: aluminum, Also entry - **The door sticks**

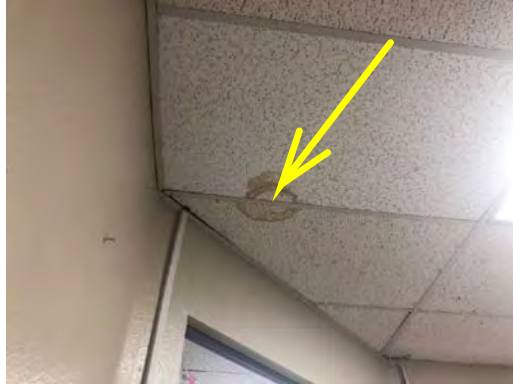
20. Needs Attention Ceiling: Suspended ceiling - Water stains present

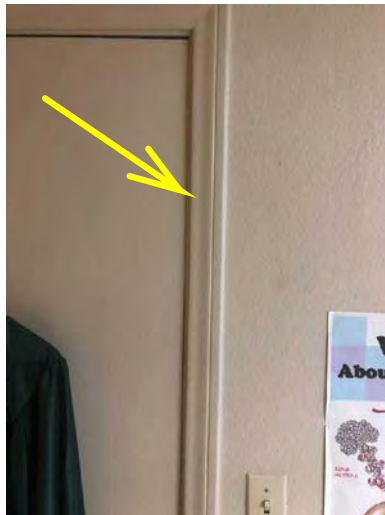
Doors: Wood - The door sticks

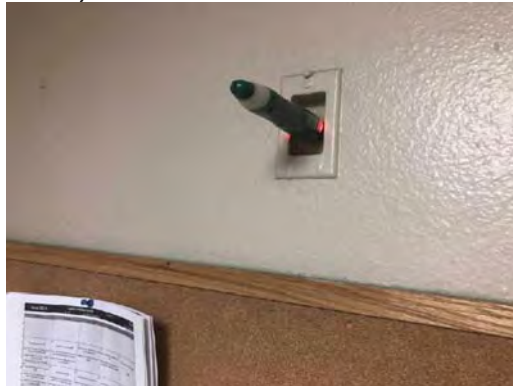
Electrical: 110 VAC, 110 VAC GFCI - Faulty outlet with loose, disconnected or crossed wires.

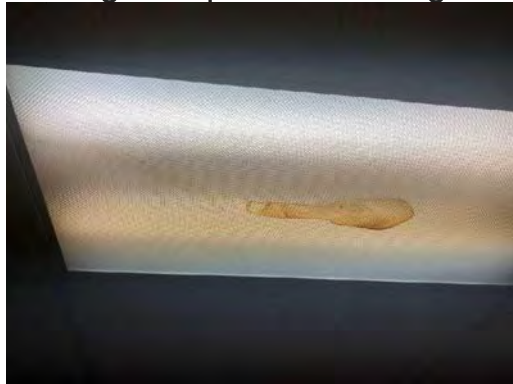
29. Needs Attention Ceiling: Suspended ceiling - **Water stains present**

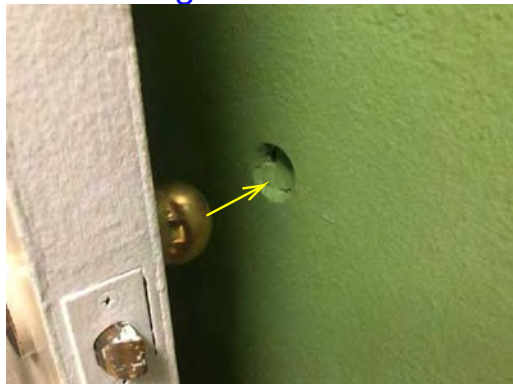
Walls: Paint and paneling - **Installation of door stopper will prevent wall damage.**

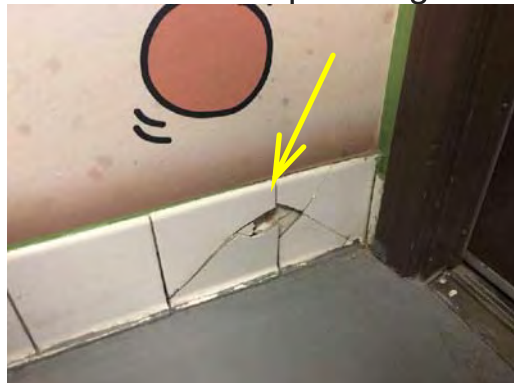
Walls: Paint and paneling - Broken base board tile

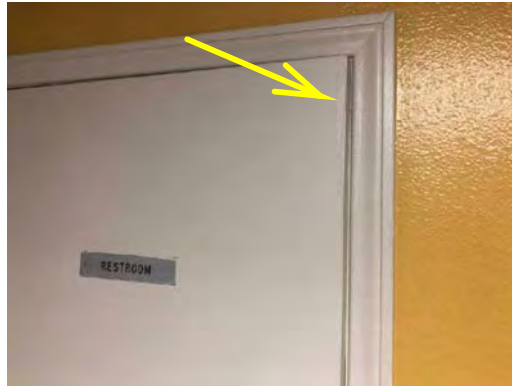
Doors: Wood - [Door sticks](#)

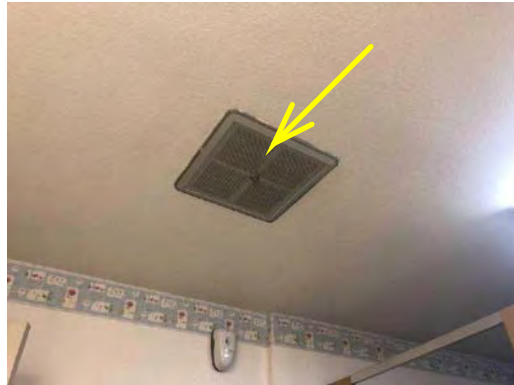
- 26. Acceptable Sink/Basin: Porcelain
- 27. Acceptable Faucets/Traps: Metal / PVC
- 28. Not Inspected Shower/Surround: Not applicable
- 29. Not Inspected Urinals: Not applicable
- 30. Acceptable Toilets:
- 31. Acceptable Grab Bars: Metal
- 32. Acceptable Partitions: Stall with door
- 33. Not Inspected HVAC Source: Not applicable
- 34. Serviceable Ventilation: Electric ventilation fan - **Fan inoperative**

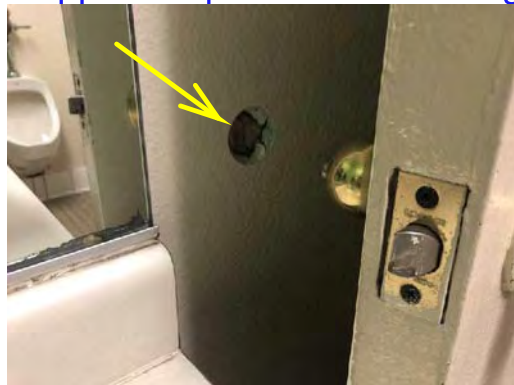
- 37. Acceptable Ceiling: Paint and Paneling
- 38. Serviceable Walls: Paint and paneling - **Damaged by door handle. Installing door stopper will prevent such damage, here and in other rooms.**

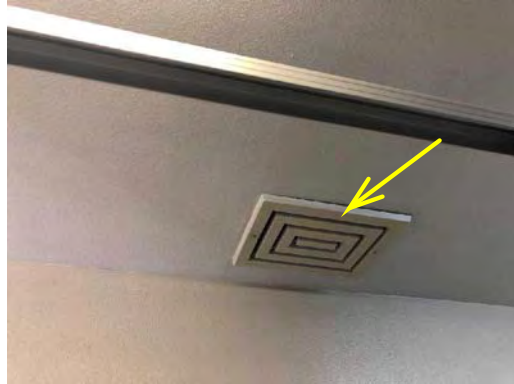
Ventilation: Electric ventilation fan - Fan inoperative

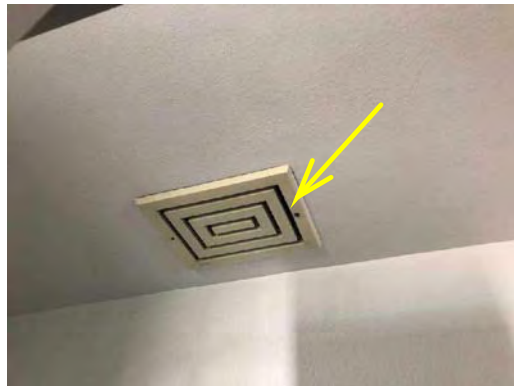
HVAC Source: Not applicable  
 Ventilation: Electric ventilation fan - **Fan inoperative**

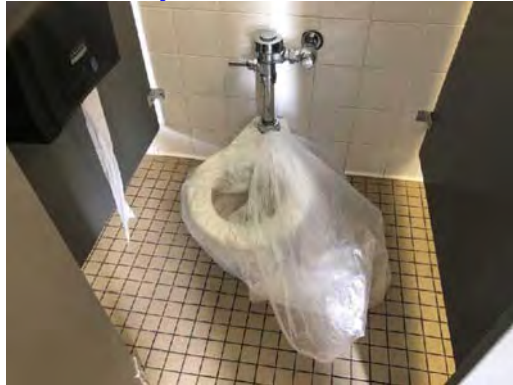
Toilets: American Standard - **Not flushing. Repair / Replace as necessary**

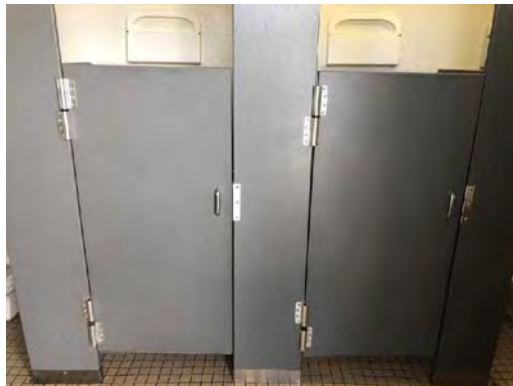
Partitions: Stall with door - **Non ADA compliance.**

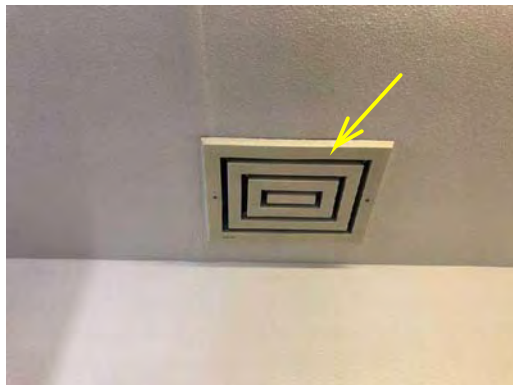
Ventilation: Electric ventilation fan - **Fan inoperative**

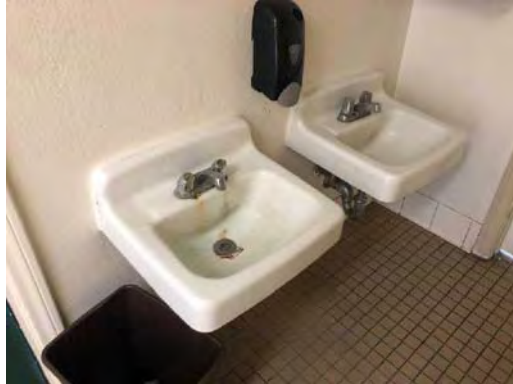
- 112. Acceptable Doors: Wood
- 113. Not Inspected Windows: Not applicable
- 114. Acceptable Electrical: 110 VAC
- 115. Not Inspected Counter/Cabinet: Not applicable
- 116. Serviceable Sink/Basin: Porcelain - **(1)Chipped (2) Low water pressure and leaking faucet: One or more**

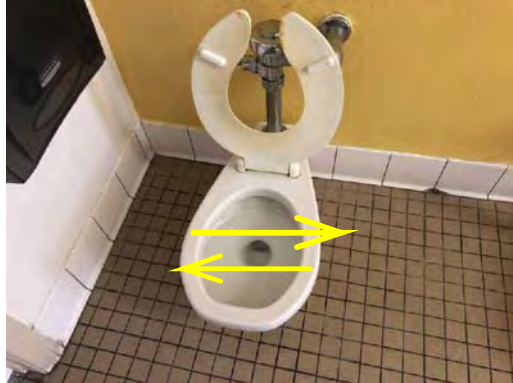
Faucets/Traps: Metal / Metal  
Shower/Surround: Not applicable  
Urinals: Not applicable  
Toilets: American Standard - **The toilet is loose.**

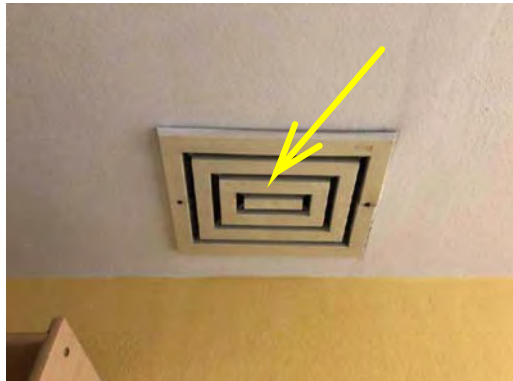
Grab Bars: **Missing. ADA non-compliance.**  
Partitions: None  
HVAC Source: Not applicable  
Ventilation: Electric ventilation fan - **Fan inoperative**

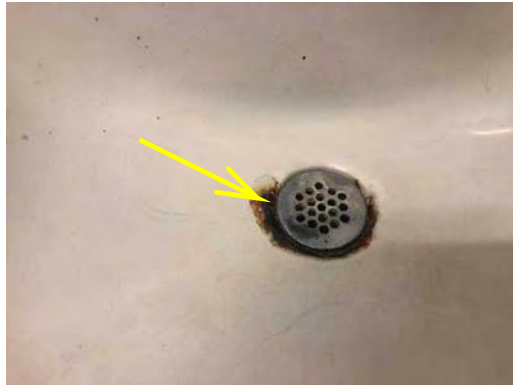
- 125. ADA Compliant No
- 126. Emergency lighting present? No  
Z4 (Class rooms at right side of the property) for room 14 and 15 boys Room Rest Room -
- 127. Acceptable Ceiling: Paint and Paneling
- 128. Acceptable Walls: Paint and paneling
- 129. Acceptable Floor: Tile
- 130. Acceptable Doors: Wood
- 131. Not Inspected Windows: Not applicable
- 132. Acceptable Electrical: 110 VAC
- 133. Not Inspected Counter/Cabinet: Not applicable
- 134. Serviceable Sink/Basin: Porcelain - **Chipped / Corroded. Prone to leakage at any time.**

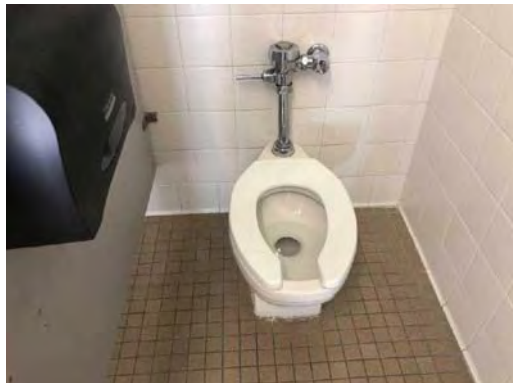
- 135. Acceptable Faucets/Traps: Metal / Metal
- 136. Not Inspected Shower/Surround: Not applicable
- 137. Not Inspected Urinals: Not applicable
- 138. Serviceable Toilets: American Standard - **Water continues to run after flushing**

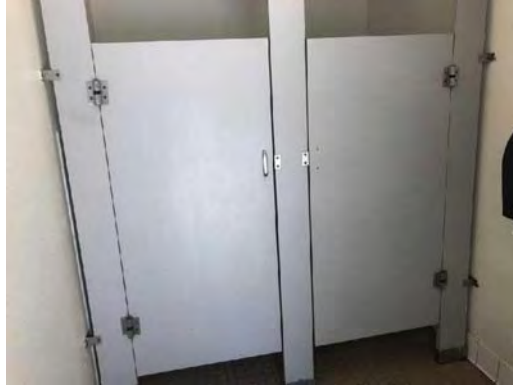
Partitions: Stall with door - **ADA Non-Compliance.**

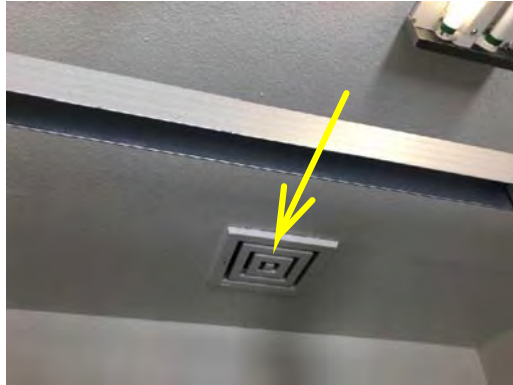
Ventilation: Electric ventilation fan - **Fan inoperative**

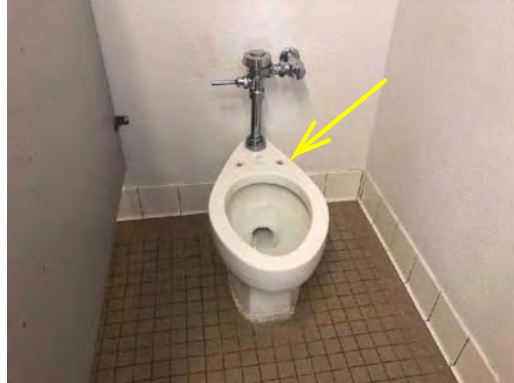
Urinals: Not applicable  
 Toilets: American Standard - **Missing top**

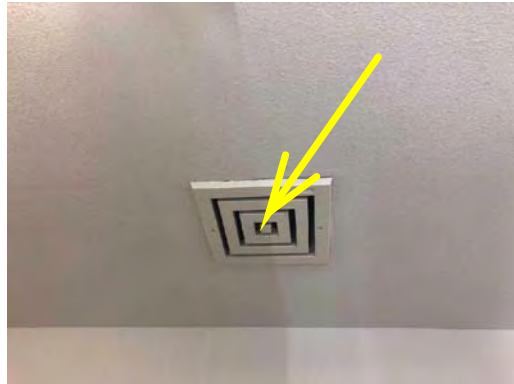
Grab Bars: **Missing. ADA non-compliance.**  
 Partitions: Stall with door - **Missing. ADA non-compliance.**  
 HVAC Source: Not applicable  
 Ventilation: Electric ventilation fan - **Fan inoperative**

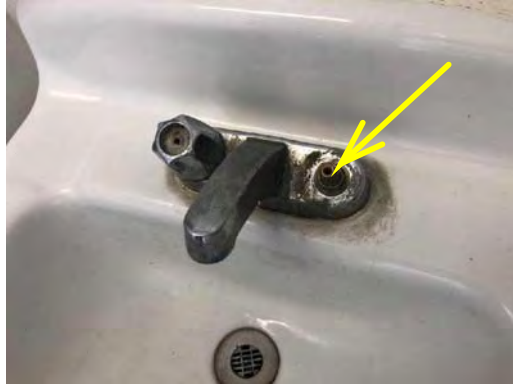
Sink/Basin: Porcelain - **Missing fixture.**

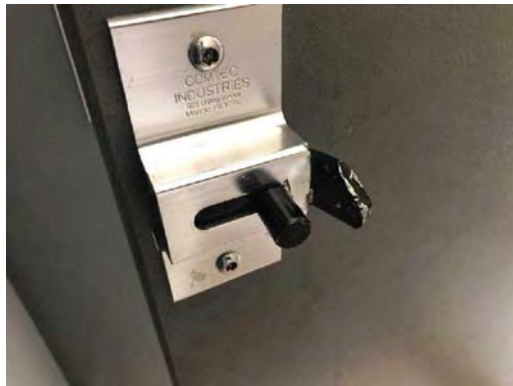
171. Acceptable  
172. Not Inspected  
173. Not Inspected  
174. Acceptable  
175. Not Inspected  
176. Serviceable

Faucets/Traps: Metal / Metal  
Shower/Surround: Not applicable  
Urinals: Not applicable  
Toilets: American Standard  
Grab Bars: **Missing.**  
Partitions: Stall with door - **Loose or missing hardware**

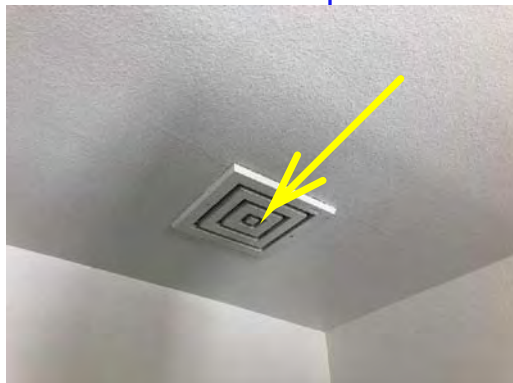
177. Not Inspected  
178. Serviceable

HVAC Source: Not applicable  
Ventilation: **Fan inoperative**

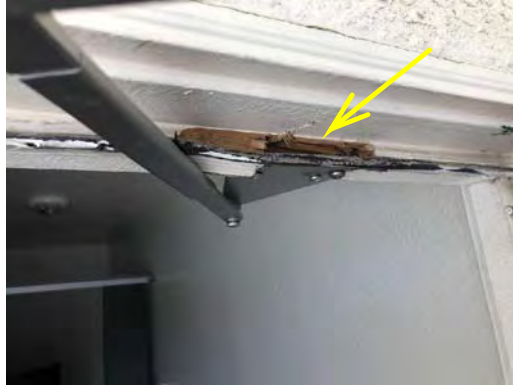
184. Serviceable

Doors: Wood - **Repair needed**

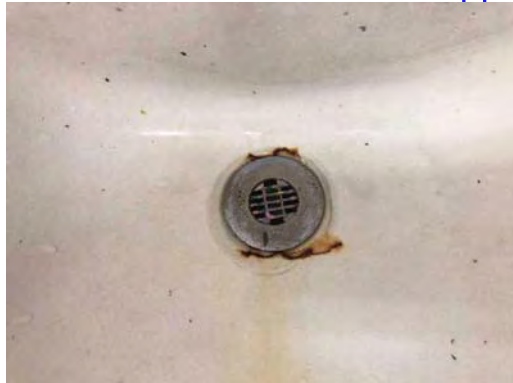
188. Serviceable

Sink/Basin: Porcelain - **Chipped. Prone to leakage.**

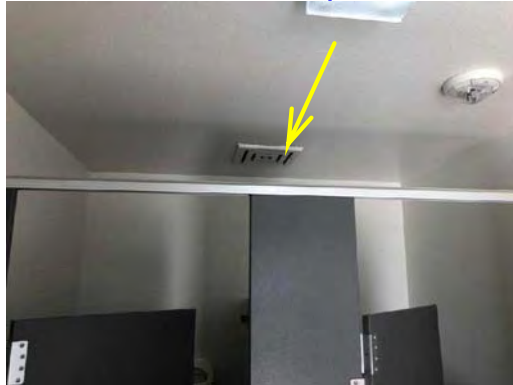
- 195. Not Inspected HVAC Source: Not applicable
- 196. Serviceable Ventilation: **Fan inoperative**

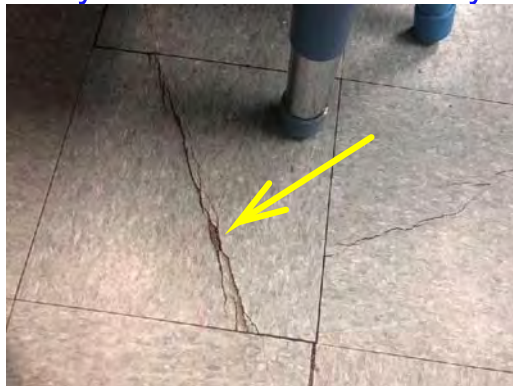
6. Needs Attention

Floor: Linoleum - (1) Damaged floor (2) Asbestos Presence

Possibility Here or in other rooms: The adhesion mastic under vinyl tiles may contain asbestos. Any change or modification here should be done cautiously and properly. Consult with an asbestos expert to verify if removal is necessary.

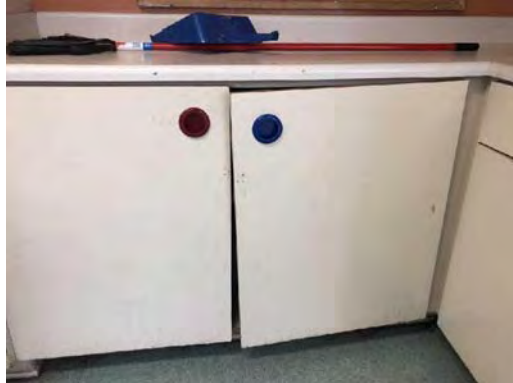
- 13. Serviceable      Closet: Shelves - [Door off hinge.](#)

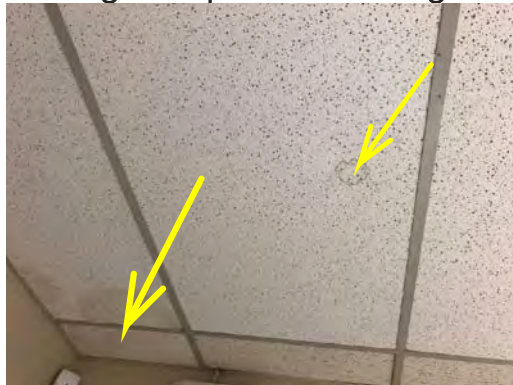
- 14. Needs Attention      Ceiling: Suspended ceiling - [Water stains present](#)

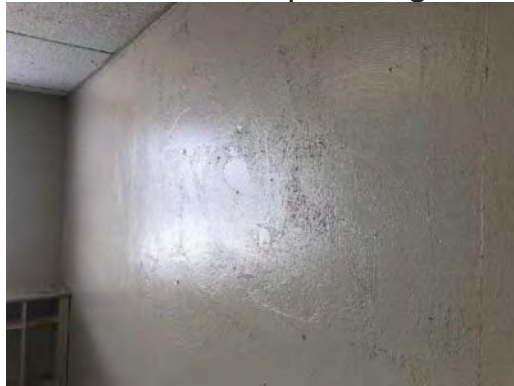
15. Needs Attention Walls: Paint and paneling - Evidence of past repair or damage

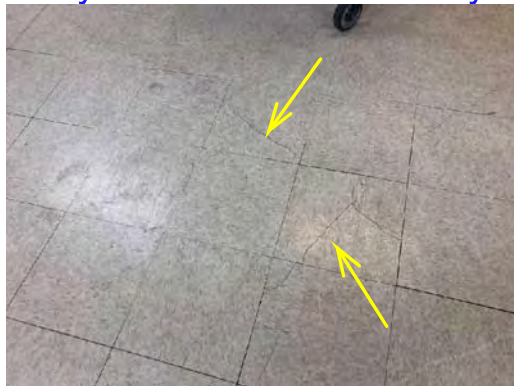
16. Serviceable

Floor: Linoleum - (1) Damaged floor (2) Asbestos Presence  
Possibility Here or in other rooms: The adhesion mastic under vinyl tiles may contain asbestos. Any change or modification here should be done cautiously and properly. Consult with an asbestos expert to verify if removal is necessary.

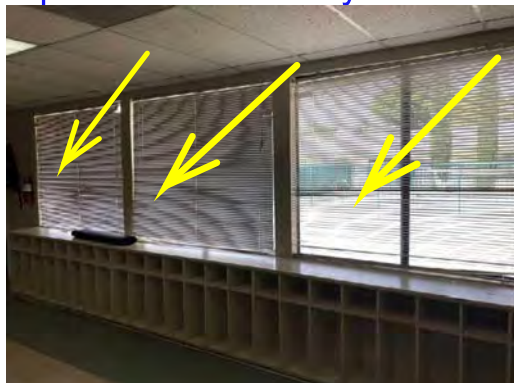
18. Serviceable

Windows: Aluminum slider - Hard operation. Lubricate, repair or replace as necessary.

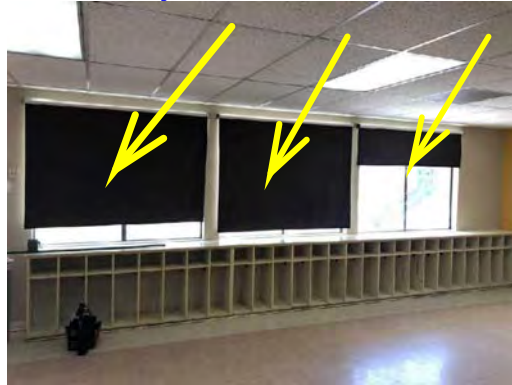
27. Serviceable Windows: Aluminum slider - Lubricate, repair or replace as necessary.

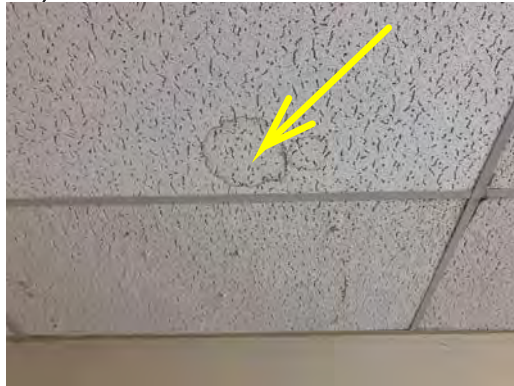
Ceiling: (continued)

31. Acceptable Closet: Shelves  
32. Needs Attention Ceiling: Suspended ceiling - Water stains present: Source and cause could relate to A/C condensation, plumbing leakage or leakage from roof.

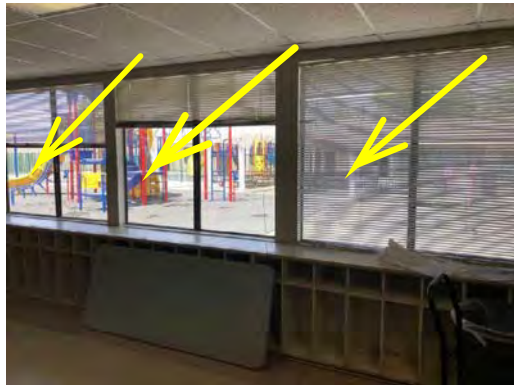
36. Serviceable

Windows: Aluminum slider - **Missing screen**

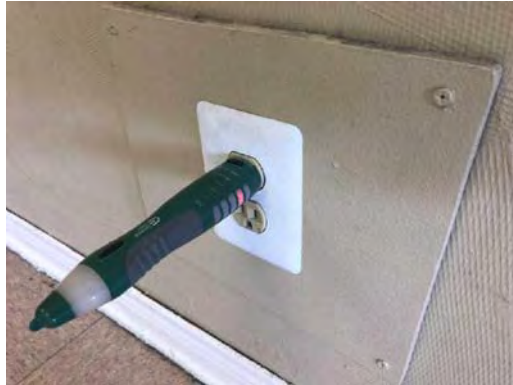
37. Serviceable

Electrical: 110 VAC - **Faulty outlet with loose, disconnected or crossed wires.**

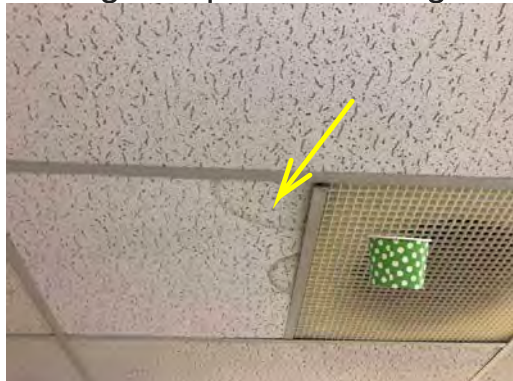
41. Needs Attention Ceiling: Suspended ceiling - **Water stains present**

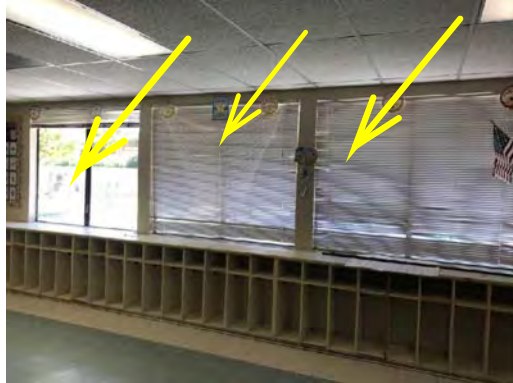
45. Serviceable

Windows: Aluminum slider - (1) Missing screen (2) Hard operation.  
Lubricate, repair or replace as necessary.

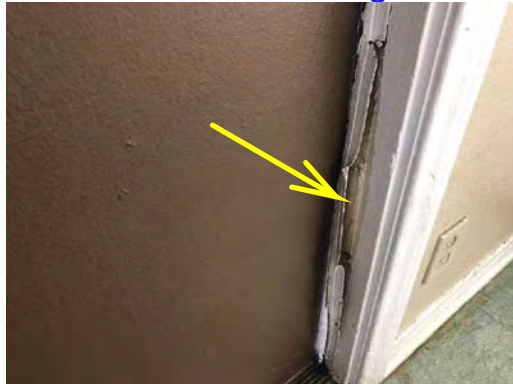
Floor: Linoleum  
Doors: Wood - **Damaged frame or edge molding.**

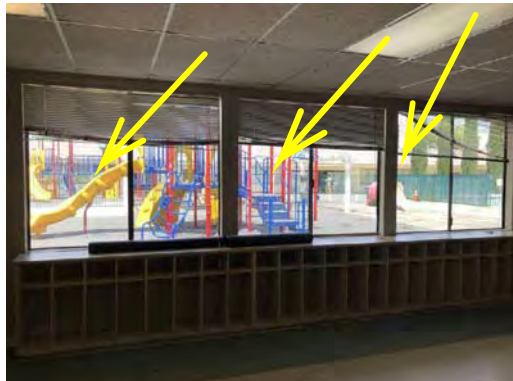
- 54. Serviceable

Windows: Aluminum slider - **Missing screen**

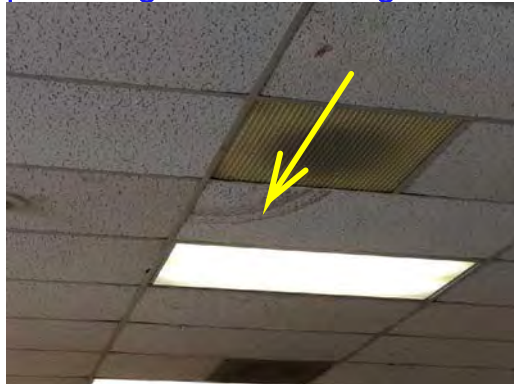
58. Acceptable Closet: Shelves  
59. Needs Attention Ceiling: Suspended ceiling - Stains due to A/C condensation , plumbing or roof leakage noted.

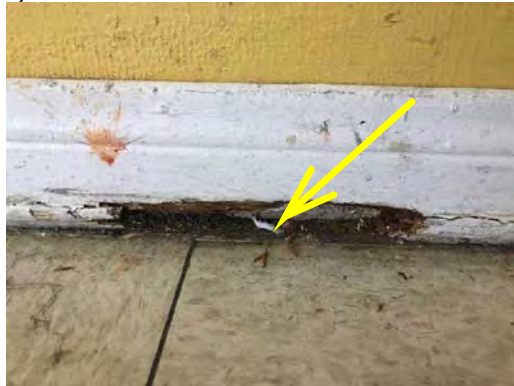
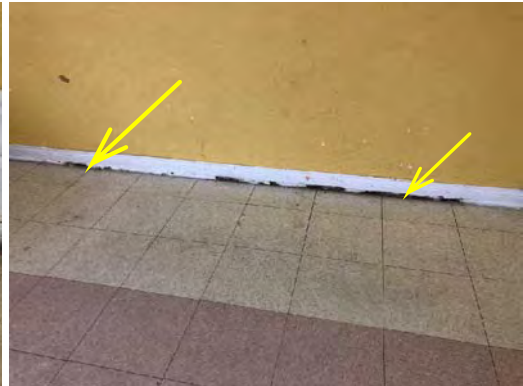
Walls: (continued)

60. Needs Attention Walls: Paint and paneling - (1) Water damage and signs of mold activity evident: Base boards show rot and mold and they all may have to be removed for mold abatement treatment. Consult with a mold expert for further evaluation and possible need of abatement (2) Underside tile mastic may contain asbestos. See notations for asbestos presence possibility, in other areas, in this report.

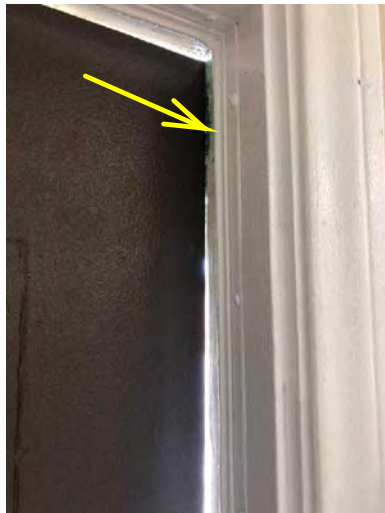
Floor: Linoleum  
Doors: Wood - **Door sticks**

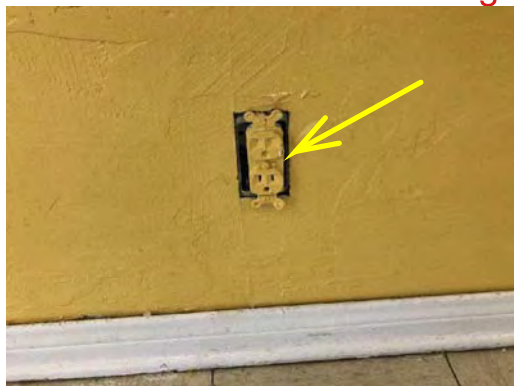
Windows: Aluminum slider  
Electrical: 110 VAC - **Missing or loose outlet/switch cover plates**

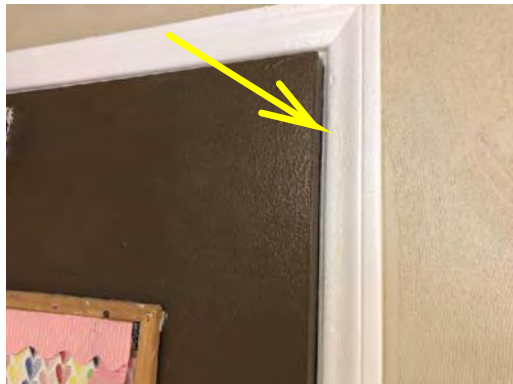
71. Serviceable

Doors: Wood - **Door sticks**

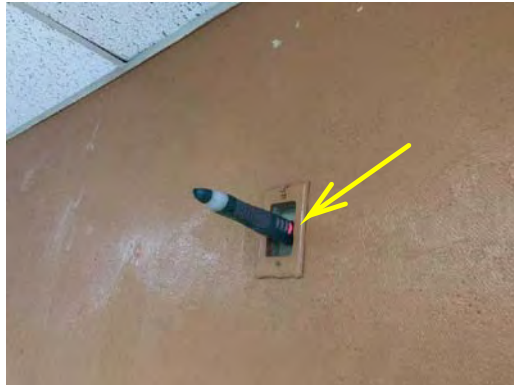
Windows: Aluminum slider  
Electrical: 110 VAC - **Faulty outlet with loose, disconnected or crossed wires.**

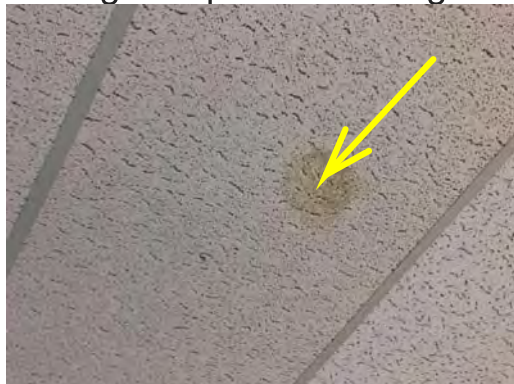
- 76. Acceptable
  - 77. Needs Attention
- Closet: Shelves  
Ceiling: Suspended ceiling - **Water stains present**

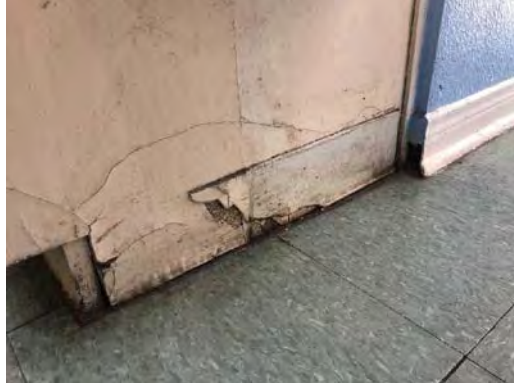
Walls: Paint and paneling - **Water damage with mold presence possibility. Consult a mold expert for further evaluation.**

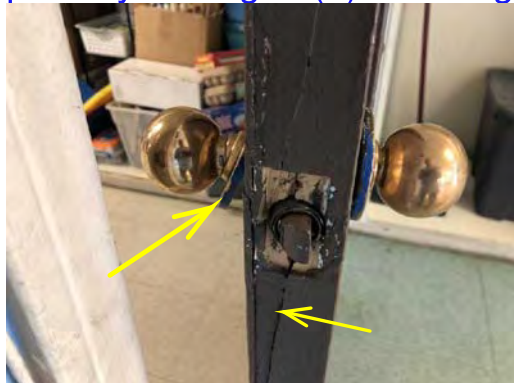
Doors: Wood - (1) Loose or missing hardware (2) Door sticks and partially damaged (3) Wall edge damaged.

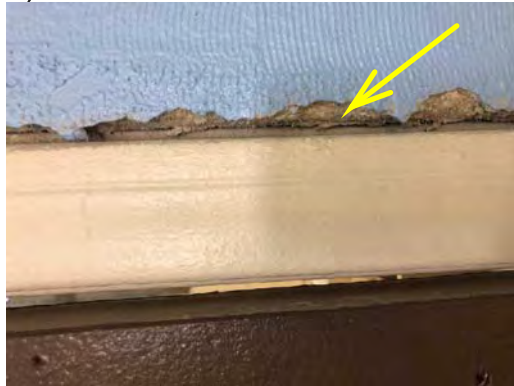
Windows: Aluminum slider - (1) Hard operation. Lubricate, repair or replace as necessary (2) Missing screen here and in the other classrooms

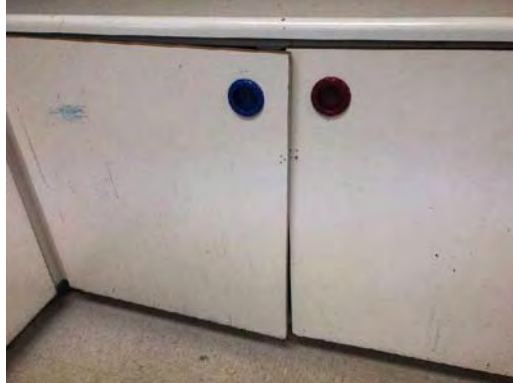
Closet: Shelves - Cabinet door needs repair

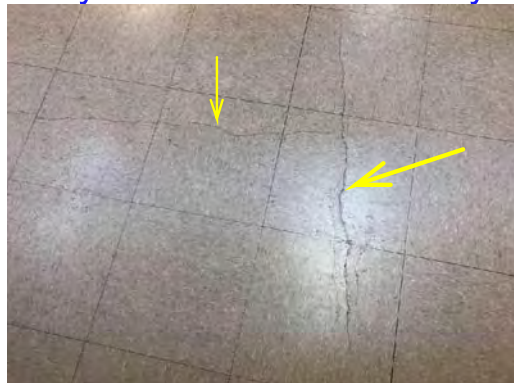
- 94. Acceptable Closet: Shelves
- 95. Acceptable Ceiling: Suspended ceiling
- 96. Acceptable Walls: Paint and paneling
- 97. Serviceable Floor: Linoleum - (1) Damaged floor (2) Asbestos Presence  
Possibility Here or in other rooms: The adhesion mastic under vinyl tiles may contain asbestos. Any change or modification here should be done cautiously and properly. Consult with an asbestos expert to verify if removal is necessary.

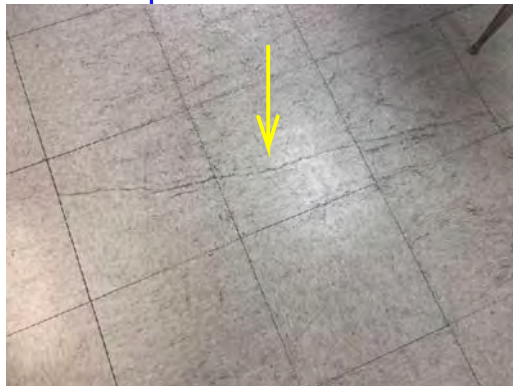
- 103. Acceptable Closet: Shelves
- 104. Acceptable Ceiling: Suspended ceiling
- 105. Acceptable Walls: Paint and paneling
- 106. Serviceable Floor: Linoleum - [Damaged floor. See other notes regarding asbestos in this report.](#)

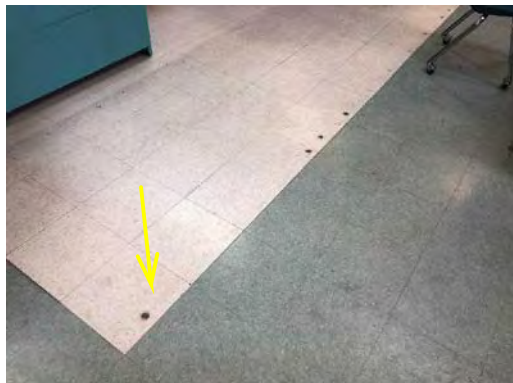
115. Serviceable Floor: Linoleum - [Damaged floor. See notes regarding asbestos in other areas.](#)

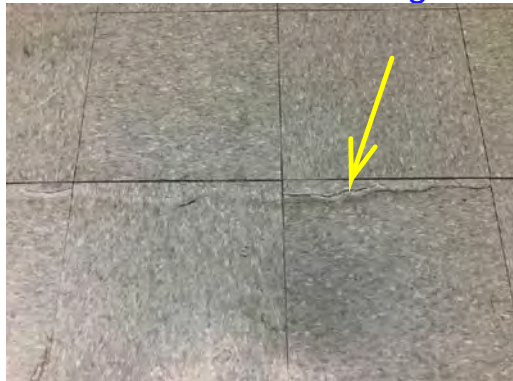
- 123. Acceptable      Walls: Paint and paneling
- 124. Serviceable      Floor: Linoleum - **Damaged floor. Asbestos presence possibility.**
