**CITY PROPERTY SERVICES**  
Commercial & Residential Inspections

# Property Inspection Report

**Sample Report Address**

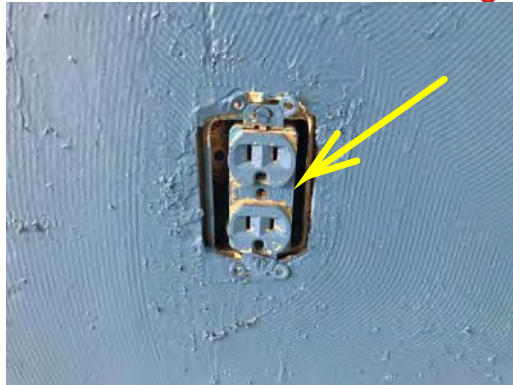
Doors: Wood  
Windows: Aluminum slider  
Electrical: 110 VAC - **Missing or loose outlet/switch cover plates**

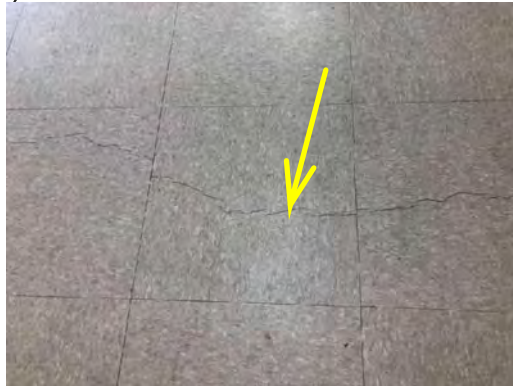
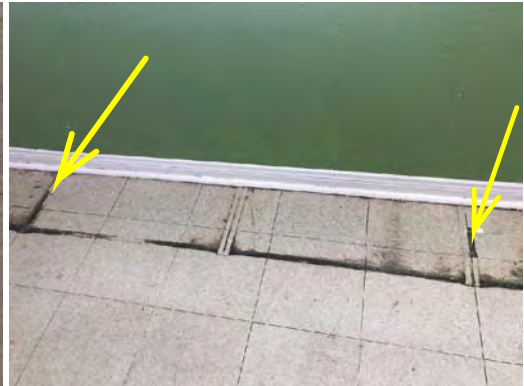
Closet: Shelves  
Ceiling: Suspended ceiling  
Walls: Paint and paneling  
Floor: Linoleum - **Damaged floor with exposed mastic. See notations regarding asbestos in other areas.**

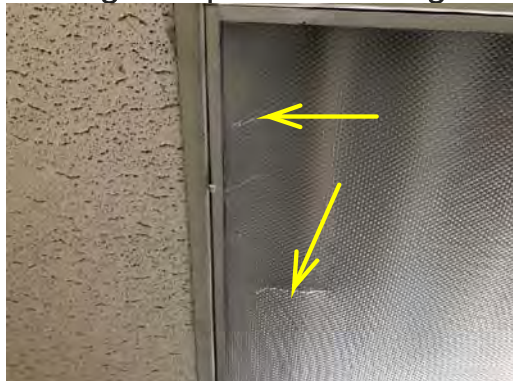
- 139. Acceptable
  - 140. Serviceable
- Closet: Shelves  
Ceiling: Suspended ceiling - **Cracked panel noted**

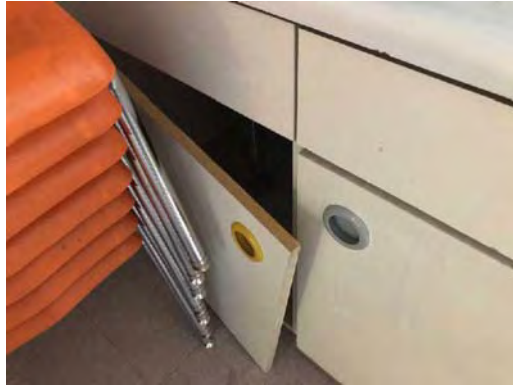
Walls: Paint and paneling - Damaged cabinets here in other rooms noted.

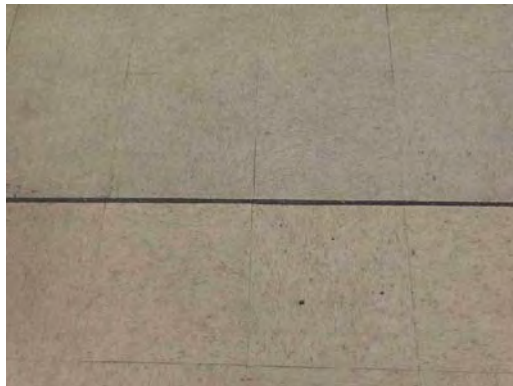
Floor: Vinyl - Damaged floor. See notations regarding asbestos in other areas.

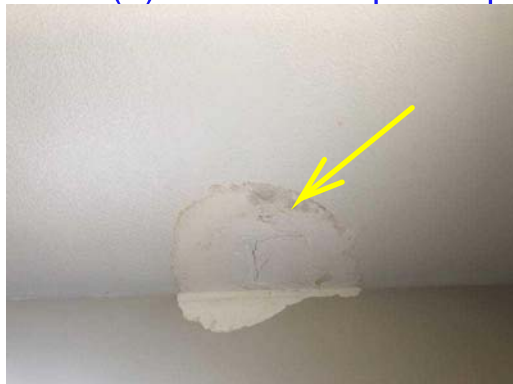
149. Needs Attention Ceiling: Paint and Paneling - **(1) Paint damage due water seepage noted (2) Evidence of past repair**

32. Maintenance Room Work Area Ceiling: Paint and Paneling - (1) Paint damage due water seepage noted (2) Evidence of past repair
33. Maintenance Room Work Area Fire Emergency Alarms All and any fire alarm and emergency apparatus should be checked by a retrofit company or electrician to verify functionality on yearly basis. Inquire with owner regarding records of last inspections and any available documentation in this regard.

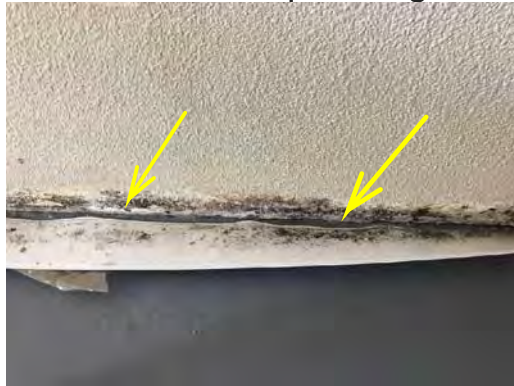
Walls: Paint and paneling - **Surface mold noted.**

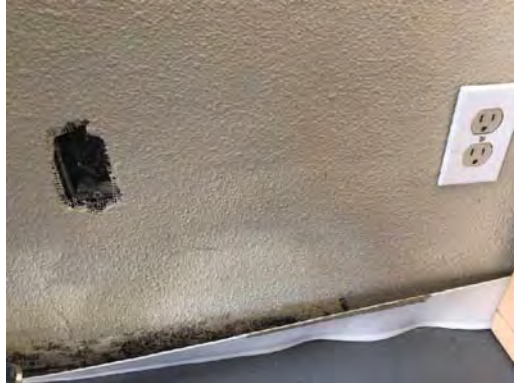
Electrical: 110 VAC - **Missing or loose outlet/switch cover plates**

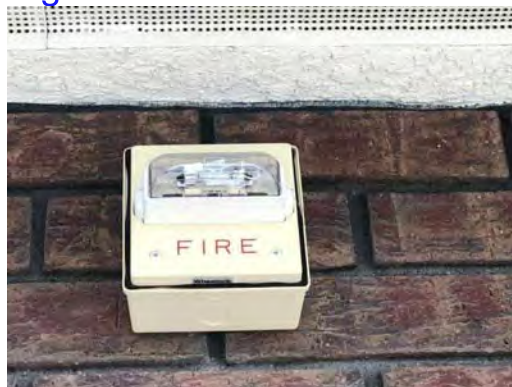
157. Needs Attention Fire Emergency Alarms All and any fire alarm and emergency apparatus should be checked by a retrofit company or electrician to verify functionality on yearly basis. Inquire with owner regarding records of last inspections and any available documentation in this regard.

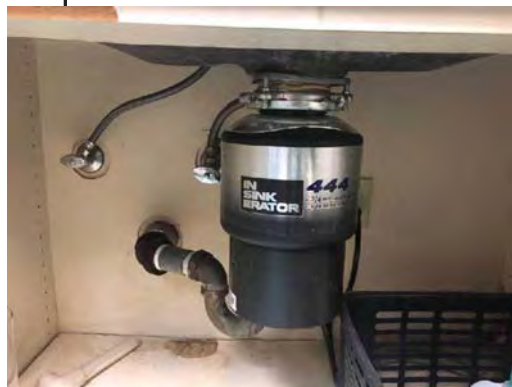
- 1. Not Inspected    Cooking Appliances: Not applicable
- 2. Not Inspected    Ventilator: Not applicable
- 3. Serviceable        Disposal: In-Sinkerator - Loud

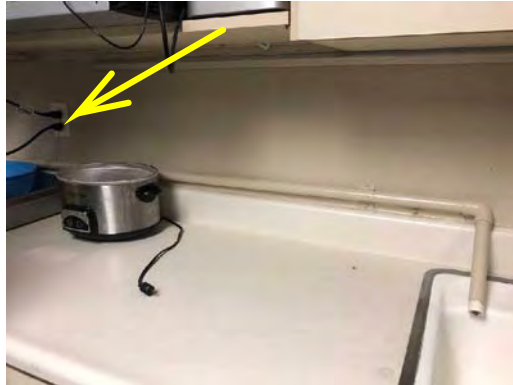
Electrical: **Non-GFCI or GFCI labeled outlet. Consult a qualified Electrician.**

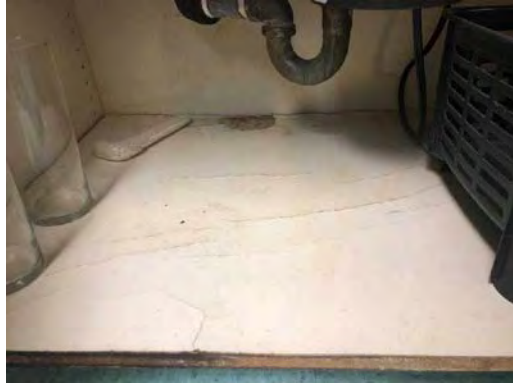
Plumbing/Fixtures: Metal / Metal  
Counter Tops: Formica - **Water damage present under the counter. Dry at inspection time.**

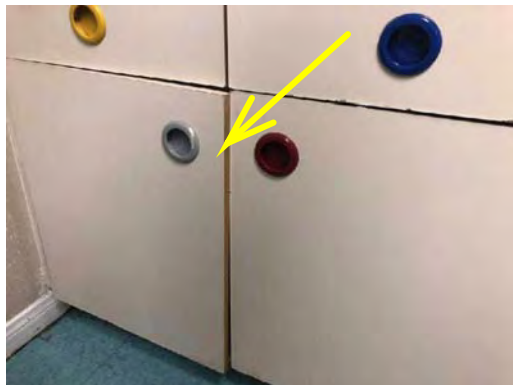
Cabinets: Wood - **Cabinet door needs adjustment**

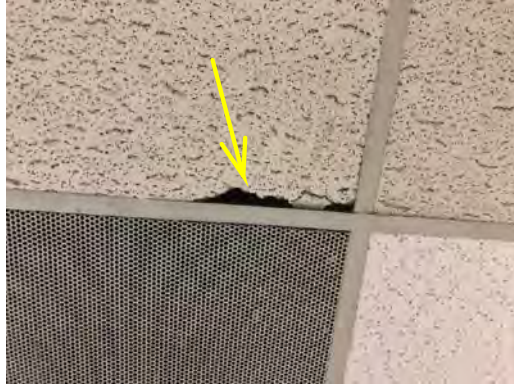
13. Needs Attention Ceiling: Suspended ceiling - Damaged panel noted. Repair will prevent insect traffic.

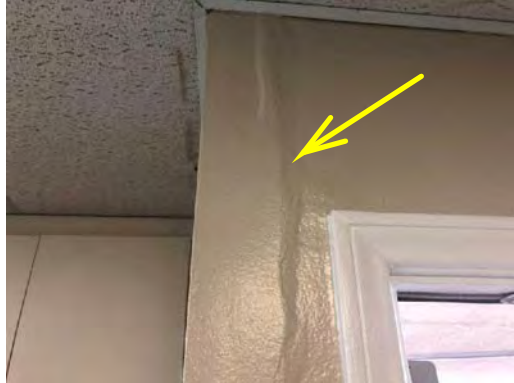
14. Needs Attention Walls: Paint and paneling - Evidence of past repair or damage.

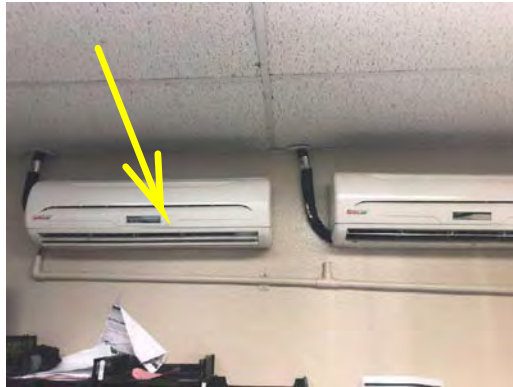
- 16. Acceptable
  - 17. Acceptable
  - 18. Serviceable
- Doors: Wood  
Windows: Aluminum slider  
HVAC Source: Wall Unit - **The left wall unit not functional/semi-functional. Consult an HVAC expert.**
